**Transformer Fire and Mineral Oil Leak at
Unit 8 of Bruce B Nuclear Generating
Station**

EVENT INITIAL REPORT (EIR)

EIR: Bruce B Unit 8 Station Service Transformer Fire and Mineral Oil Leak	
Prepared by: Directorate of Power Reactor Regulation, Bruce Regulatory Program Division	
Licensee: Bruce Power	Location: Bruce B Unit 8
Date Event was Discovered: December 6, 2018	Have Regulatory Reporting Requirements been met? Yes <input checked="" type="checkbox"/> No <input type="checkbox"/> Proactive Disclosure: Licensee: Yes <input checked="" type="checkbox"/> No <input type="checkbox"/> CNSC: Yes <input checked="" type="checkbox"/> No <input type="checkbox"/>
Overview	
Reporting Criteria: A declaration of an emergency, within the nuclear facility, where personnel or resources are mobilized by the licensee in response to an unexpected occurrence that creates a hazard to the safe operation of the nuclear facility, to the environment, to the health and safety of persons.	
Description: At 19:17 hrs on December 6, 2018, the CNSC duty officer (DO) was informed by Bruce Power of a fire at the Unit 8 station service transformer (SST or TSS8) outside of the Bruce B Power House Building. Unit 8

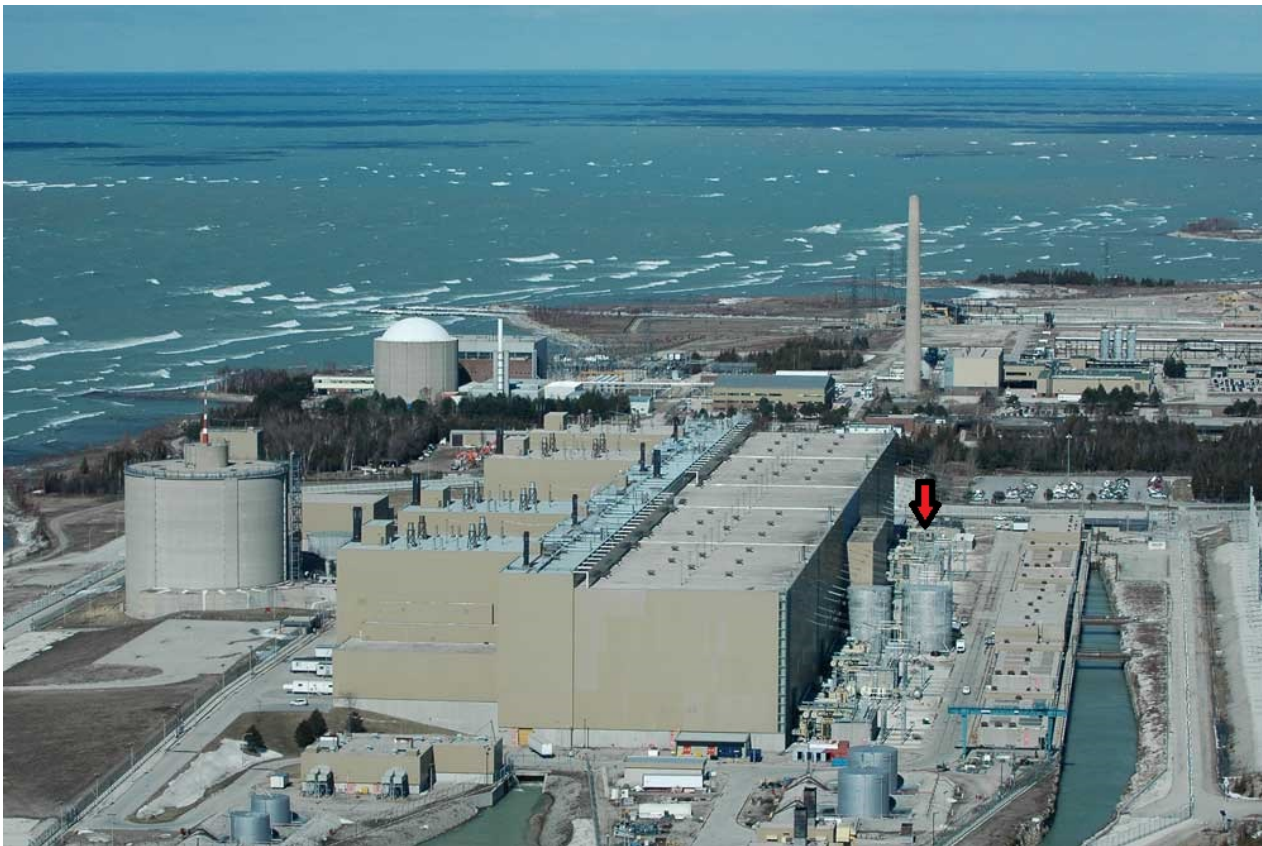
Figure 2: Photograph of Bruce B Showing the Location of the Unit 8 SST Fire

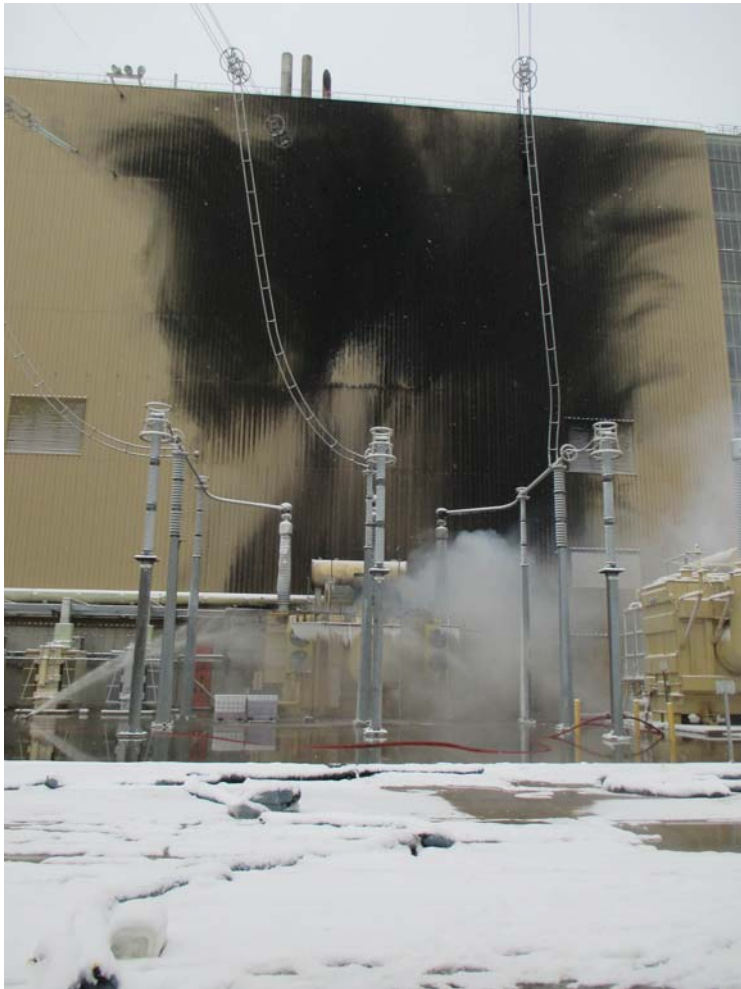
Figure 4: Photograph of Transformer and Powerhouse Wall on Dec. 7, 2018 after the Fire was Extinguished
