CMD 23-M20.1

Bruce A Unit 4 Heat Transport
Purification System Heavy Water Leak

Bruce A Unit 4 Heat Transport Auxiliaries Heavy Water Leak

EVENT INITIAL REPORT

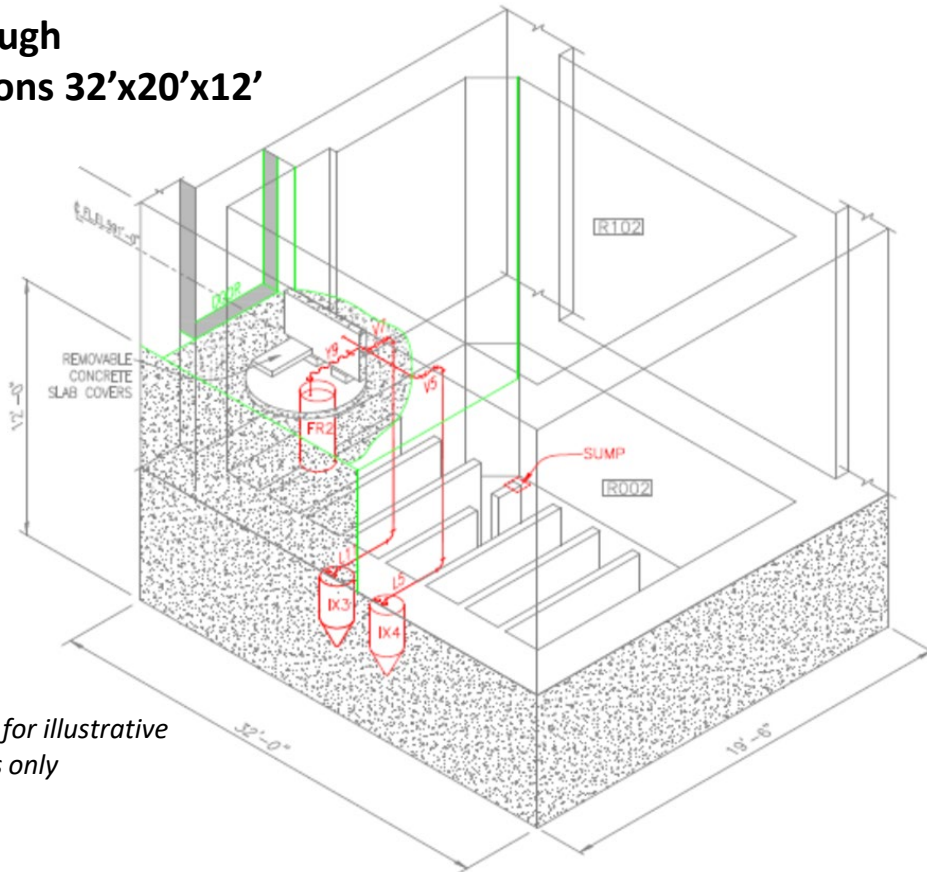
Vault Rough Dimensions 32'x20'x12'

- Ruptured PHT Purification Hose was not isolated until after unit 4 was shutdown and depressurized.
- Leak detection system for the PHT filter room failed which challenged diagnosis of leak location.

- All 8 hoses for U4 purification filters replaced.
- Additional camera installed in R002 as secondary leak detection.
- Interim operating procedure (ACM Op Memo) generated to aid in leak diagnostic. Specifically will go look for leakage in Rm 102 vault.
- Independent review of response by Governance Oversight & Learning (Training).
- Analysis of pressure tube and steam drum piping impacts completed with acceptable results.
- Operational review of return to service requirements completed.
- Station Leadership discussion with Site CNSC Director and Site Inspectors.
