**Oral presentation by
Énergie NB Power**

**Update on partial loss of Class IV
power and heavy water leak of
December 2022 at NB Power's Point
Lepreau Nuclear Generating Station**

Point Lepreau Nuclear Generating Station

Update on Partial Loss of Class IV Power
and Primary Heat Transport (PHT) System
Leak in December of 2022.

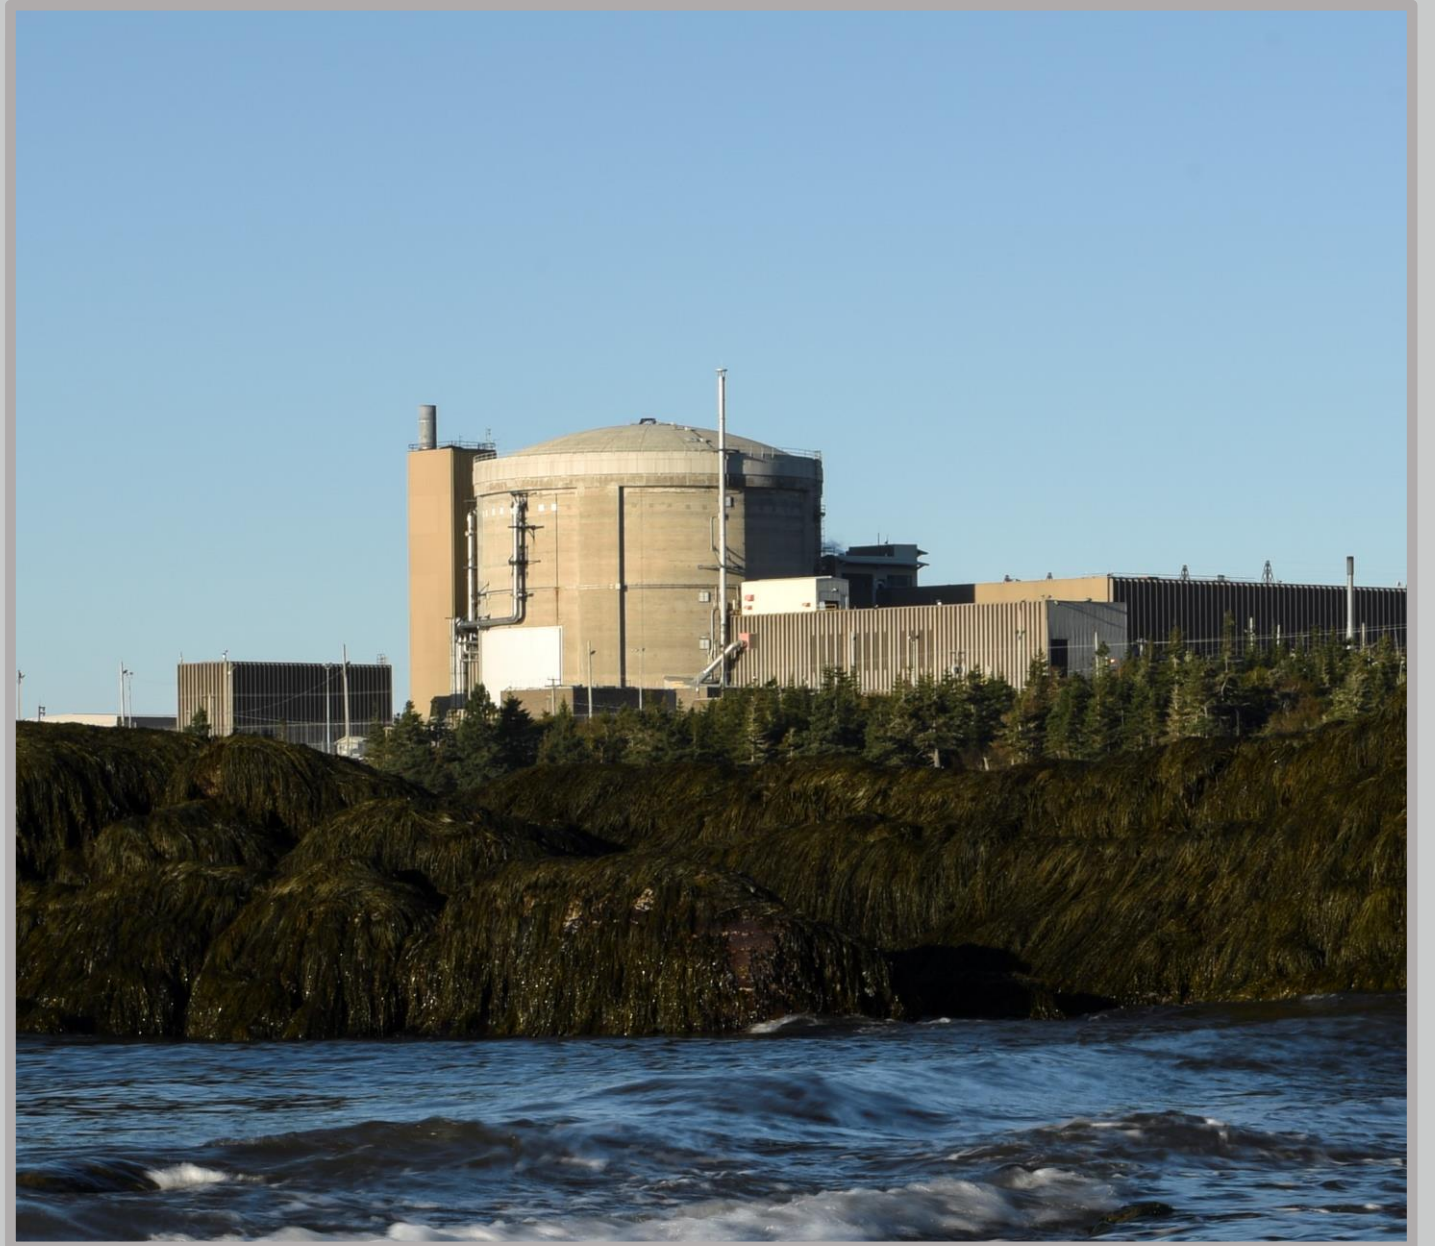
- On December 14, 2022, the station was taken offline due to a partial loss of Class IV power:
 - An electrical fault on the Unit Service Transformer (UST) initiated the automatic shutdown of the transformer.
 - The fault was determined to be due to a separation of the cable connector shielding on cable PA-18.
 - Shortly after, reactor building annunciators indicated the presence of a contained leak from the Primary Heat Transport system associated with a 3/8-inch instrument line.
 - The analysis of the instrument line determined that it was a result of high cycle fatigue.

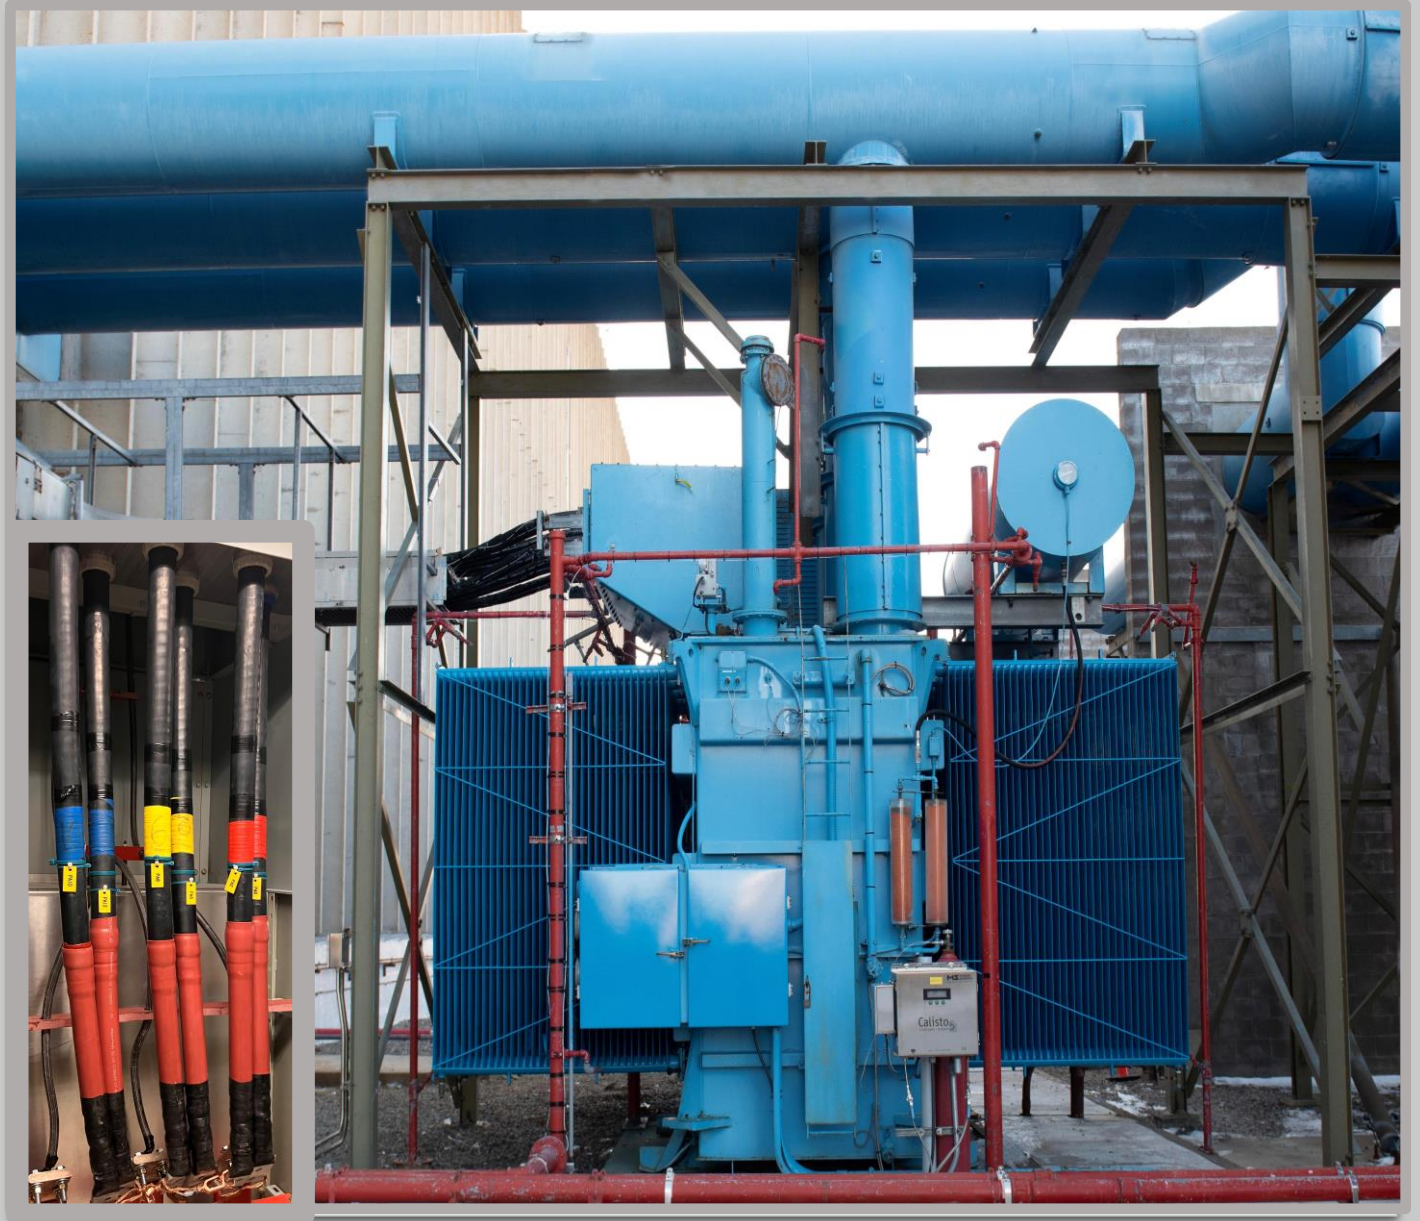
- Cable terminations performed in 2019 on the UST did not have the required overlapping of copper shielding.
- The procedure for conducting the cable terminations did not provide sufficient guidance for overlapping the copper shielding.
- The subject matter expert for the terminations had insufficient detailed technical direction.
- The station is updating our infrequently performed maintenance process to incorporate the lessons learned from this event.
- Extent of condition for all similar cables has been performed.

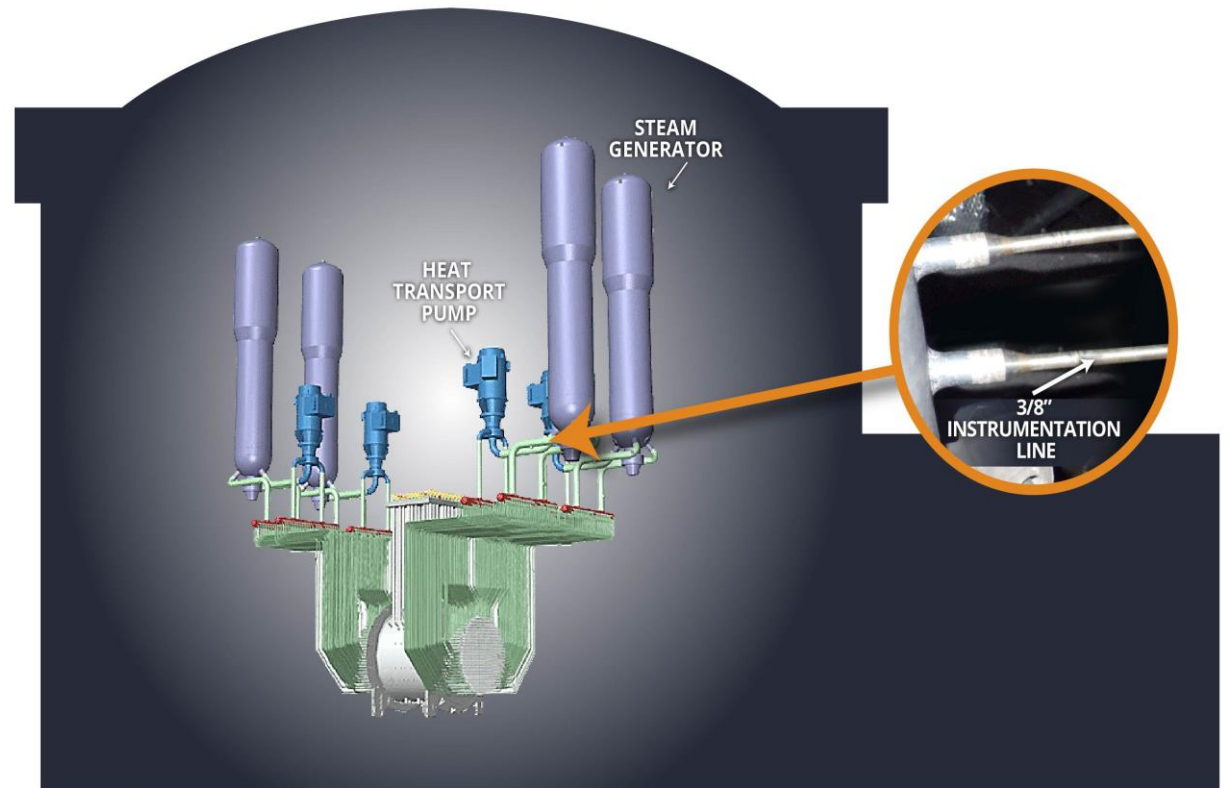
Reactor Building

- Analysis determined the cause of the failure to be high cycle fatigue cracking on the instrument tube near a weld.
- Weld repairs to cut and cap the affected instrument line were successfully completed.
- Three similar instrument lines were cut and capped as an extent of condition and preventive measure.
- Instrumentation lines were associated with restriction orifice monitoring installed during original construction.
