CMD 25-M36 - CNSC Staff Submission

Workplace injuries at Ontario Power Generation's Darlington New Nuclear Project Site

EIR: Workplace injury at Ontario Power Generation's Darlington New Nuclear Project Site

Location: Darlington New Nuclear Project (DNNP) Site

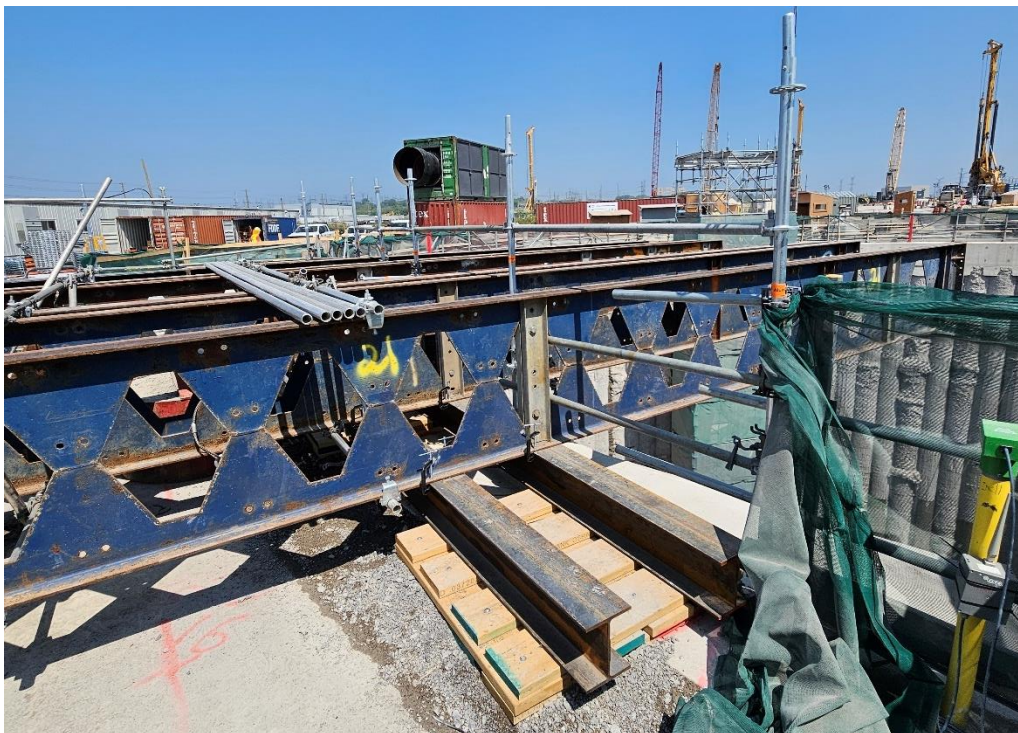
On July 14, 2025, at approximately 10:15 pm, an AECON Group Inc. (AECON) sub-contracted worker sustained injuries to both heels, requiring hospitalization. The incident occurred near the excavation site for the DNNP Tunnel Boring Machine (TBM) launch shaft (see Figure 1).

At the time of the incident, work was underway to construct a stairway tower for access to the bottom of the excavation shaft. This large tower structure, built with I-beams, is cantilevered over the TBM. Construction of this structure involved the placement of concrete counterweights near the end of the I-beam deck, opposite to the portion of the platform hanging over the TBM launch shaft. The concrete blocks were being lifted by a tower crane and guided into position by the worker on the south edge of the deck using a long reach tool. While positioning one of the concrete blocks, the receiving worker lost his balance and jumped off the I-beam to the surface 4.5 feet (1.38 metres) below (see Figure 2), resulting in fracture to both heels.

Figure 1: I-beams cantilevered over the Tunnel Boring Machine launch shaft

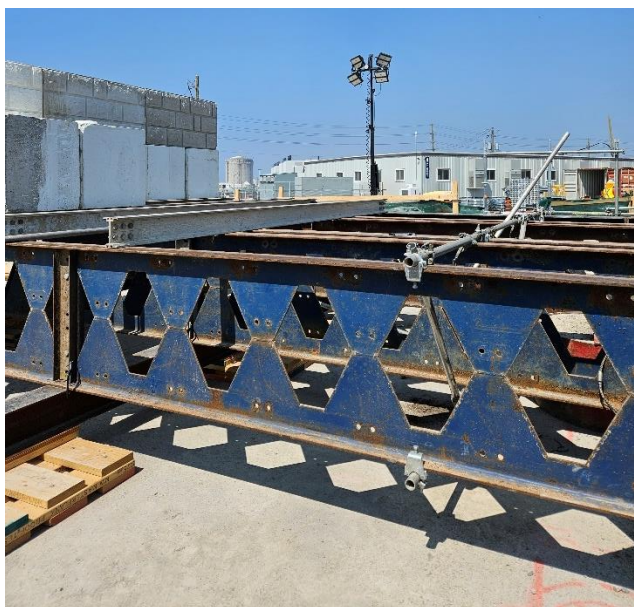
Figure 2: Location where the worker jumped down from the I-beams and sustained injuries while directing counterbalance concrete blocks

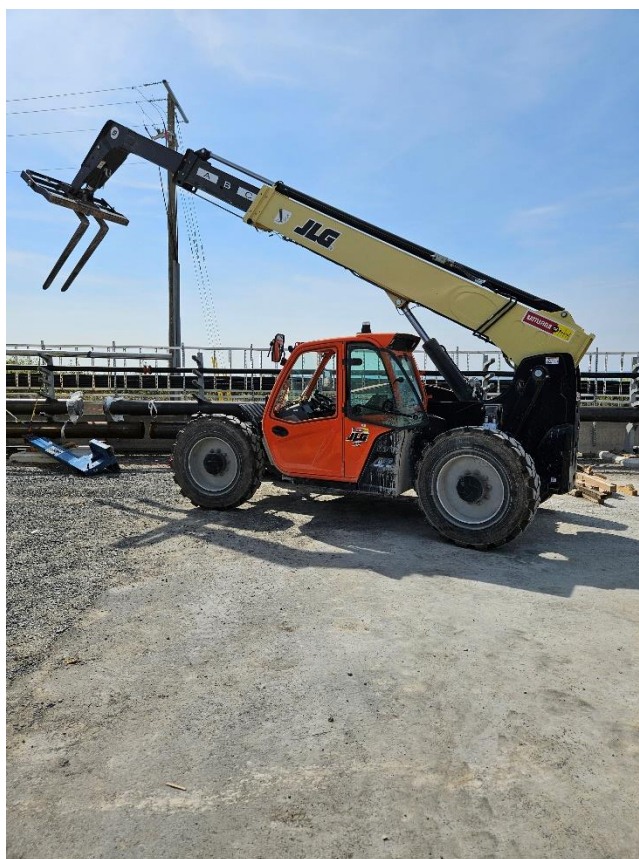
On July 24, 2025, at approximately 9:00 am, an AECON worker sustained an injury to their humerus bone, which required hospitalization. The event occurred at a work area located to the southeast of the TBM launch shaft.

Workers were in the process of lifting a pipe onto an elevated installation area with a telehandler (see Figure 3). As the pipe was placed into position, a worker started to unhook the straps off the piping. During this time, the lift device (known as a jib) connected to the forks of the telehandler fell and struck the worker in the shoulder. The worker was transported to the hospital by ambulance.

Figure 3: Telehandler and lifting attachment

- Work activities only resumed onsite over the course of several weeks once OPG has deemed the work site to be safe, and that identified corrective actions have been taken.
