**CMD 26-M11 - CNSC Staff Submission**

**Event Initial Report – Roof Fire at Candu Energy Inc.**

<b>EIR: Roof fire at Candu Energy</b>	
<b>Prepared by:</b> Wastes and Decommissioning Division, Directorate of Nuclear Cycle and Facilities Regulation	
<b>Licensee:</b> Candu Energy Inc.	<b>Location:</b> 2233 Speakman Drive, Mississauga, Ontario
<b>Date Event was Discovered:</b> 2026-02-28	<b>Have Regulatory Reporting Requirements been met?</b> Yes <input checked="" type="checkbox"/> No <input type="checkbox"/>  <b>Proactive Disclosure:</b> Licensee: Yes <input checked="" type="checkbox"/> No <input type="checkbox"/> CNSC: Yes <input checked="" type="checkbox"/> No <input type="checkbox"/>
<b>Overview</b>	
<b>Reporting Criteria:</b>  General Nuclear Safety and Control Regulations (SOR/2000-202)  29 (1) Every licensee who becomes aware of any of the following situations shall immediately make a preliminary report to the Commission of the location and circumstances of the situation and of any action that the licensee has taken or proposes to take with respect to it: <ul style="list-style-type: none"> <li>(d) a situation or event that requires the implementation of a contingency plan in

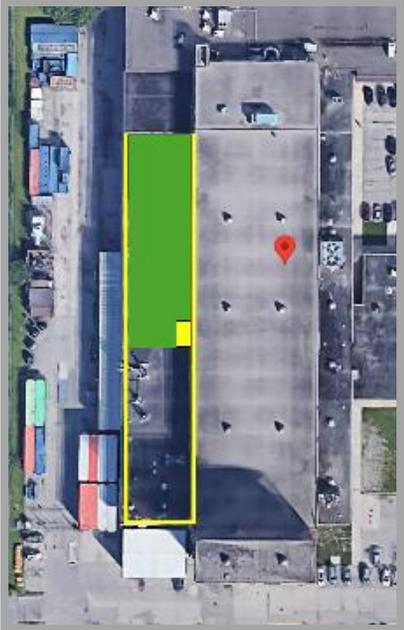
**Figure 1 above:** yellow square indicates roof fire location; green is previously completed roof repair; balance of area within the yellow border is remaining section of the roof where repair work has not commenced

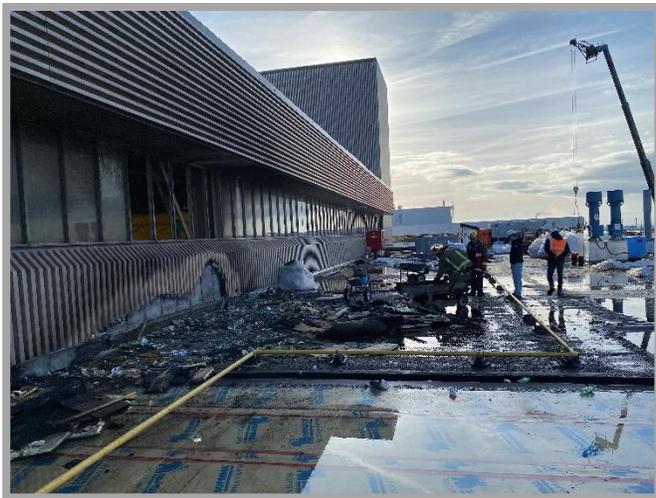
**Figure 2 above:** roof with fire damage

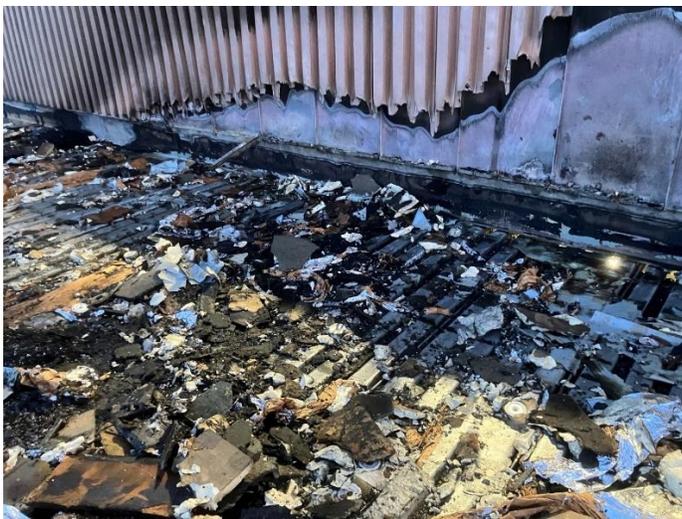
**Figure 3 above:** section of the roof that breached building exterior

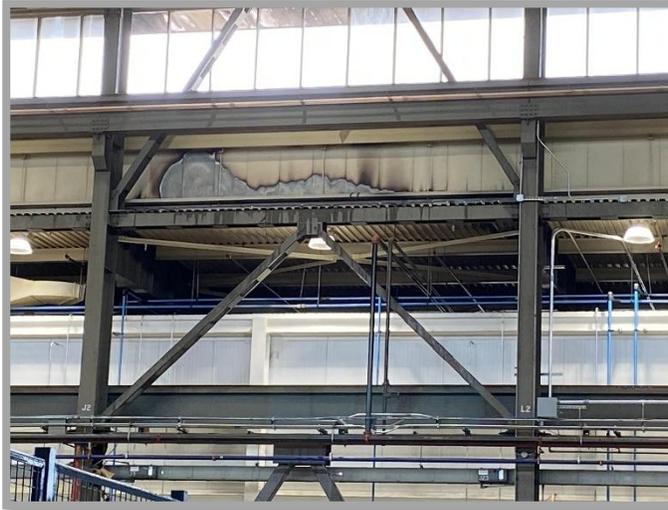
**Figure 4 above:** building interior damage where fire breached building exterior

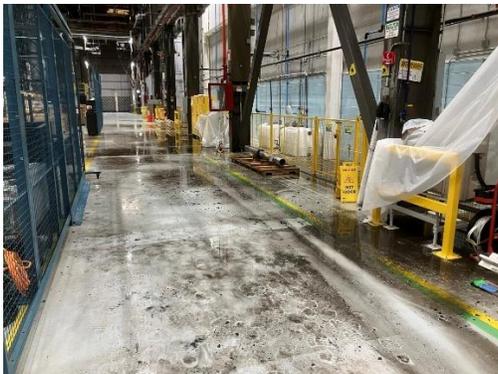
**Figure 5 above:** interior building water damage

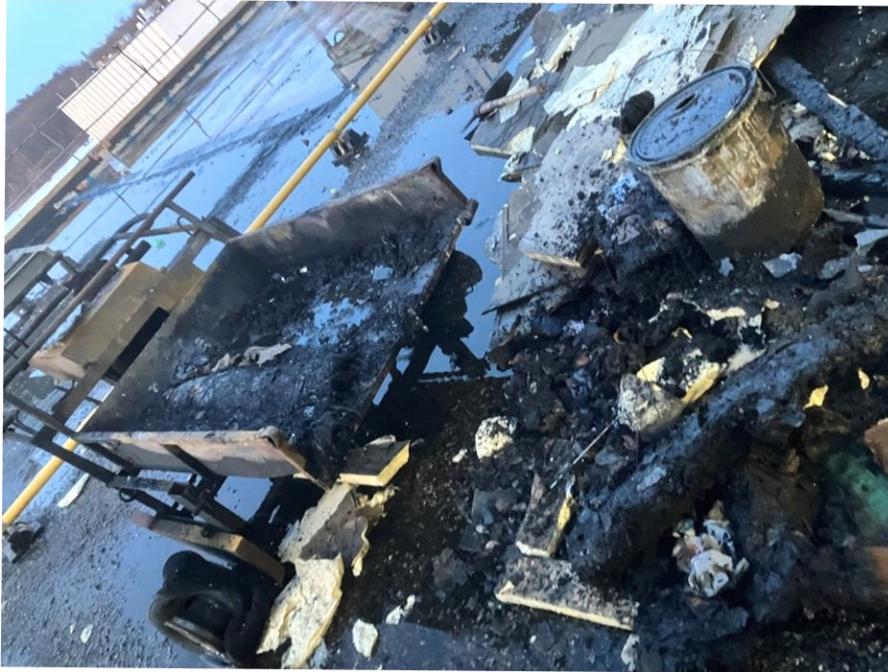
**Figure 6 above:** roofing repair equipment cart that contained lithium-ion battery portable light

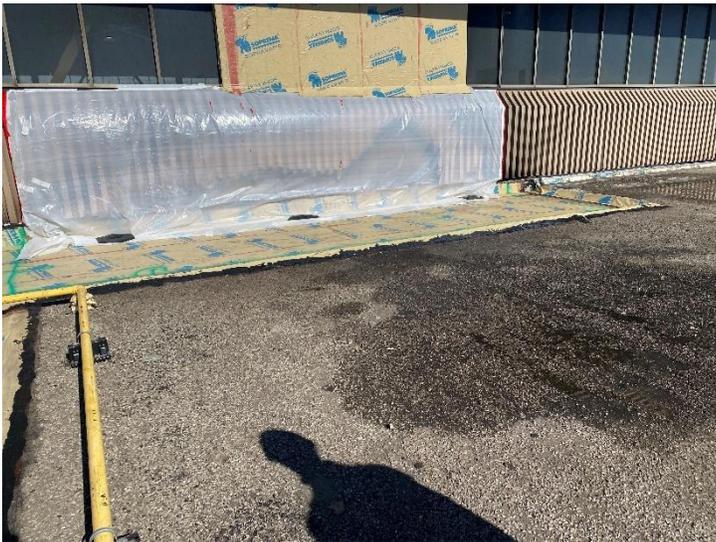
**Figure 7 above:** area of the roof and building wall panels showing the plywood and tarp material installed in place of the roof windows as temporary protective measure
