**CMD 26-M32.1**

Update on the root cause of generator  
fault at the Point Lepreau Nuclear  
Generating Station

## Main Generator Fault Root Cause Update

CMD 26-M32.1

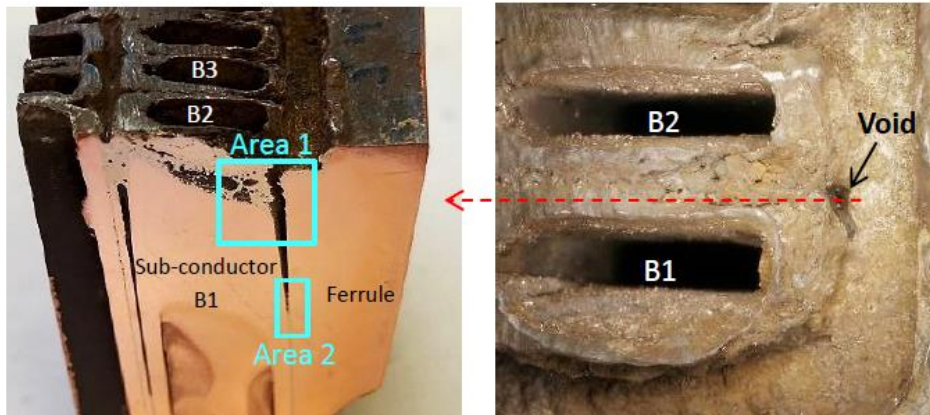
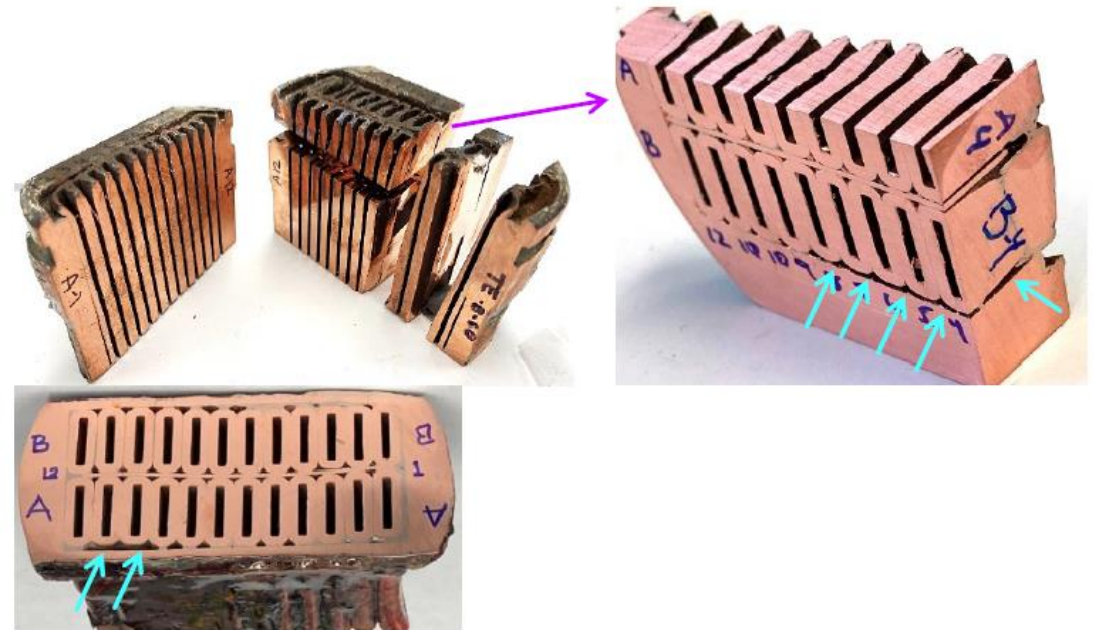
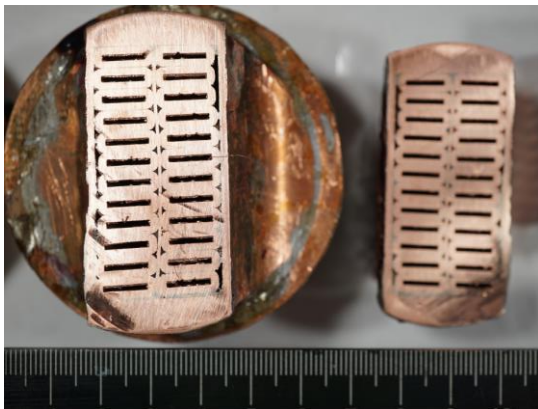
# B60 – Leak Path Through Braze

- Internal investigation identified that the stator windings exhibited manufacturing-related braze and solder voids, as well as surface conditions that provided a pathway for localized corrosion of the stator bars (braze and solder). The non-uniform surface condition of the braze at the bar ends established localized crevices, allowing crevice corrosion to initiate and propagate through the braze.
- The failed bar (B60) exhibited crevices and surface voids, which are known to increase susceptibility to crevice corrosion. Corrosion of the braze “cake,” together with the significant voids within the braze, provided flow paths for leakage. Once established, these flow paths allowed stator cooling water to pass through the braze and wet the winding insulation.

- B60 - leak path through braze (void in cake between B1 and B2 strands) and visible braze voids.
