**December 13, 2018**

Date: 2018-12-13 File / dossier: 6.02.04

<b>Update from CNSC Staff</b>	Mise à jour du personnel de la CCSN			
Status Update on Port Hope Harbour Wall Collapse of October 9, 2018	Mise à jour au sujet de l'effondrement du mur au port de Port Hope le 9 octobre 2018			
Commission Meeting	Réunion de la Commission

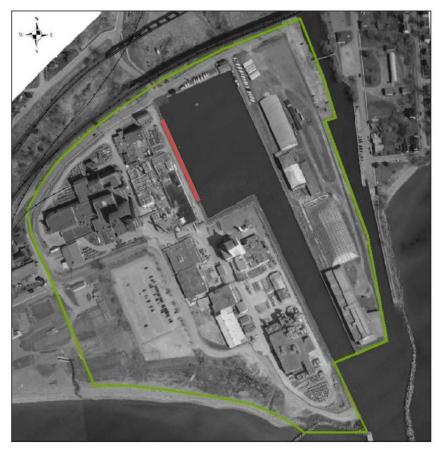
Figure 1: Arial view of the Port Hope Harbour. The main PHCF site, harbour, and Center Pier are outlined in green. The red line indicates the approximate area of the collapsed harbour wall.

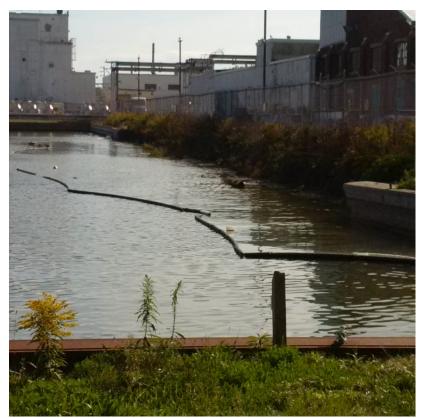
Figure 2: Photograph of collapsed section of harbour wall and silt curtain (view from North)

The collapsed section of the harbour wall is outside of, and immediately adjacent to the Cameco PHCF. Cameco operations, including the cooling water discharge, fenceline and internal road behind the fence were not affected. The existing silt curtain installed by the Municipality performed as expected, although it did receive minimal damage. The Municipality installed an additional curtain on October 12 and is meeting regularly with Cameco and CNL to discuss potential impacts that may result from the collapse of the wall. The Municipality is currently having the wall assessed to determine appropriate repair measures since the potential for erosion is high, and additional erosion could impact Cameco's fenceline and internal roadway. As a precautionary measure Cameco has closed the internal roadway running parallel to the harbour wall to vehicle traffic. Cameco is also planning the construction of an additional fence that will ensure the site security perimeter is maintained should further erosion of the shoreline compromise the existing fence.

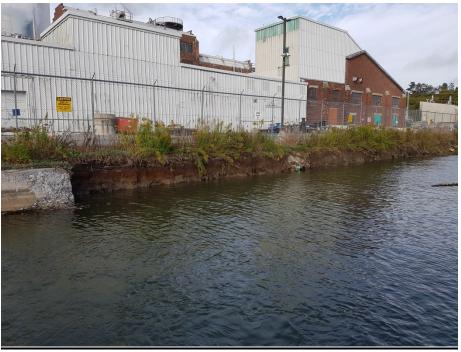
Figure 3: Photograph of collapsed section of harbour wall (view from South)

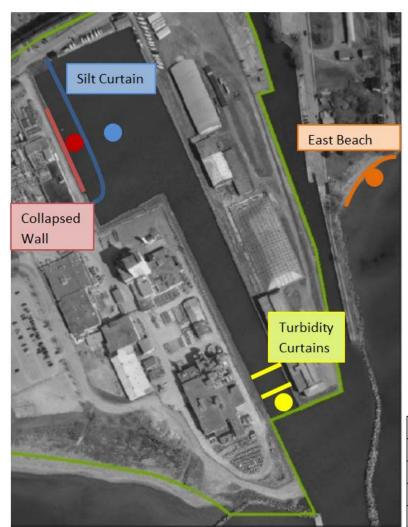
Figure A-1: Surface water sampling locations

Sample	Location
W1 <b>(</b>	Harbour Wall
W2	Harbour
W3 🛑	Lake Ontario
W4 🛑	East Beach
