**Supplementary written submission
from Ontario Power Generation**

**Opportunity to be heard on the orders
issued by a Designated Officer to Bruce
Power and Ontario Power Generation**

Pickering and Darlington NGS: Submission of Supplemental Information in Response to Designated Officer Orders and to Support Opportunity to be Heard Public Hearing

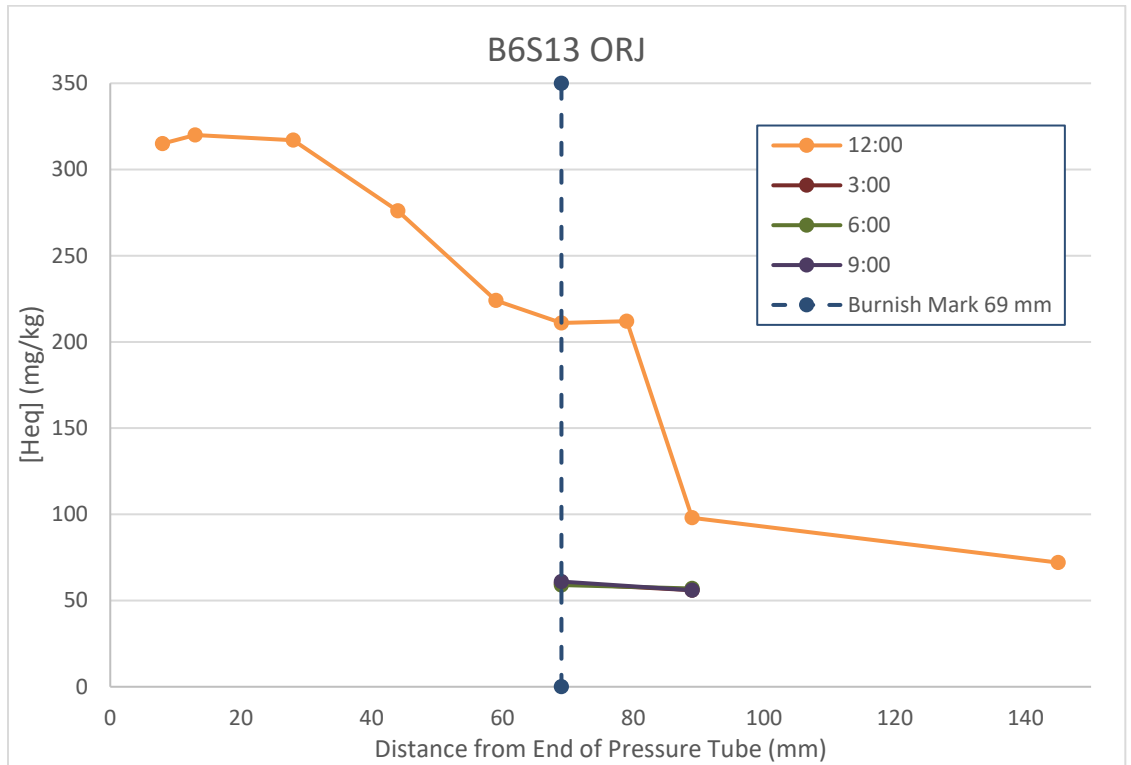
Figure 1: B3S13 Outlet RJ Measurements [8]

Based on current understanding and modeling of the BP OPEX, which postulates that flow by-pass at the outlet end of the pressure tube could result in lower temperatures at the top of the tube, it is expected that bulk hydrogen in the vicinity would migrate to the colder location (12 o'clock top dead center), resulting in a localized hydrogen equivalent concentration ([Heq]) accumulation at the top of the tube. This is supported by measurements from the B6S13 and D3S13 (Figures 1 and 2) that demonstrate that the high [Heq] measurements are limited to the top region of the tube. There is no evidence that measurements of a similar magnitude are occurring at the bottom of the tube (6 o'clock position), consistent with the postulated mechanism which is leading to the BP OPEX.

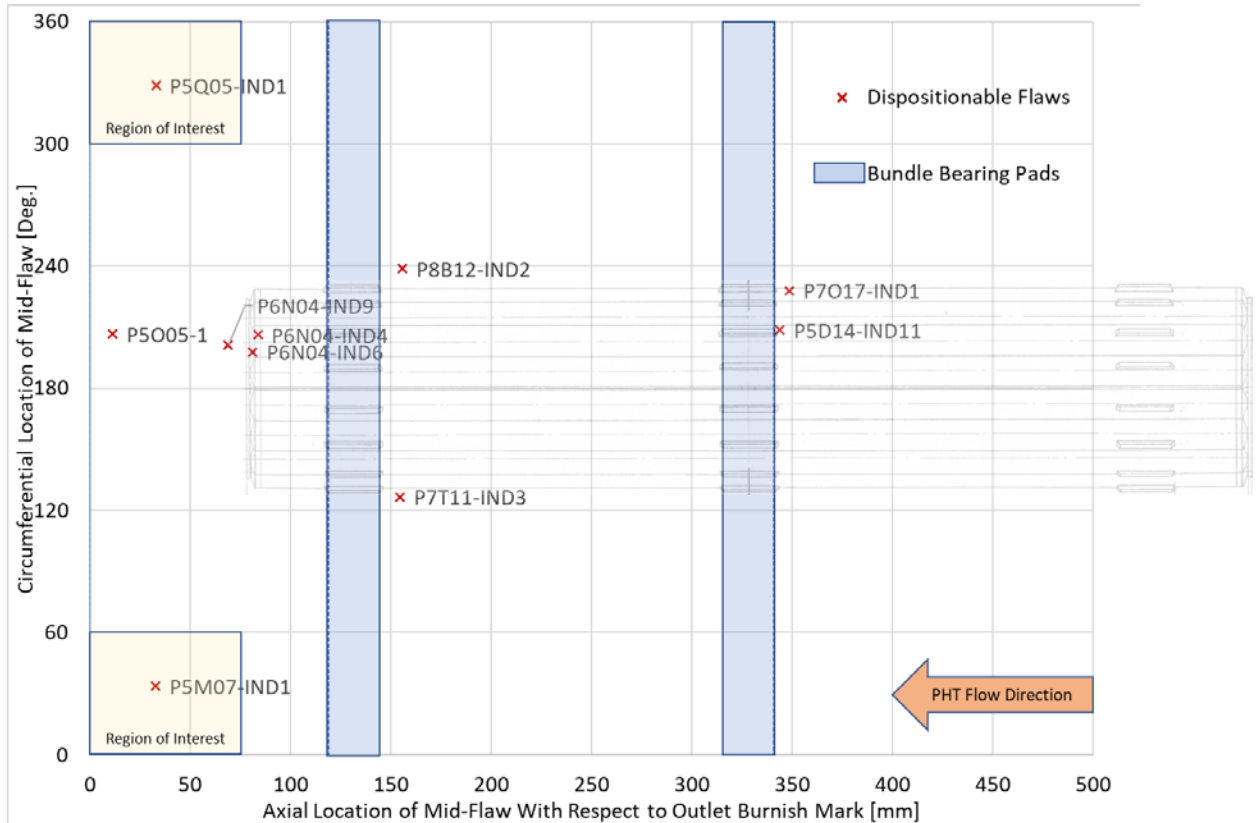
Figure 3: Overlay of Outlet End Fuel Bundle with Dispositionable Flaws in Pickering 5 to 8

In Pickering 5 to 8, during normal operating conditions, the shield plug holds the fuel string in position in the fuel channel against the forces applied by the flow of the coolant through the channel. Figure 3 shows an overlay of the last fuel bundle at the outlet end with the locations of dispositionable flaws in Pickering Units 5 to 8. The figure demonstrates that the shield plug is situated in the region of interest, thereby preventing flaw formation during normal operating conditions. This is supported by the fact that the majority of flaws correspond to either the fuel bundle bearing pads or the end plate positions in the bottom half of the PT. Therefore, fuel bundles are only in contact with the region of interest during

fueling operations as they continuously move throughout the fueling operation and pose no risk of flaw formation during normal operation. Fueling operations are of insufficient duration to result in the creation of dispositionable fretting flaws.

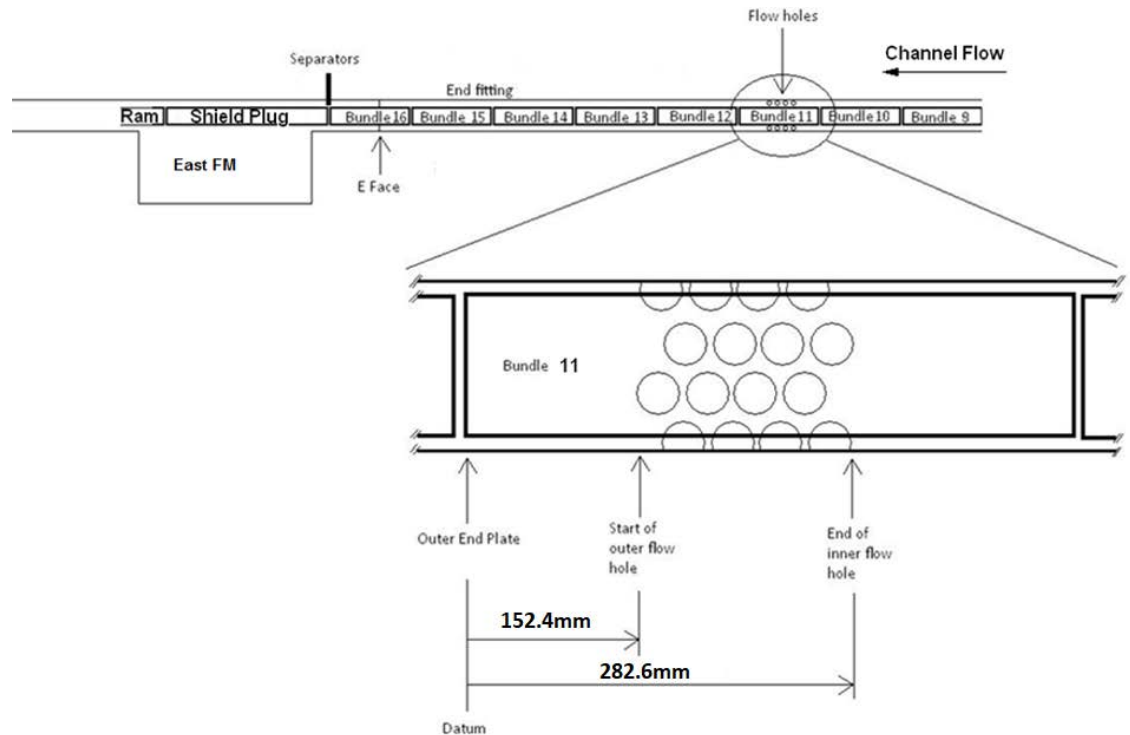
Figure 4: Location of Fuel Bundle from P5Q05 from January 2012 Cross Flow Event [11]

During fueling, cross flow conditions occur when a fuel bundle is transitioned through the reactor for fueling and it passes over the flow holes in the liner tube. Damage to the fuel bundle and/or pressure tube can occur if the fuel bundle remains in this position for an extended period of time as the turbulent flow may eventually cause fuel bundle damage. The bundles remain in this position due to fueling machine issues preventing fuel bundle movement through the cross flow region. Fuel bundles in cross flow for extended durations are rare event given the frequency of channel fueling. Fuel bundle damage may cause the bearing pads to fret against the PT. Figure 4 provides a schematic of the position of fuel bundle P49540C during an extended cross flow event, which resulted in P5Q05-IND1 [11].

OPG tracks and records cross flow events in Station Condition Records (SCRs) and station operating logs. A review of SCR was completed for cross flow events of extended duration which indicates that both dispositionable flaws in P5 in the region of interest were due to cross flow events. The fuel program also

Based on OPEX from fuel bundle and pressure tube events, OPG implemented operational procedure changes in 2015 that reduced the allowable time for irradiated fuel in cross flow conditions from 48 to 24 hours. Within 24 hours, the bundle must be removed from cross flow conditions or the Unit is required to be shutdown. Additionally, as a result of the cross flow flaws from P1N13 and P5Q05, channels which experienced significant cross flow conditions were added to the V&D channel selection criteria used for each planned maintenance outage.

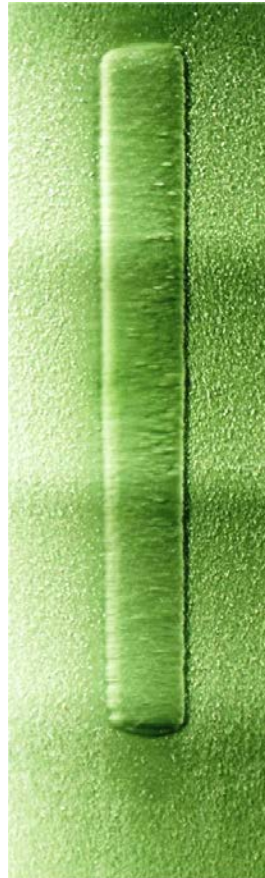
Figure 5: Optical Image of P5Q05-IND1 Flaw Replica [12]

V&D inspection provides information such as flaw length, depth and location. Additional flaw characterization can be obtained through application of a replica compound to establish the flaw size, shape and orientation. Replicas of flaws from cross flow events have demonstrated that these flaws are typical of a bearing pad fret flaw as shown in Figure 5. Bearing pad fret flaws are volumetric flaws created by fretting between the fuel bundle bearing pad and the pressure

tube, which results in local removal of material with a relatively large root radii in both the circumferential and axial directions (blunt flaws). These flaws are not an integrity issue (not predicted to initiate) due to the smooth and relatively large root radius which results in a lower stress concentration compared to sharp flaws.

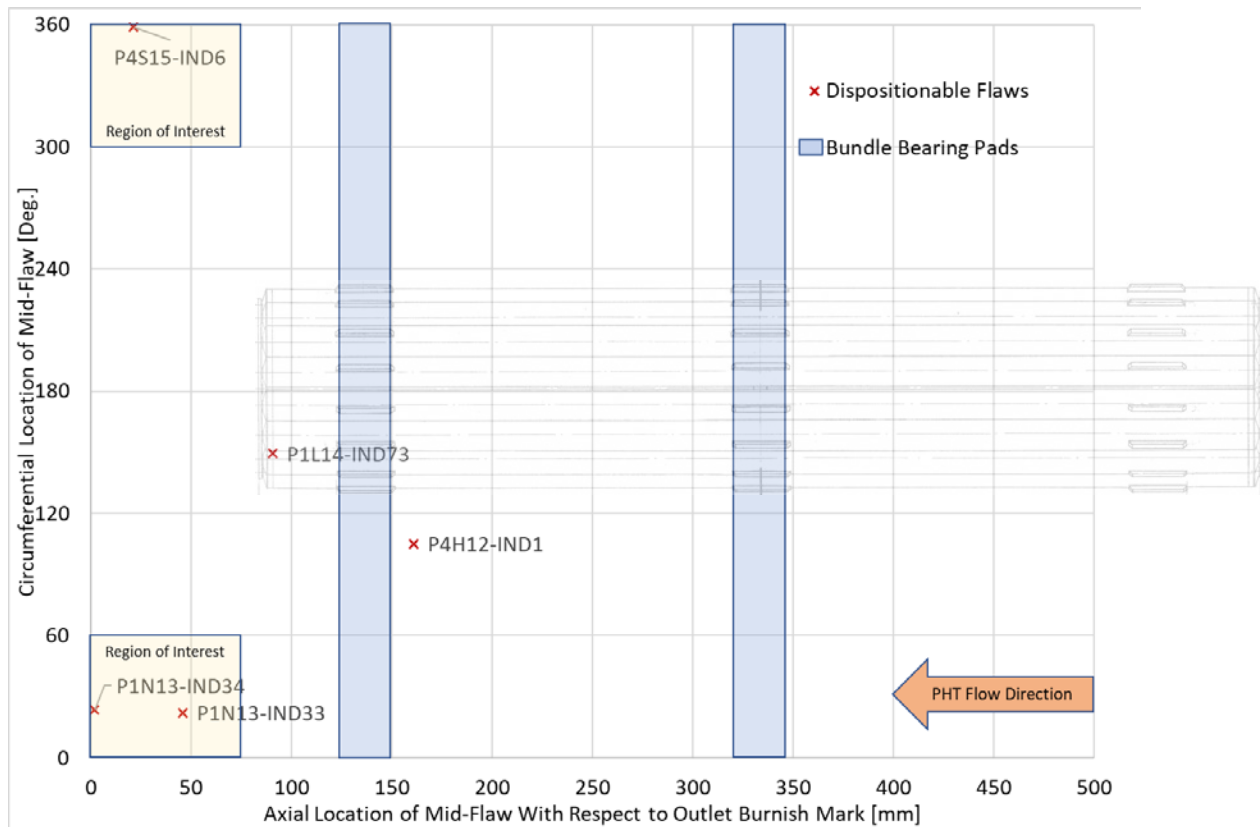
Figure 6: Overlay of Outlet End Fuel Bundle with Dispositionable Flaws in Pickering 1 and 4

Similar to Pickering 5 to 8, the shield plug in Pickering 1 and 4 holds the fuel string in position in the fuel channel against the forces applied by the flow of the coolant through the channel. Figure 6 shows an overlay of the last fuel bundle at the outlet end with the locations of dispositionable flaws. The shield plug is situated in the region of interest, thereby preventing flaw formation during normal operating conditions. This is supported by the fact that the majority of flaws correspond to either the fuel bundle bearing pad or the end plate positions in the bottom half of the PT. Therefore, fuel bundles are only in contact with the region of interest during fueling operations as they continuously move throughout the fueling operation and pose no risk of flaw formation during normal operation. Fueling operations are of insufficient duration to result in the creation of dispositionable fretting flaws.

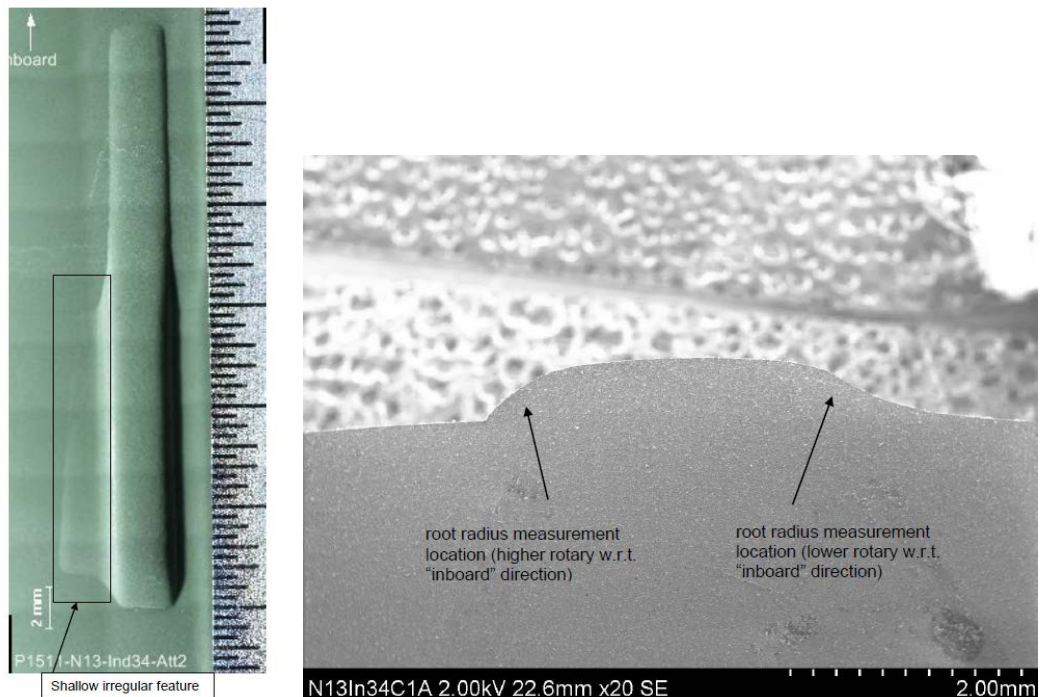
Figure 7: Optical Image of P1N13-IND34 Flaw Replica and Example of Sectioning Cut [14]

Replicas of the cross flow flaw in P1N13-IND34 has been shown to be typical of a bearing pad flaw, as shown in Figure 7. These flaws are not an integrity issue due to the smooth and relatively large root radius which results in a lower stress concentration compared to sharp flaws. Based on the location of flaw P1N13-IND33 (same circumferential location as IND34), IND33 is expected to be also due to the same cross flow event.

Based on OPEX from fuel bundle and pressure tube events observed, OPG introduced operational procedure changes in 2015 that reduced the allowable time for irradiated fuel in cross flow conditions from 48 to 24 hours. At which point, the bundle must be removed from cross flow conditions within 24 hours or the Unit is required to be shutdown. Additionally, as a result of the cross flow flaws from P1N13 and P5Q05, channels which experience significant cross flow conditions were added to the V&D channel selection criteria used for each planned maintenance outage.

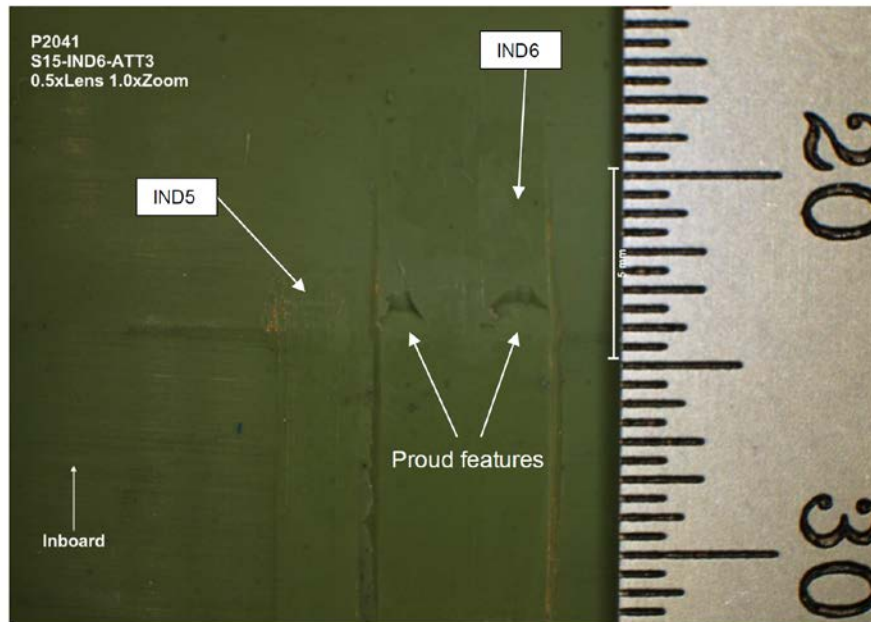
Figure 8: Optical Image of P4S15-IND5 and P4S15-IND6 Flaw Replica [16]

For P4S15-IND6, this flaw was detected after a Fueling Machine interaction that occurred during the P2041 outage (mechanical damage flaw was also observed on the bottom of the tube which was attributed to the Fueling Machine event). This is considered a unique one-time event and corrective actions have been implemented.

Due to the proximity of P4S15-IND6 to P4S15-IND5, the two flaws were combined and assessed using bounding dimensions. Based on review of the cross-section of the replica, a flat bottom bearing pad fret was utilized to represent the flaw while accounting for residual stresses for mechanical damage flaws [15]. The flaw is blunt with a relatively large root radius of 0.113mm and a depth of 0.2mm (which is slightly larger than the dispositionable limit of 0.15mm) [16].

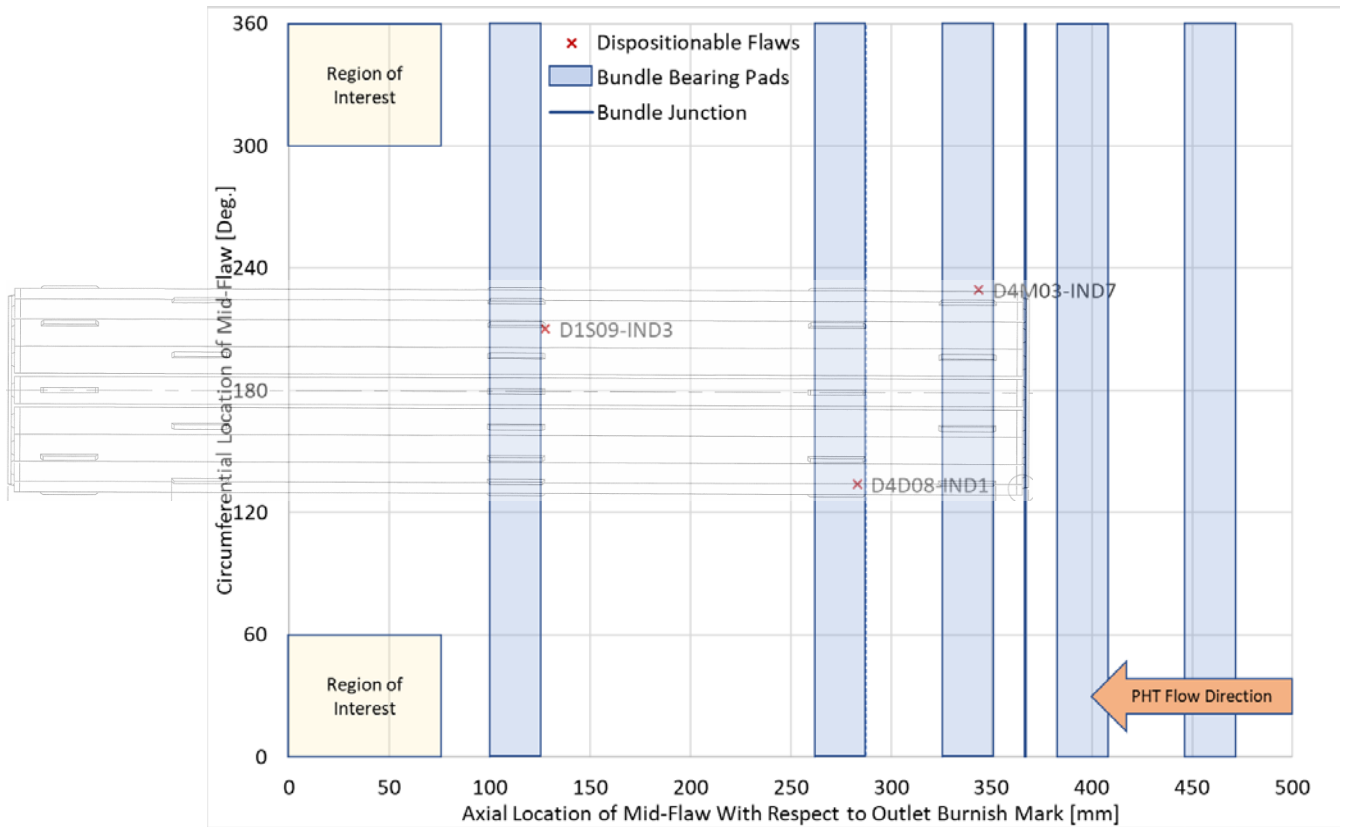
Figure 9: Overlay of Outlet End Fuel Bundle with Dispositionable Flaws in Darlington 1 and 4

A review of inspected channels was performed to determine the number of dispositionable flaws 75mm inboard of the outlet burnish mark. Out of 131 unique inspected channels [17] in Darlington Units 1 and 4, there are no dispositionable flaws located within 75mm of the outlet RJ on the upper half of the PT. No flaws can mechanistically be formed in this axial region during operation (see Section 5.2), thus providing confidence that there are no dispositionable flaws in the region of interest from the BP OPEX.

In Darlington the shield plug is situated outboard of the region of interest and the fuel bundle therefore straddles the region of interest. Figure 9 shows an overlay of the last fuel bundle at the outlet end with the locations of dispositionable flaws. The fuel bundles are positioned in the channel to ensure that the fuel bundle bearing pads are not located in the region of interest, thereby preventing flaw formation during normal operating conditions. This is supported by the fact that all dispositionable flaws near the outlet correspond to the fuel bundle bearing pad positions.

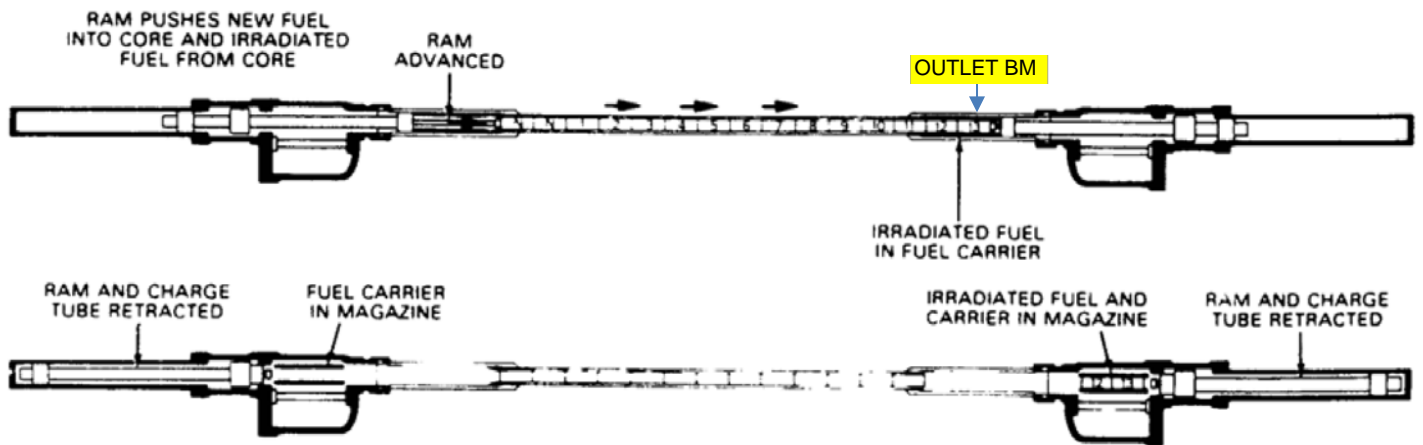
Figure 10: Fuel Carrier at Darlington

During fueling at Darlington Units 1 and 4, an irradiated fuel carrier is used to remove the fuel from the fuel channel. This fuel carrier supports the fuel as it moves through cross flow conditions which prevents fuel bundle damage and therefore pressure tube fretting.
