CMD 25-M24 - CNSC Staff Submission

Increased Fish Impingement at Bruce A NGS

EVENT INITIAL REPORT (EIR)

EIR: Increased Fish Impingement at Bruce A NGS	
Prepared by: Directorate of Power Reactor Regulation (DPRR) and Bruce Regulatory Program Division (BRPD)	
Licensee: Bruce Power Inc.	Location: Bruce Nuclear Generating Station (NGS) A
Date Event was Discovered: 2025-02-13	Have Regulatory Reporting Requirements been met? Yes <input checked="" type="checkbox"/> No <input type="checkbox"/> Proactive Disclosure: Licensee: Yes <input checked="" type="checkbox"/> No <input type="checkbox"/> CNSC: Yes <input checked="" type="checkbox"/> No <input type="checkbox"/>
Overview	
Reporting Criteria: 15) Issues, events, occurrences that the Directors-General (DGs) or their designates judge to have potential for repercussions outside the CNSC and for which the DGs or their designates believe the Commission should be informed.	
Description: Increasing numbers of Gizzard Shad fish were observed being impinged on the Condenser Cooling Water (CCW) intake screens since January 30, 2025. On February 13, 2025, there was a substantial increase in fish impingement, which led to high differential pressur

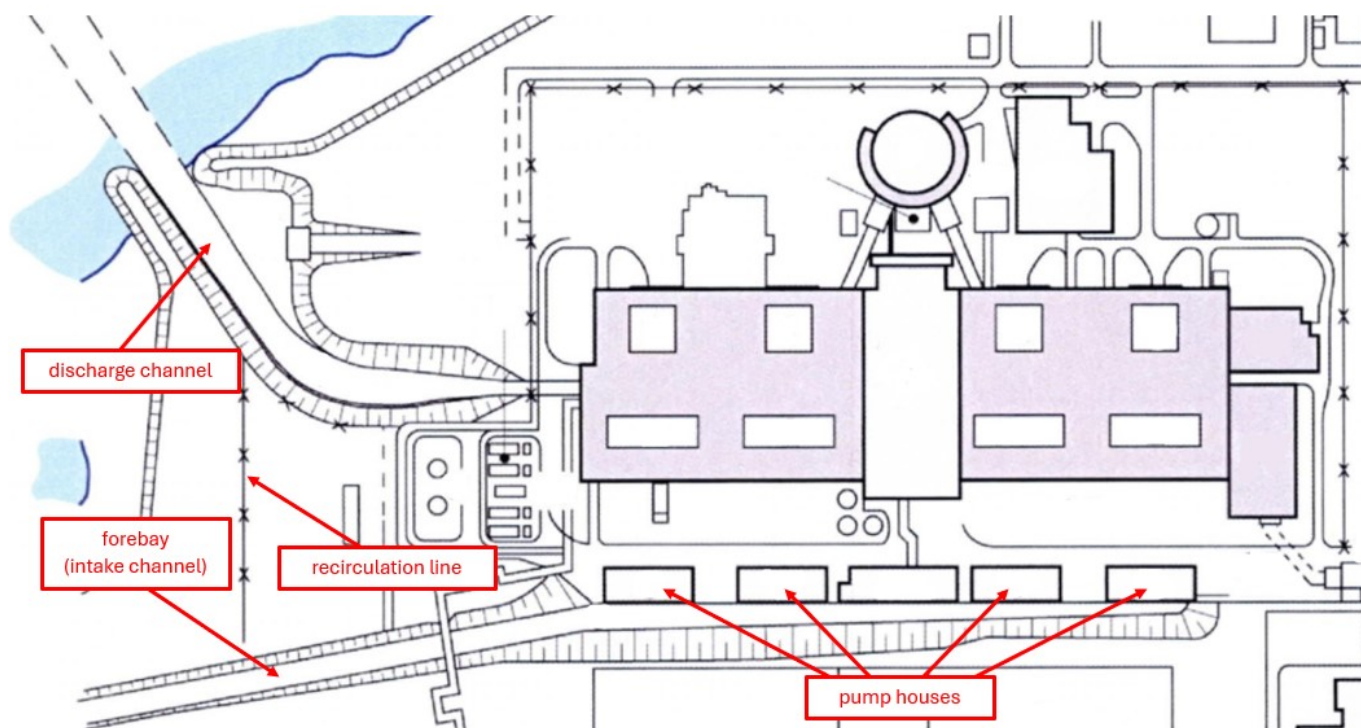
Figure 1: Layout of Bruce A (source: Bruce Power)

Bruce A has a common forebay that draws water from Lake Huron to provide cooling water to the pumphouses for all units. This water comes in from a deep-water intake channel, 550m offshore, 11m below the surface with a velocity cap. The velocity cap is meant to reduce water velocity at the intake, reducing the number of fish that will end up in the forebay. Bruce A has a common water discharge channel for all cooling water exiting the station that sends warmed water back to Lake Huron. A recirculation system diverts, during the winter months, some of the warmed water back to the forebay to raise the temperature as a means of preventing frazil ice formation (tiny, needle-like crystals that form in water in supercooled, turbulent conditions). These Bruce A structures are depicted in Figure 1 below.
