# CMD 25-M28 - CNSC Staff Submission

## Workplace injury at Ontario Power Generation's Darlington New Nuclear Project Site

# **Workplace injury at Ontario Power Generation's Darlington New Nuclear Project Site**

EIR: Workplace injury at Ontario Power Generation's Darlington New Nuclear Project Site

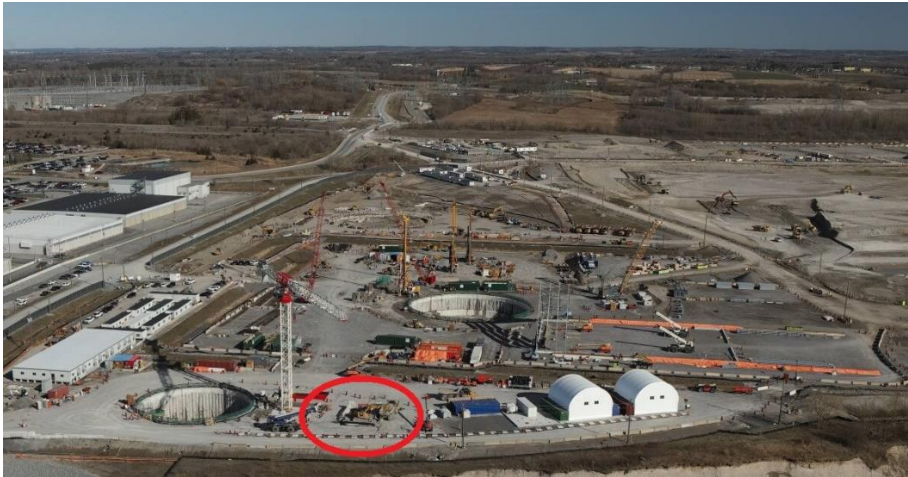
</div> <div>Figure 1: The DNNP construction site. The Tunnel Boring Machine launch shaft excavation is in the lower left corner. The worker injury occurred in the circled location.</div>

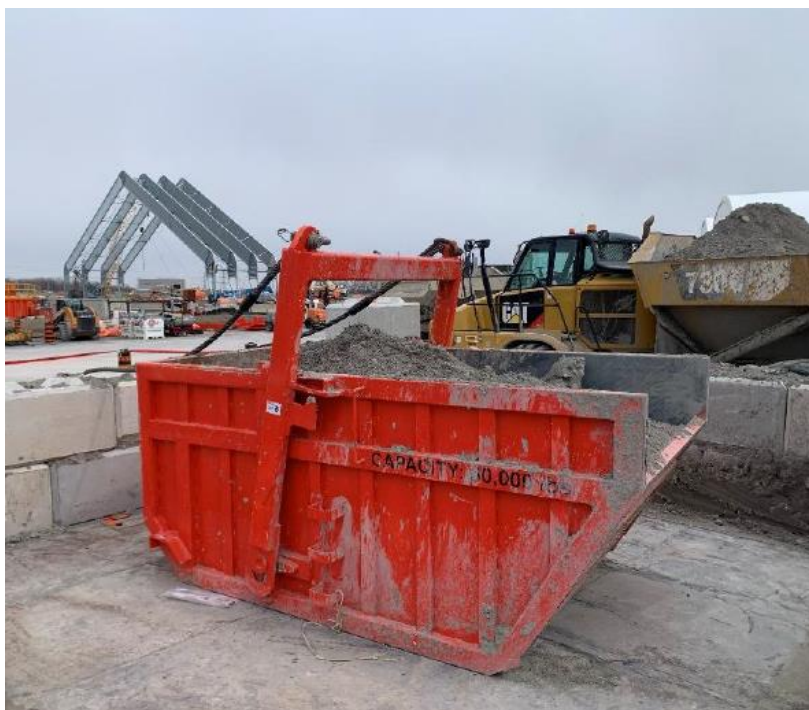
<div>Description:</div> <div>On April 9, 2025, Ontario Power Generation personnel contacted the CNSC duty officer to report a serious injury to a contracted worker involved in construction activities at the Darlington New Nuclear Project (DNNP) site.</div> <div>The event occurred inside the DNNP construction island, at the excavation site for the BWRX-300 Tunnel Boring Machine (TBM) launch shaft (Figure 1). The work underway at the time was being conducted by the contractor, Aecon Group Inc. (Aecon). This work involved a tower crane lifting a large metal bin into the excavation, where an excavator would fill the bin with excavated material. The tower crane would then lift the bin out of the excavation and land it inside an enclosure made of concrete blocks. Once the bin was landed, a worker would enter the enclosure to release safety latches on the bin and then exit the enclosure. The crane operator would then dump the excavated material into the enclosure and return the bin to the excavation, while a second excavator transferred the dumped material from the enclosure into a dump truck. This operation had been performed approximately 70 times prior to the event.</div> <div>At approximately 11:20 AM, the tower crane had landed a bin full of excavated material inside the enclosure. With the bin resting on the ground, a worker entered the enclosure to release the safety latches on the bin, as per the established process. As the worker was walking around the bin to access the second safety latch, the bin shifted, pinning the worker against the wall of the enclosure (Figure 2).</div> <div>

**Figure 2: The inside of the enclosure; the large red bin shifted and pinned the worker against the concrete block wall.**

- Aecon stopped all work on site until April 14, 2025.
- Prior to work gradually resuming across the site, work packages deemed to involve high risk activities were identified; for these work packages, challenge meetings were held with OPG and Aecon staff to review work plans and job hazard analyses, and to discuss any safety enhancements.

- OPG to submit a Detailed Event Report in accordance with REGDOC 3.1.1, *Reporting Requirements for Nuclear Power Plants*, v2.
- Aecon will identify and implement corrective actions through their corrective action program prior to resuming work at the incident site.
