CMD : 26-M14

STATUS REPORT ON POWER REACTORS

This document summarized the status of the
Power Reactor Facilities as of April 24, 2026.

Subject Installation Deficiencies Associated with Hilti Anchors at Bruce Power/Déficiences liées à l'installation
Objet d'ancrages Hilti à Bruce Power

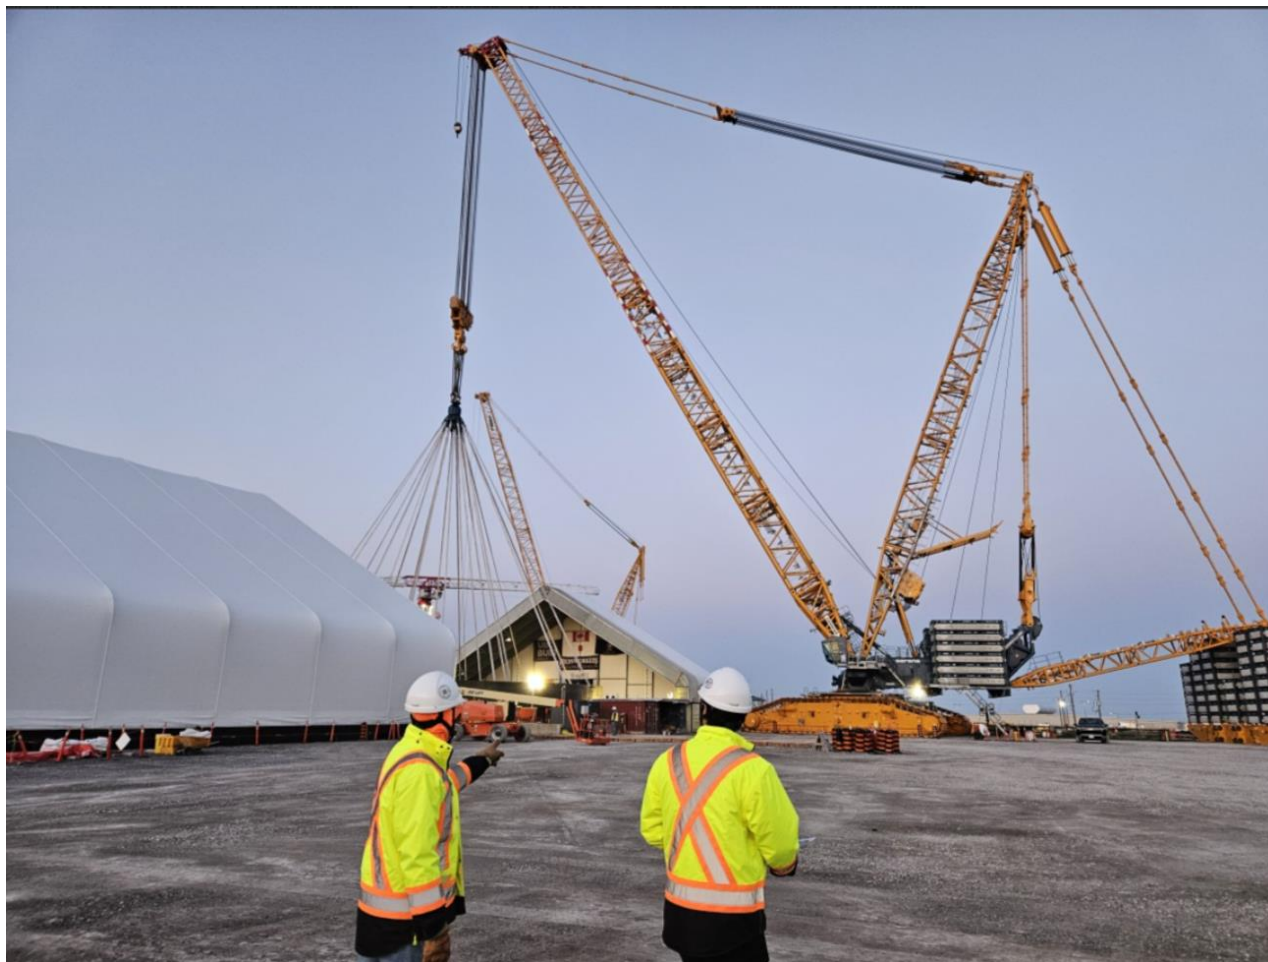
Figure 1: CNSC inspectors conducting a walkdown of the exclusion area prior to basemat lift (Source CNSC staff, April 2026)

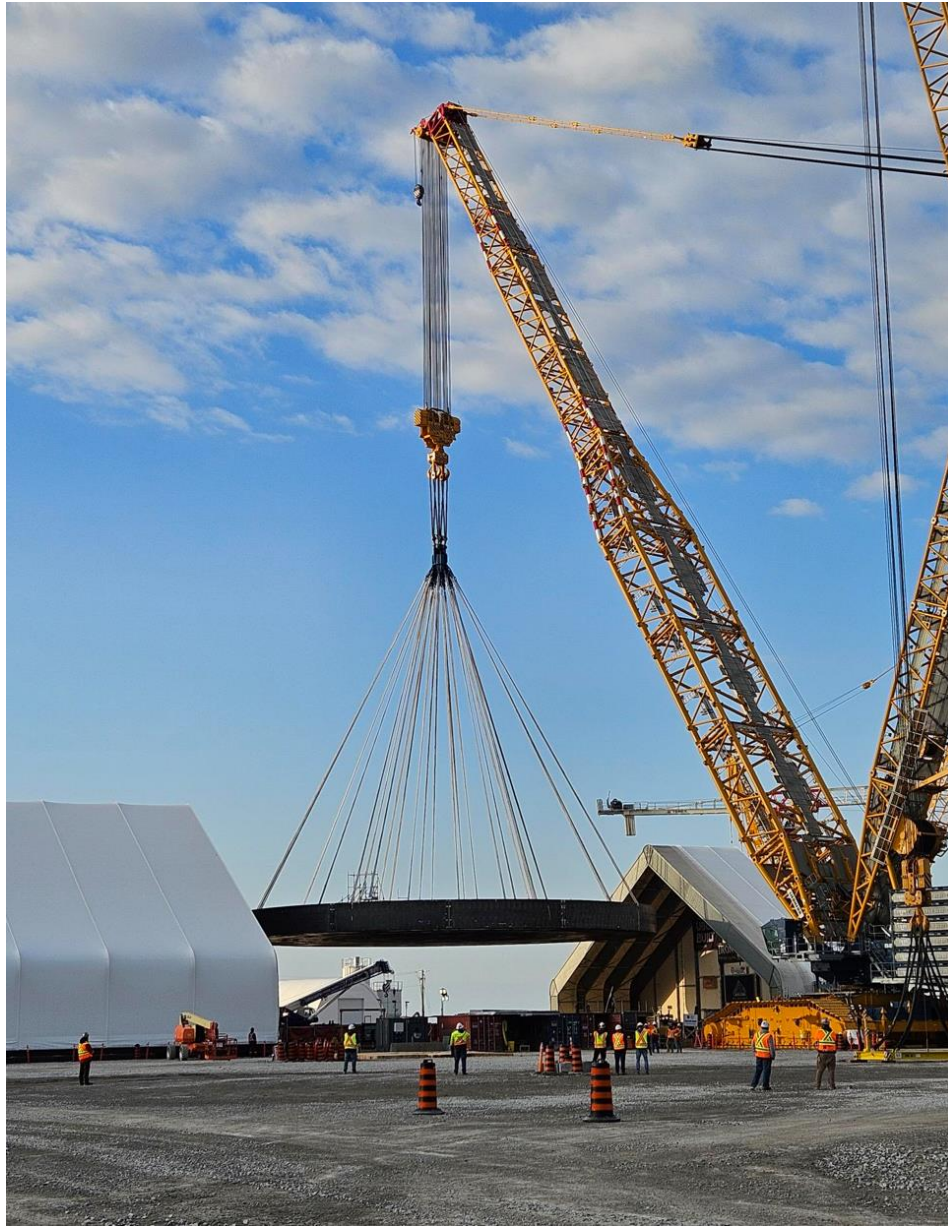
Figure 2: Basemat being hoisted out of the Pre-assembly building (Source CNSC staff April 2026)

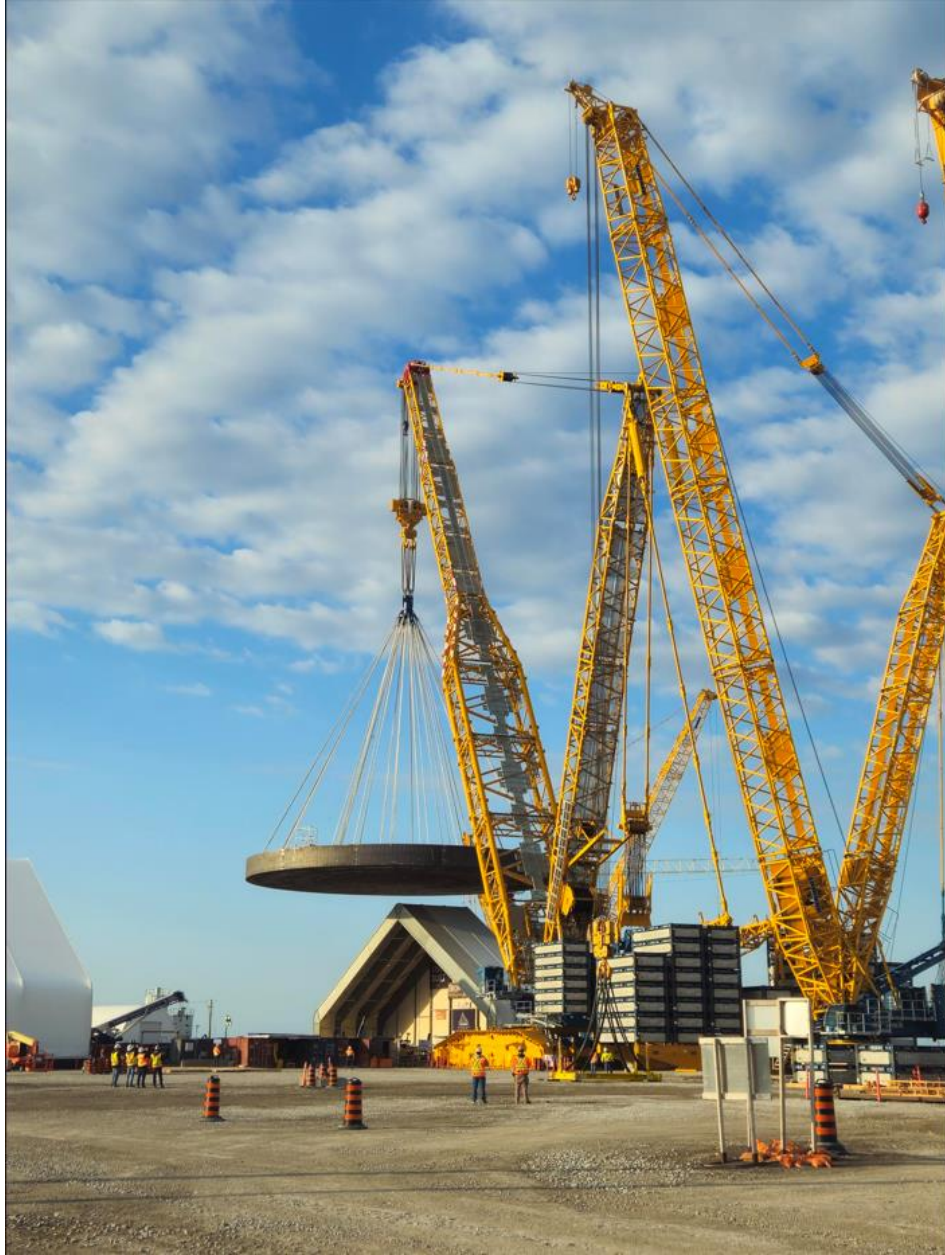
Figure 3: Basemat being hoisted over the Pre-assembly building (Source CNSC staff April 2026)

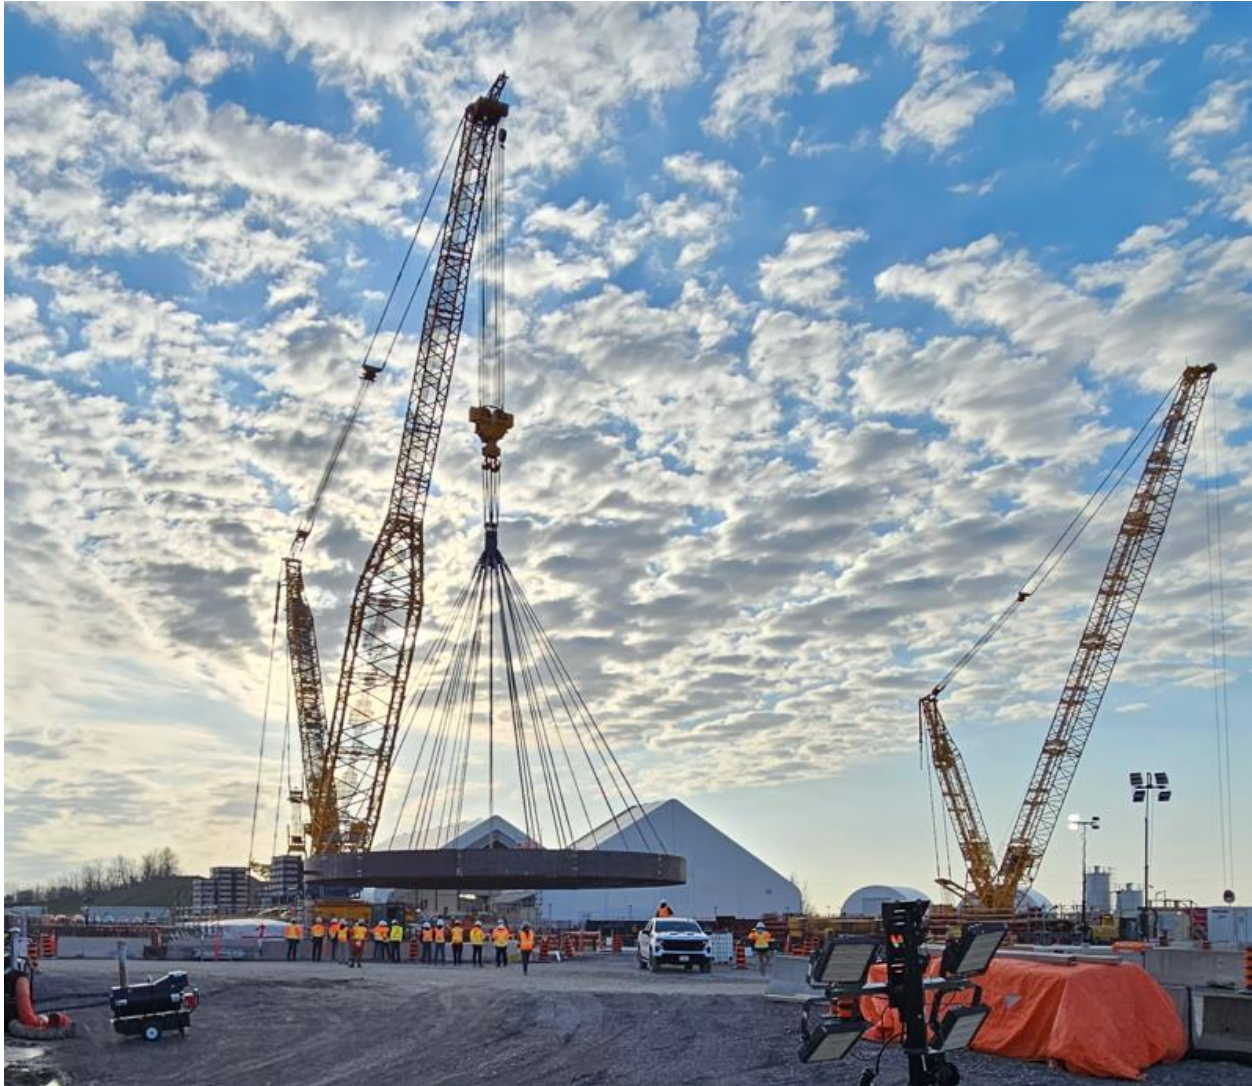
Construction Status – DNNP-1
Major construction work in progress: <ul style="list-style-type: none"> Reactor building (RB) shaft excavation has been completed. The Diaphragm Plate Steel Composite (DP-SC) Basemat has been assembled (in the pre-assembly building) and successfully craned into the RB shaft on April 22, 2026. (Figures 1-4)

Figure 4: Basemat being hoisted into the RB shaft (Source CNSC staff April 2026)

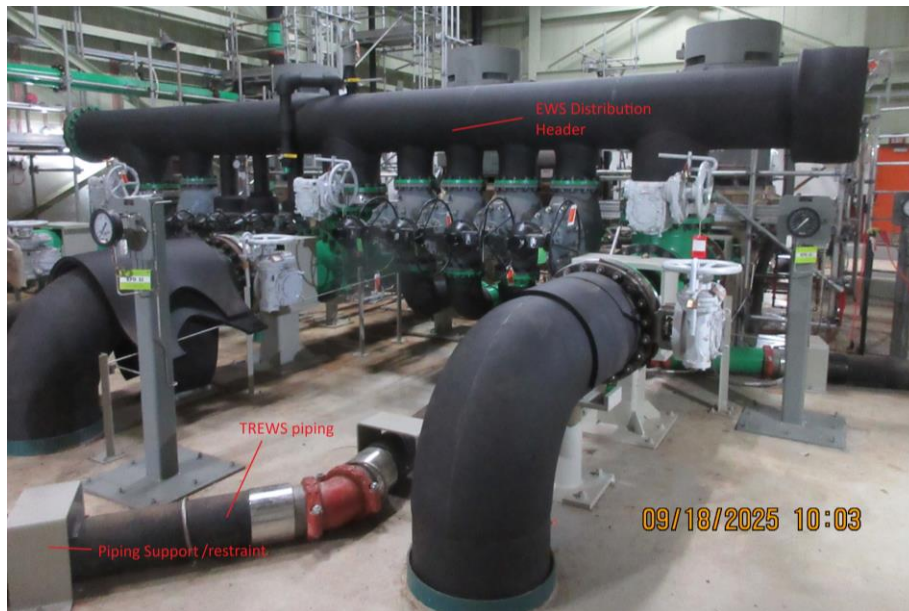
In March 2025, CNSC staff received an external complaint regarding deficiencies with work being performed on TREWS, specifically the installation of Hilti anchors (HDA-P) supporting 8-inch rigid hoses. The work involved mapping out the holes using the support plates, drilling holes into the concrete, setting the anchors in place using a Hilti-specific tool to undercut the anchor bolt head at the bottom of the hole, and finally installing the pipe support baseplate. See Figures 1, 2 and 3 showing various TREWS piping with supports/restraint brackets.

Figure 1: Picture showing TREWS piping connection to EWS distribution header

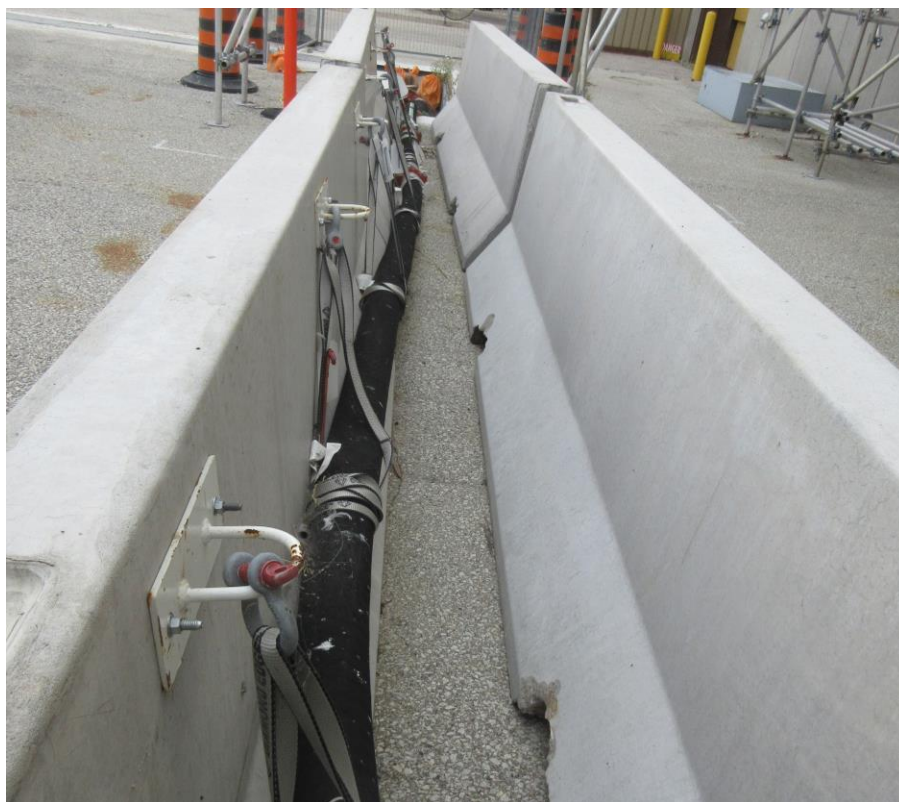
Figure 2: Picture showing TREWS piping with tie-in restraints located outside of Bruce B

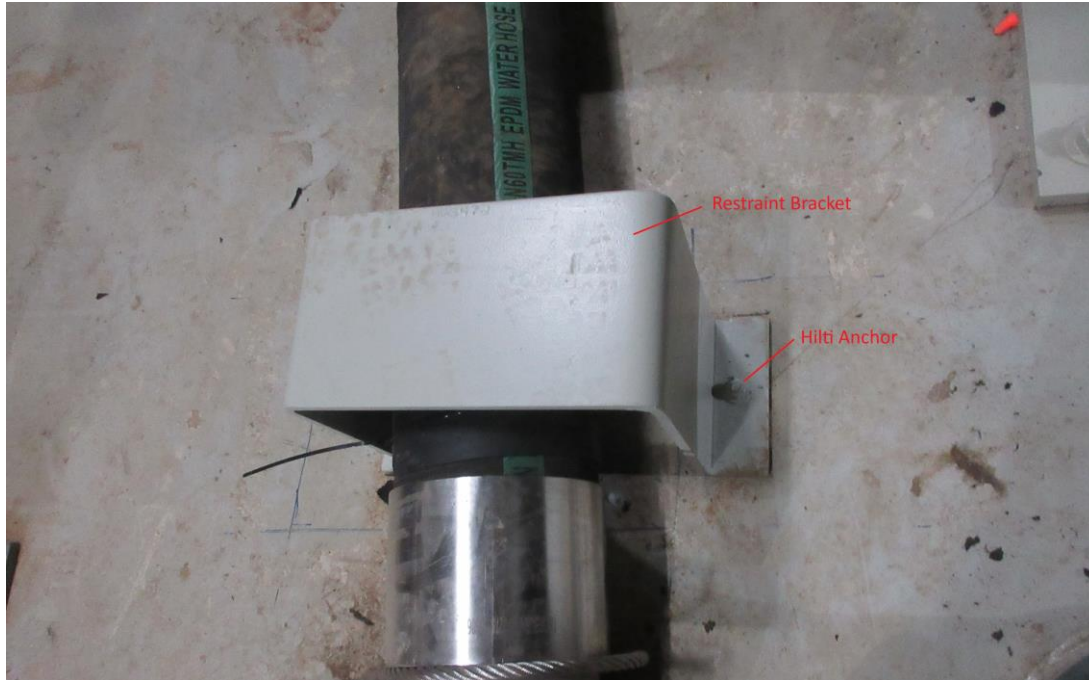
Figure 3: Figure showing TREWS piping with restraint bracket and anchor

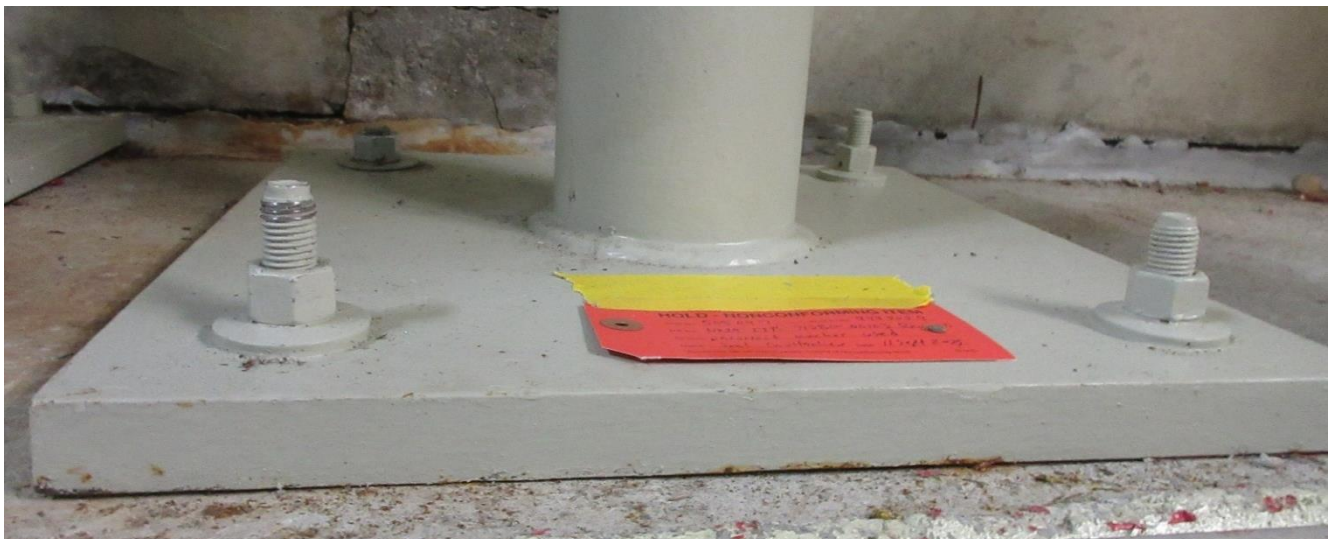
CNSC staff did observe evidence of rework in several areas, attributable to difficulties encountered by workers in aligning anchors with the steel baseplates due to rebar interactions during installation; several abandoned holes had been backfilled with cement. Some non-conformances remained, including instances where baseplates were not flush with the ground.

See Figure 4 for an image of the baseplate with Hilti anchors; It was noted that several anchors had varying lengths of exposed thread.

Figure 4: Figure showing anchors with varying lengths of exposed thread sticking out of the baseplate

In March 2026, Bruce Power extended its inspection scope to include all anchors associated with the TREWS project, representing approximately 580 anchors in total. Each anchor will be assessed on a case-by-case basis, beginning with visual inspection. Bruce Power also committed to conducting a defined percentage of pull tests to full design load. The details of the corrective actions taken will be provided through the CARB process.

Finally, Bruce Power is developing a comprehensive remediation schedule to remedy non-compliant anchors, which is planned to be completed by the end of October 2026. If Bruce Power determined that remediation of a specific anchor cannot be performed safely while the unit is operating, that work would be deferred and scoped into the next planned outage.

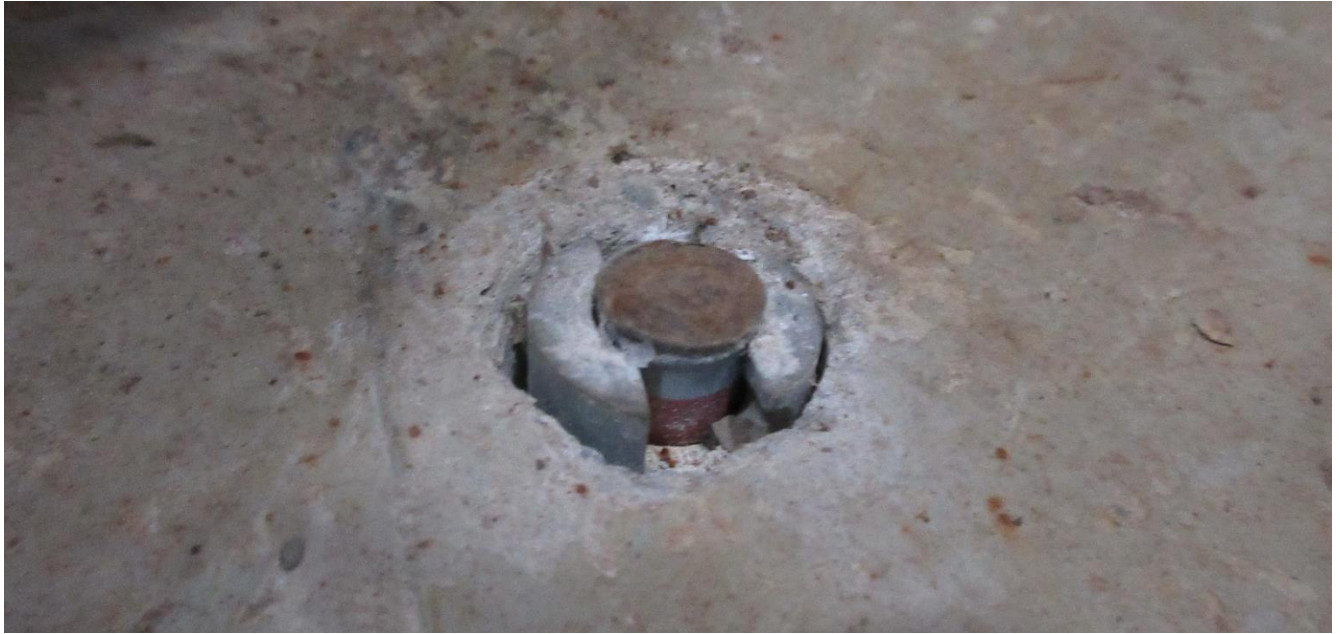
Figure 5: Cut anchor that was not used due to issues with the location of another anchor; the bracket was relocated.

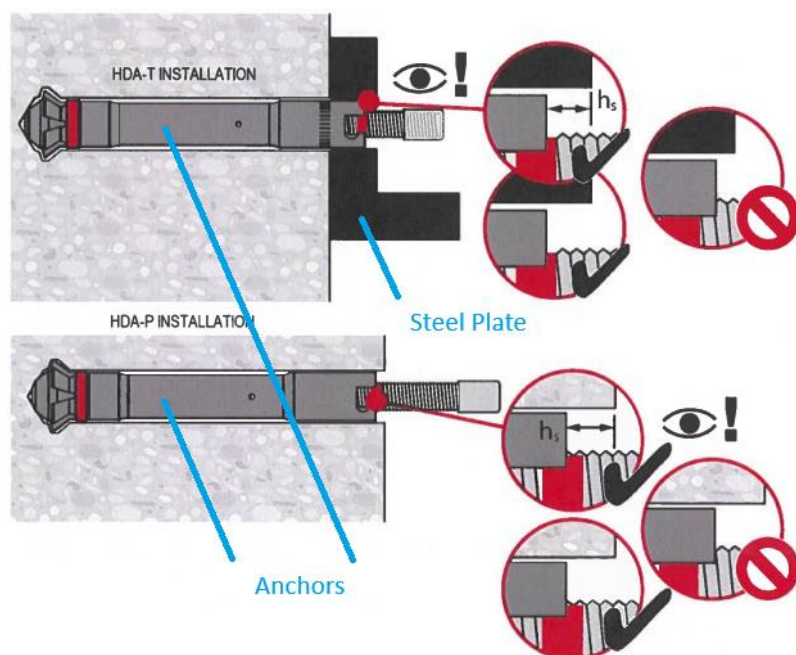
To address CNSC staff's concerns, Bruce Power initiated removal of additional baseplates to permit visual examination of the installed anchors in March 2026. Bruce Power also contacted Hilti to clarify installation requirements, which identified additional steps beyond torque verification. These steps included confirming that all dust and debris were removed from the drilled hole prior to the anchor placement, as well as visually verifying the presence of the red indicator on the anchor thread to confirm that the required embedment depth has been achieved. Figure 6 below provides the manufacturer's diagram illustrating the visual inspection criteria for the red stripe for properly installed anchors (HDA-P and HDA-T [Note: HDA-T anchors are not used for the TREWS program]).

Figure 6: Manufacturer's diagram illustrating the visual inspection criteria for properly installed anchors

As these Hilti specified steps had not been consistently completed, and visual examinations identified anchors that did not meet installation requirements, Bruce Power withdrew the initial engineering evaluation and initiated corrective actions. Bruce Power further indicated that it would undertake the necessary corrective actions, which include extending the verification of condition to all HDA-P and Kwik Bolt TZ2 anchors on TREWS and submitting a revised technical submission to CNSC staff in support of declaring TREWS to be Available for Service (AFS).
