CMD 26-M17 - CNSC Staff Submission

Event Initial Report – Workplace Injury at McMaster Nuclear Reactor

EIR: Workplace Injury at the McMaster Nuclear Reactor	
Prepared by: Nuclear Processing Facilities Division, Directorate of Nuclear Cycle and Facilities Regulation	
Licensee: McMaster Nuclear Reactor	Location: McMaster University, Hamilton, Ontario
Date Event was Discovered: 2026-03-26	Have Regulatory Reporting Requirements been met? Yes <input checked="" type="checkbox"/> No <input type="checkbox"/> Proactive Disclosure: Licensee: Yes <input checked="" type="checkbox"/> No <input type="checkbox"/> CNSC: Yes <input type="checkbox"/> No <input checked="" type="checkbox"/>
Overview	
Reporting Criteria: <i>General Nuclear Safety and Control Regulations (SOR/2000-202)</i> 29 (1) Every licensee who becomes aware of any of the following situations shall immediately make a preliminary report to the Commission of the location and circumstances of the situation and of any action that the licensee has taken or proposes to take with respect to it: h) A serious illness or injury incurred or possibly incurred as a result of the licensed activity

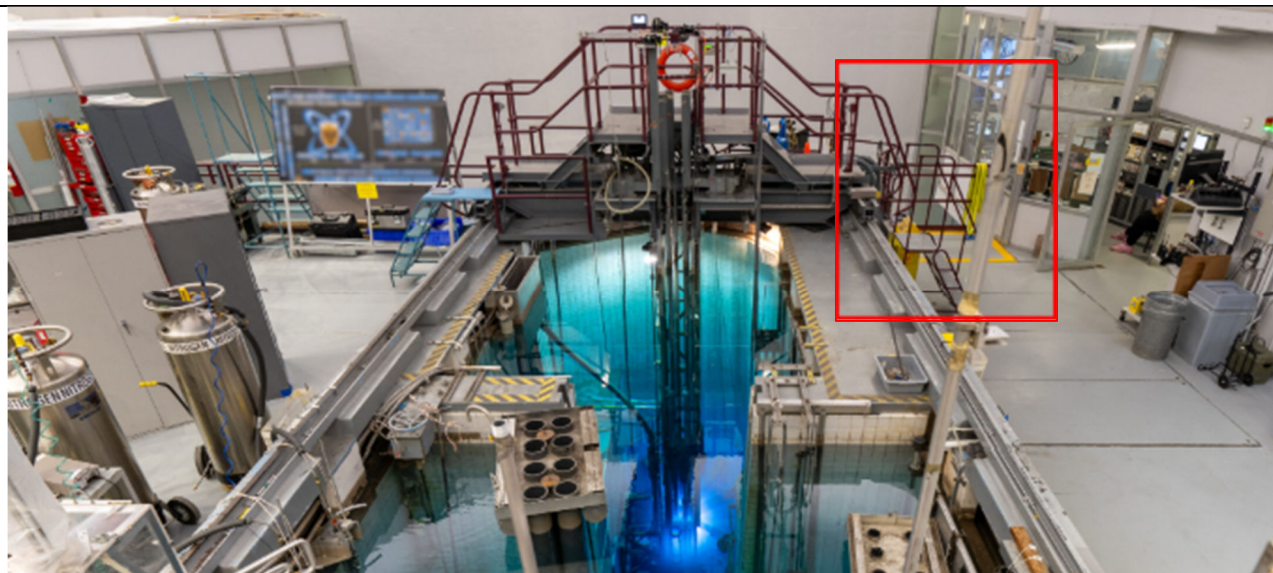
Figure 1. Red box indicates the area of the accident, adjacent to the reactor bridge.

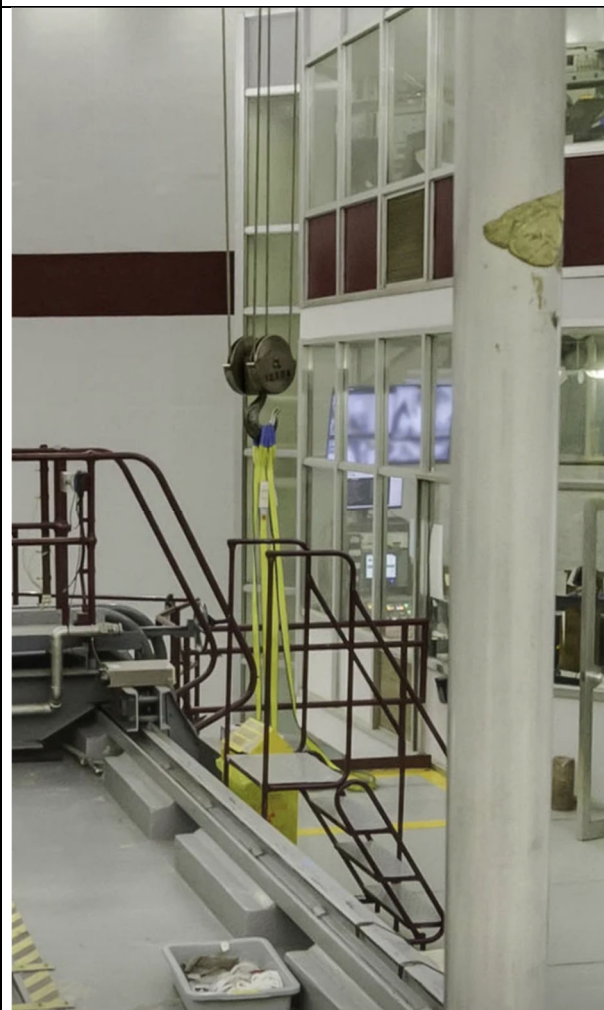
Figure 2. Photo of the crane, hook, and slings (yellow).

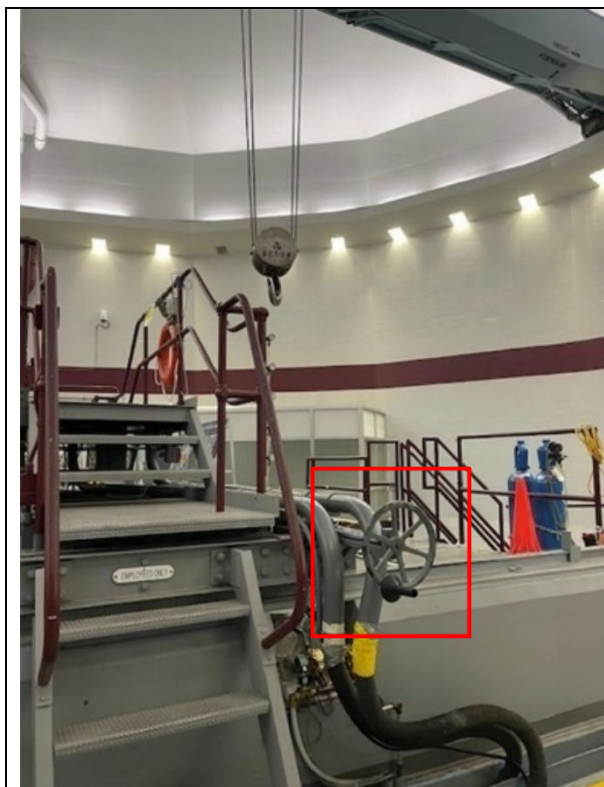
Figure 3. Photo to show the wheel that is used to move the reactor bridge. The yellow crane slings got caught on the wheel while the crane was moving upwards.

- The licensee notified the CNSC in the evening of March 26 as per the reporting requirements.
- On Tuesday, March 31, the licensee sent a communication to all users of the MNR overhead crane warning them of the dangers of a system under tension and instructing them to halt all crane movement and remove hands from the controls in the event the crane becomes stuck.

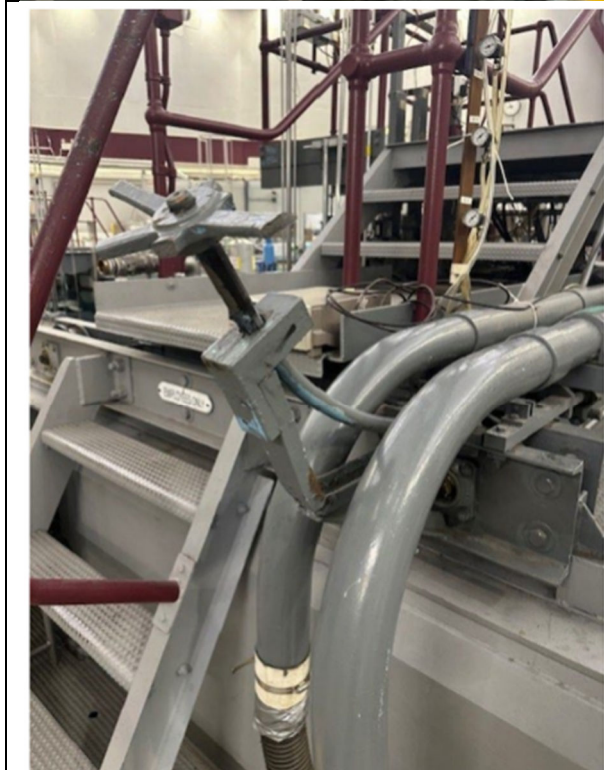
- The licensee conducted an investigation into the status of reactor structures, systems and components (SSCs) in response to the reactor bridge being slightly lifted by the crane. Results of the investigation informed the reactor restart decision as per MNR procedures. All required approvals were received, and the reactor was restarted up to 3 MW thermal power on April 13, 2026 without issue.

Figure 4. Crank assembly after the incident, curved upward and the wheel is sheared off.

Figure 1: damaged crank assembly
