# CMD 26-M37 - CNSC Staff Submission

## Event Initial Report Workplace Injury at Denison Mines Corp.'s Wheeler River Project

# **Workplace Injury at Denison Mines Corp.'s Wheeler River Project**

| EIR: Workplace Injury at Denison Mines Corp.'s Wheeler River Project | |

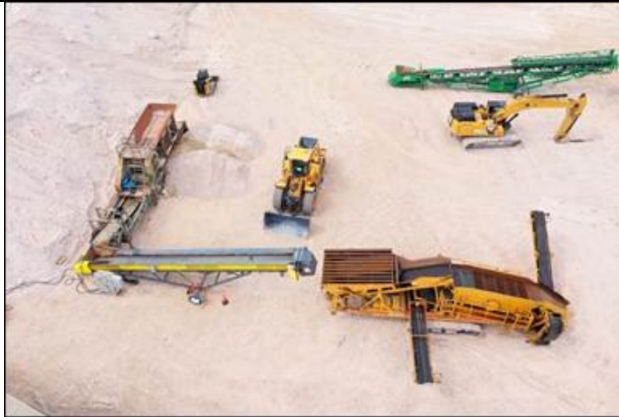
*Fig 1. Aerial reference photograph of the crusher pad showing the mobile crushing spread, 60-foot stacker, loader and adjacent equipment.*

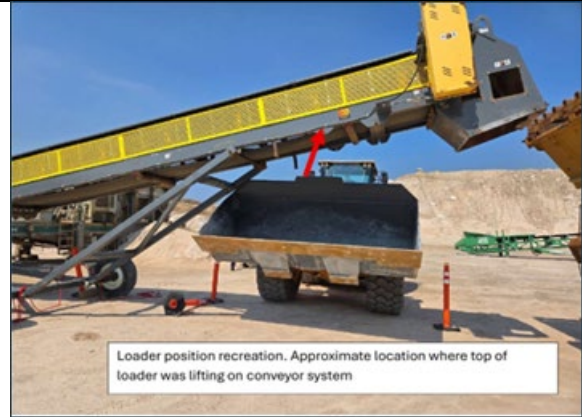
*Fig 2. Post-incident view of the raised stacker head end with the loader bucket adjacent to the frame, illustrating the loader-to-stacker contact.*

CF2: The retaining pin was removed while it remained bound and under load, with the stacker supported solely by a front-end loader bucket and no secondary mechanical support in place.

IC3: Inadequate equipment: The stacker was being supported solely by a front-end loader bucket, with no evidence of secondary support such as cribbing, blocking, or jack stands. The support arrangement was inadequate for safely removing a load bearing positioning pin as it did not allow for continuous support of top end of stacker, or provide the ability for controlled, incremental adjustments of load heights.

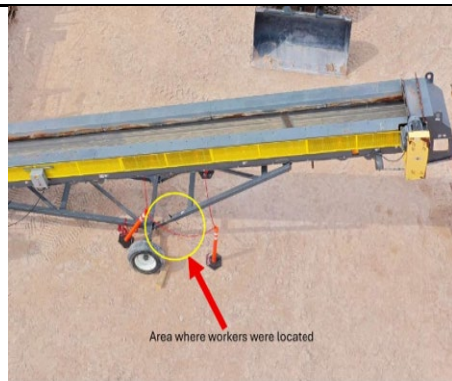
*Fig 3. Workers' location at the time of incident*

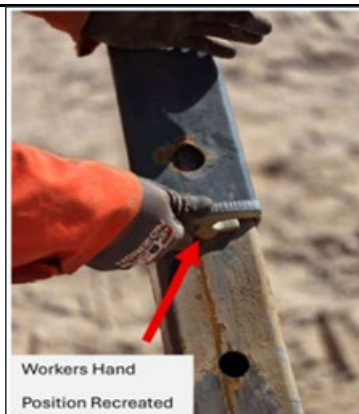
*Fig 4. Recreated the IP's hand position at the pin lifting handle.*

CF1: The injured worker's fingers were positioned on the pin handle within the pinch point/line of fire during the removal attempt.

IC1: Failure to appreciate risk: the IP placed their fingers on the pin handle while a bound pin was being manipulated and while the loader bucket position was being adjusted. The pinch point and line-of-fire hazards were not fully recognized or appreciated

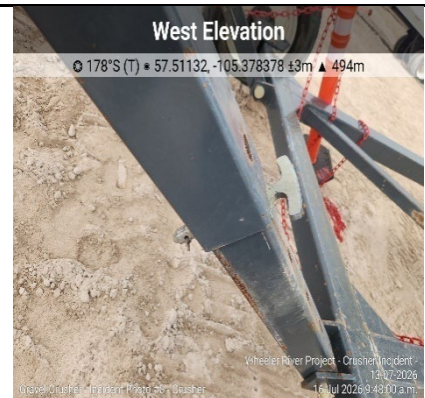
*Fig 5 Close-up of the sliding support and the T pin arrangement.*

IC2: Unanticipated Exposure to Mechanical Hazards: the telescoping movement of the stacker frame and pin handle created a mechanical pinch/crush point which trapped the worker's fingers.

CA1: Develop and implement an original equipment manufacturer/engineering approved procedure for stacker height adjustment and pin removal, to be reviewed and approved by Project Internal Project Management Team. (note: Post investigation the crusher involved in incident was removed from site. The replacement crusher is outfitted with a hydraulic actuated conveyor positioning feature, which negates the use of pins and manual height adjustment).
