**Written submission from
Bruce Power**

**Opportunity to be heard on the orders
issued by a Designated Officer to Bruce
Power and Ontario Power Generation**

BP-CORR-00531-01908

Designated Officer Order to Bruce Power – Unplanned Outage Restart Request

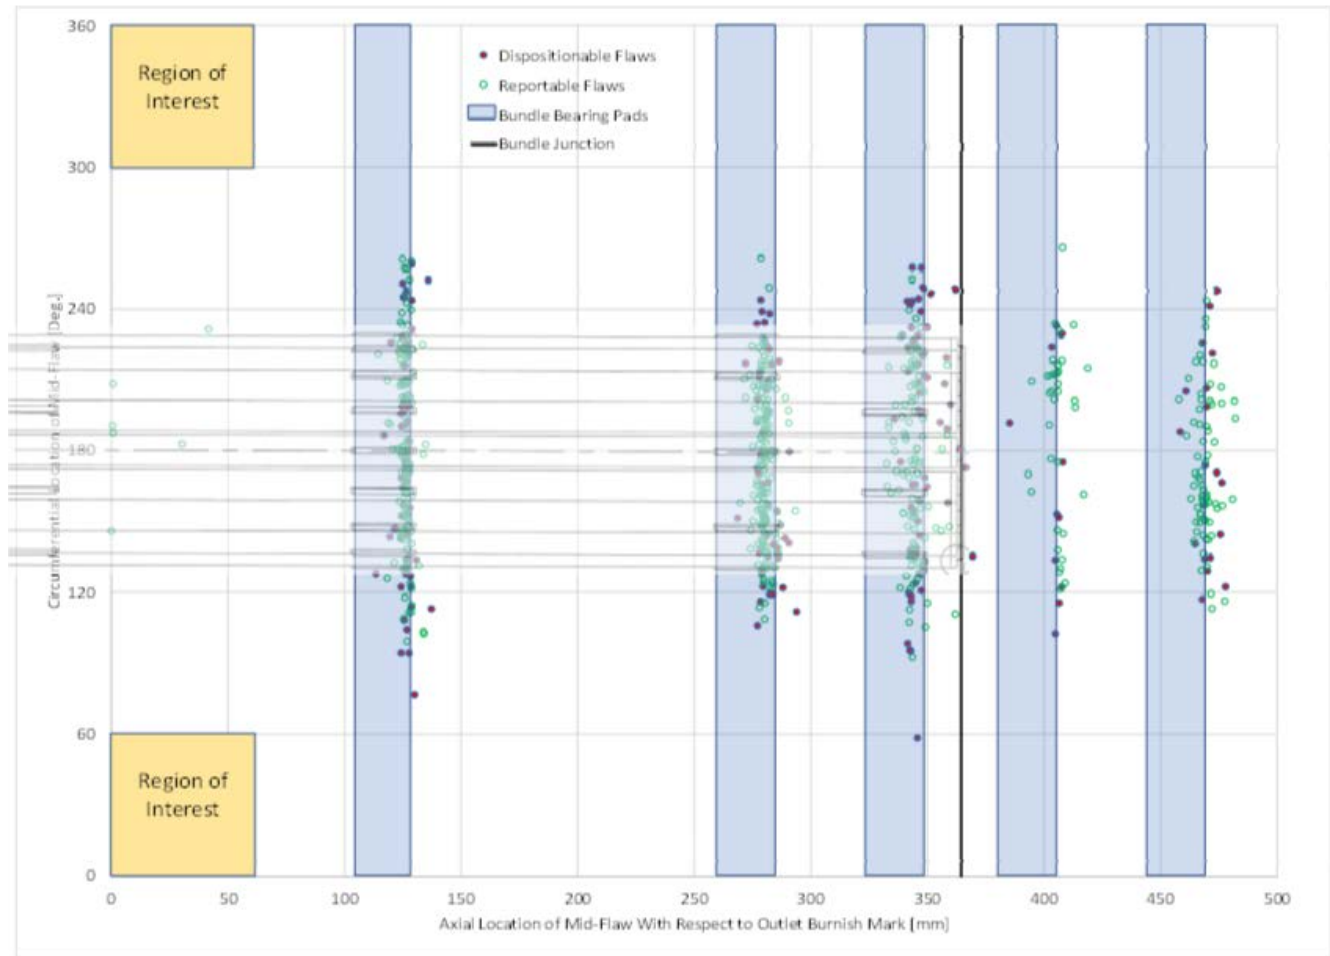
Figure D1: Detected Flaws in Units 3-8 in the first 500mm outlet portion of the PT

The following information demonstrates with a high degree of confidence that no flaws are present in the region of pressure tubes where the models failed to conservatively predict the elevated [Heq] in Units 3, 4, 5, 7 and 8 (See Figure D1).

1. This figure includes all unique reportable and dispositionable flaws in B3-B8 for flaw types that have the potential for crack initiation. These include debris flaws, bearing pad flaws, crevice corrosion, PT/CT contact, erosion, linear indications, mechanical damage & manufacturing flaws, and exclude deposits, corrosion, roughness & proud indications, fueling scratches, OD scratches & scrapes.
2. This figure does not account for the A2131 volumetric inspection. The 4 flaws almost coincident with the burnish mark (at 0mm) actually straddle the burnish mark and extend inboard by no more than 2.1mm. Such flaws carry a significantly reduced risk of crack initiation due to the net compressive stress that exists outboard of the burnish mark.
3. 'Mid-flaw' is the middle point of the flaw in terms of axial and circumferential location.

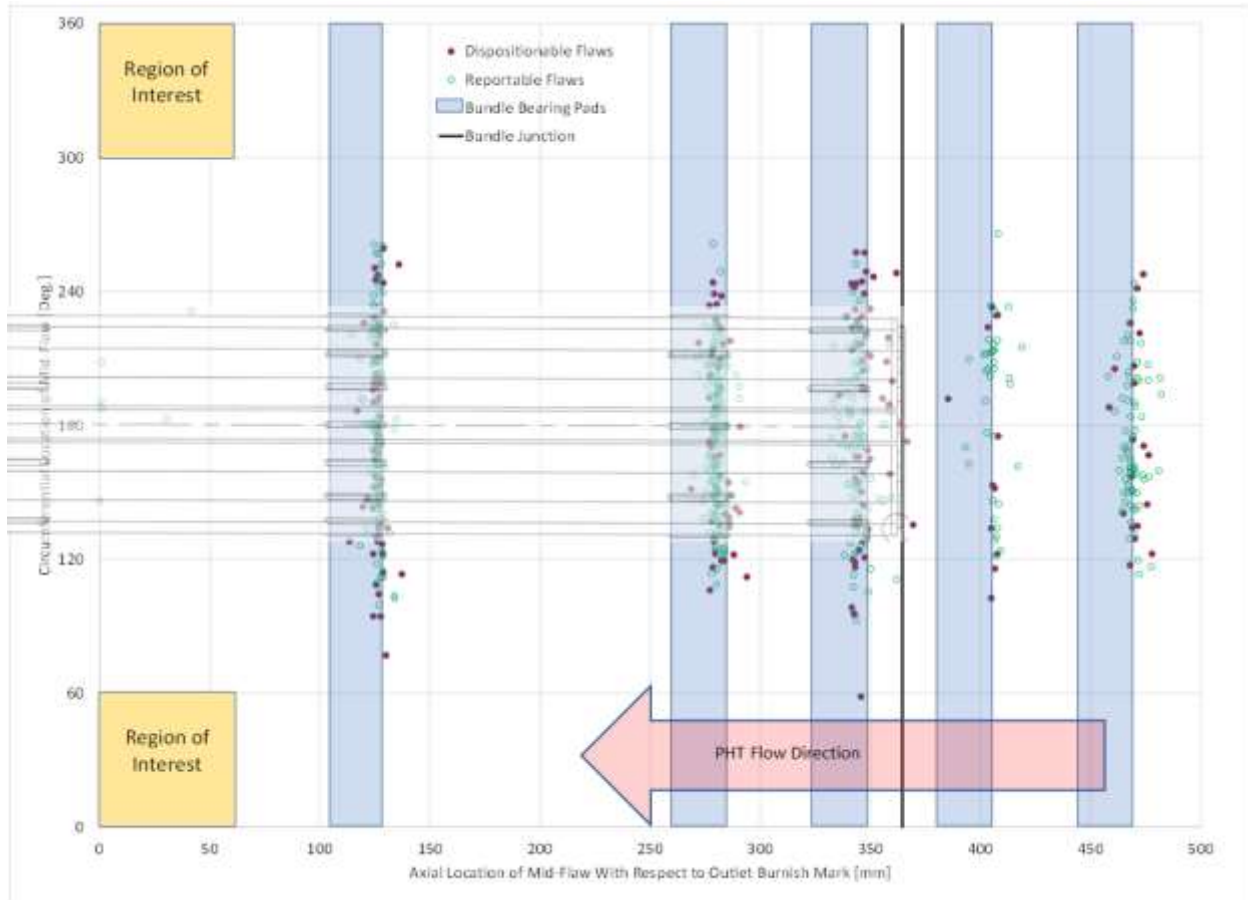
Figure A1: Detected Flaws in Units 3-8 in the first 500mm outlet portion of the PT

1. This figure includes all unique reportable and dispositionable flaws in B3-B8 for flaw types that have the potential for crack initiation. These include debris flaws, bearing pad flaws, crevice corrosion, PT/CT contact, erosion, linear indications, mechanical damage & manufacturing flaws, and exclude deposits, corrosion, roughness & proud indications, fueling scratches, OD scratches & scrapes.

2. This figure does not account for the A2131 volumetric inspection. The 4 flaws almost coincident with the burnish mark (at 0mm) actually straddle the burnish mark and extend inboard by no more than 2.1mm. Such flaws carry a significantly reduced risk of crack initiation due to the net compressive stress that exists outboard of the burnish mark.
