Date: 2026-06-29

**Written Submission from
Orano Canada Inc.**

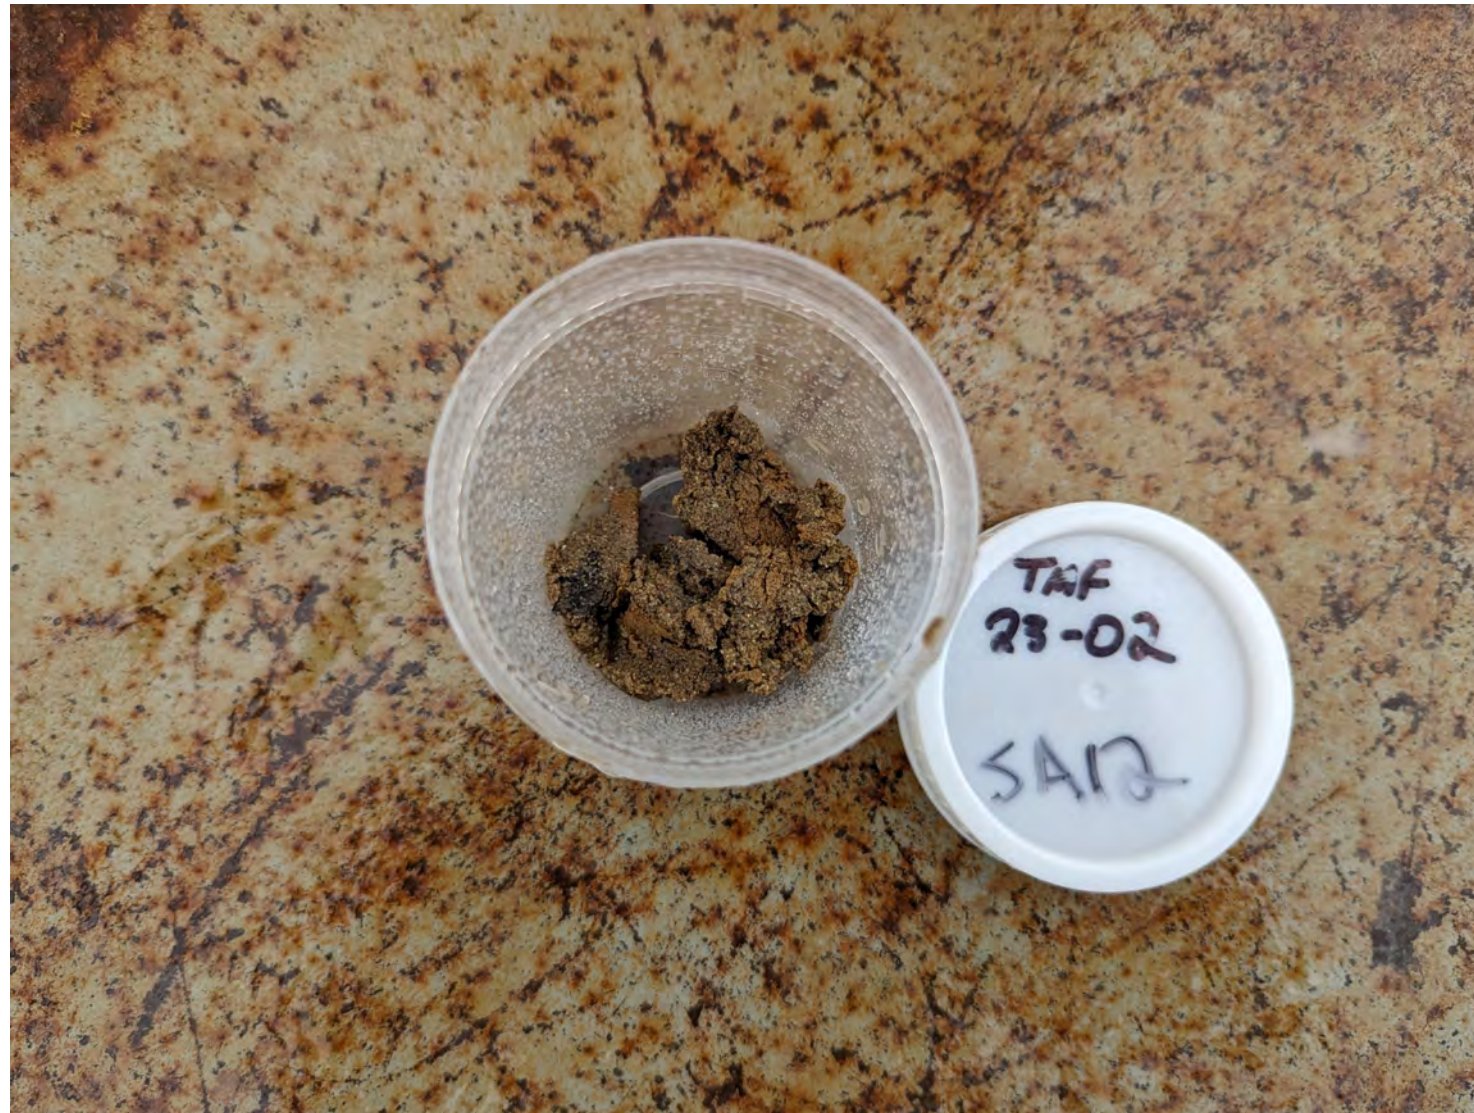
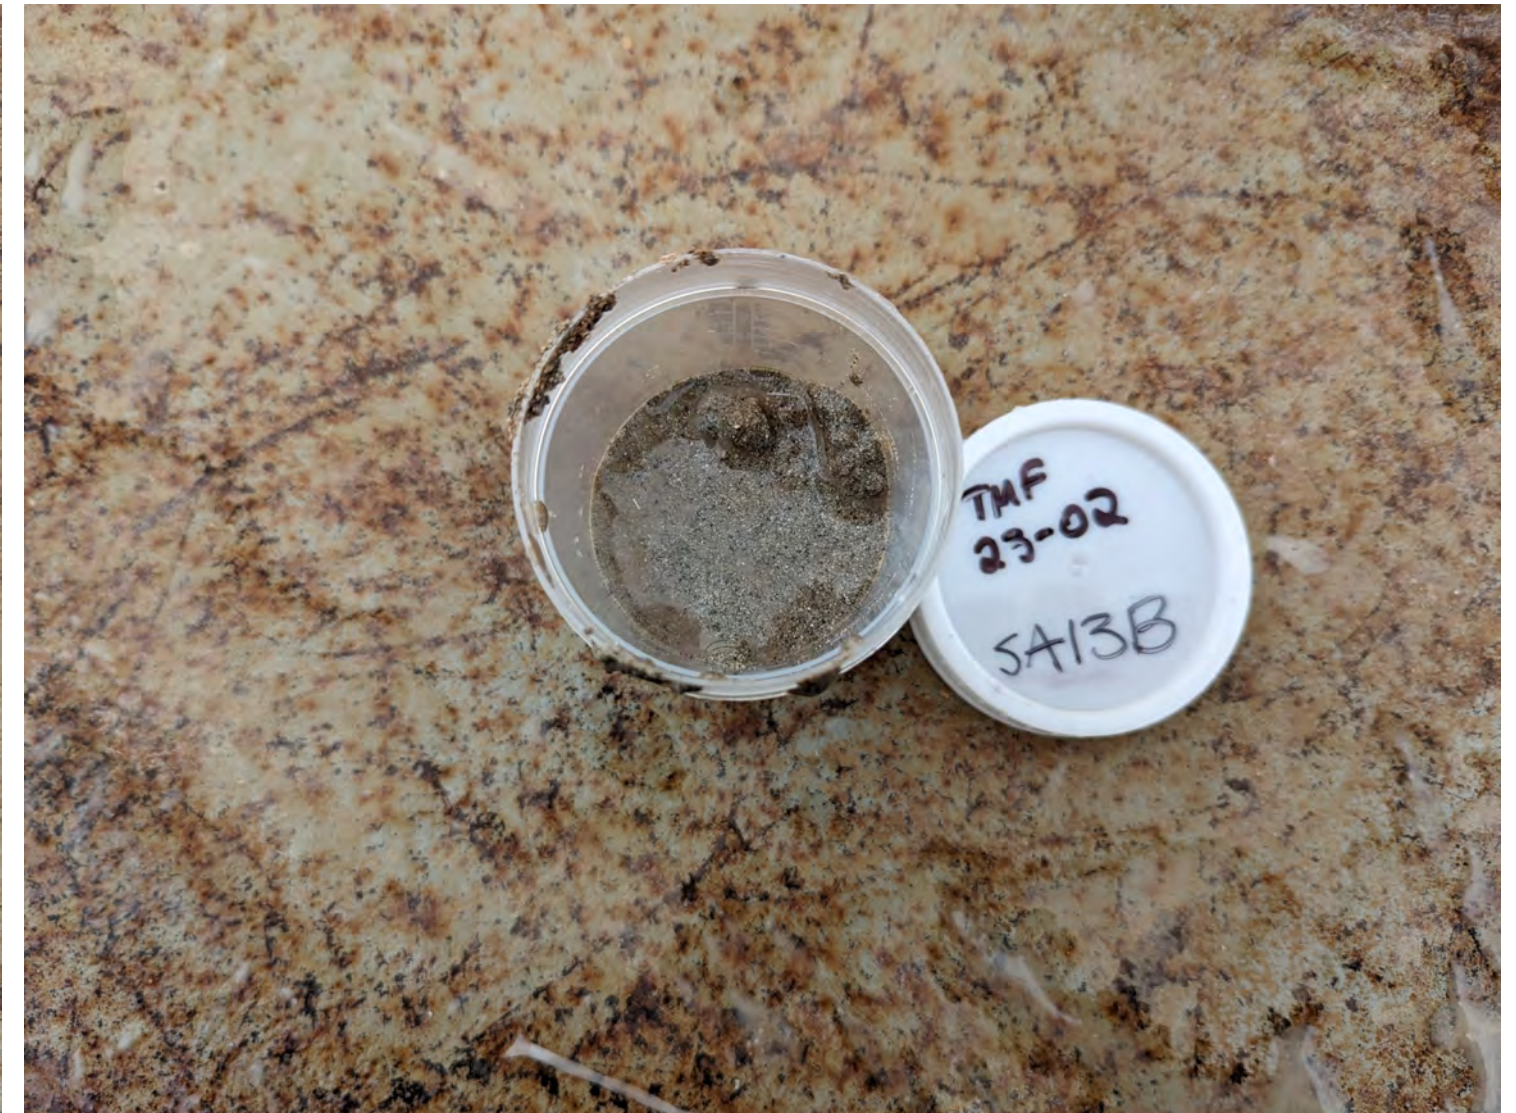
Photo 5: Subsample collected from TMF23-02-SA12. Brown, non-plastic, coarse sand. As shown, material was at a much lower insitu moisture content other samples collected.

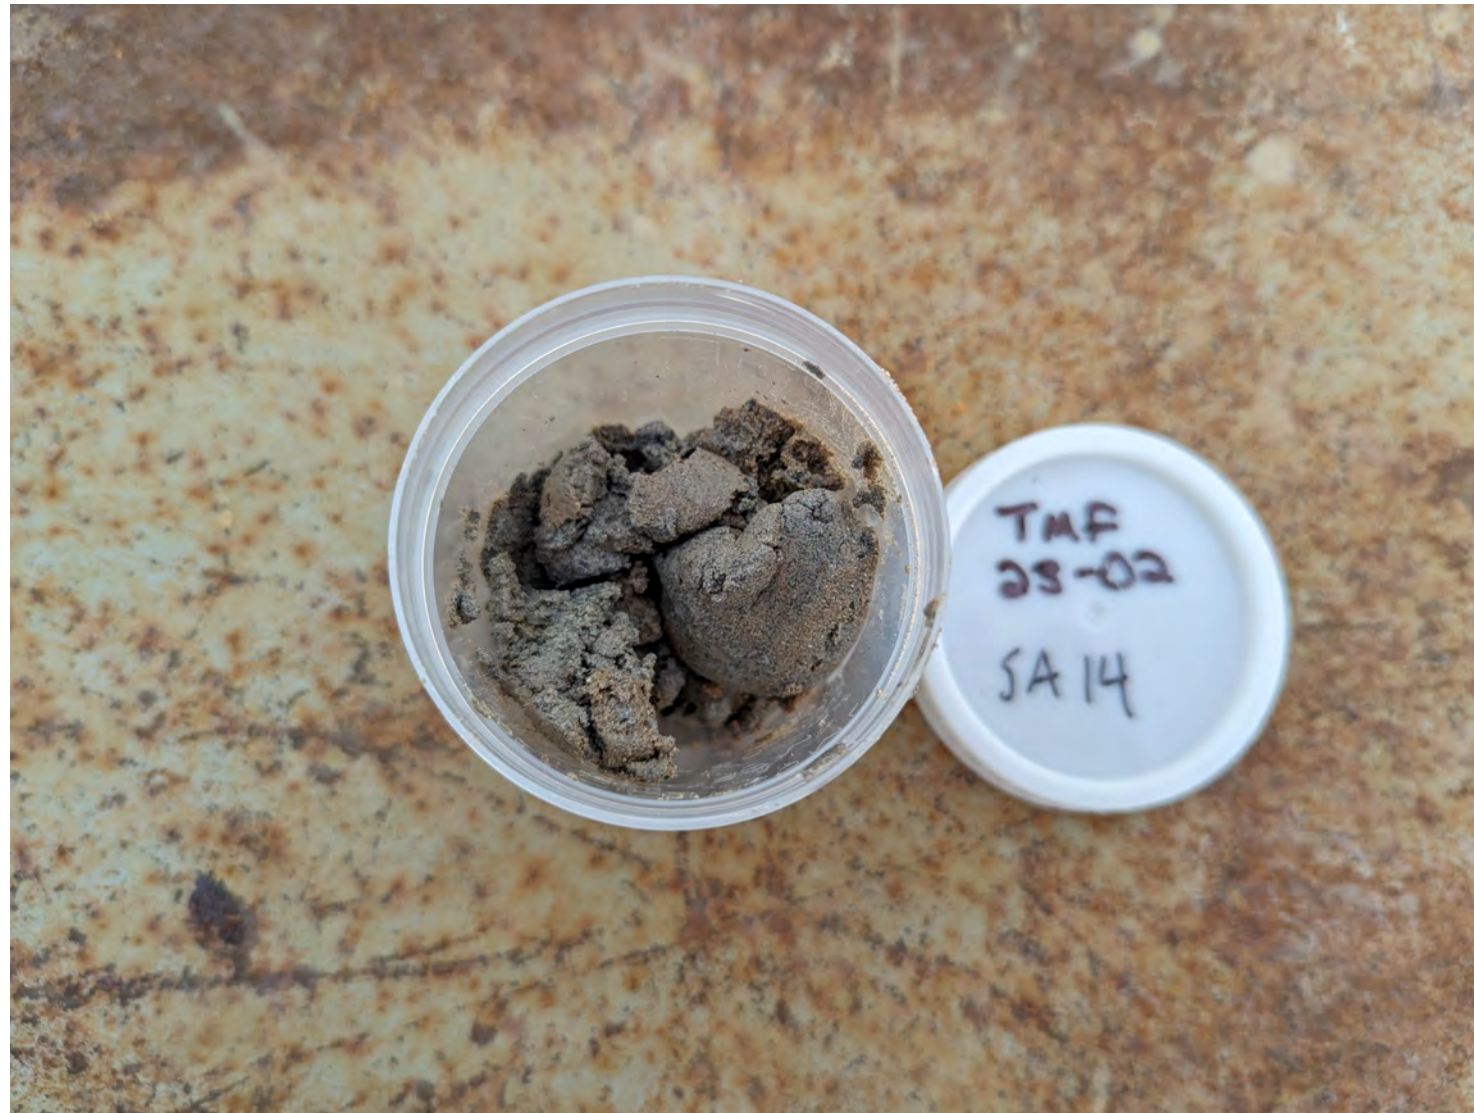
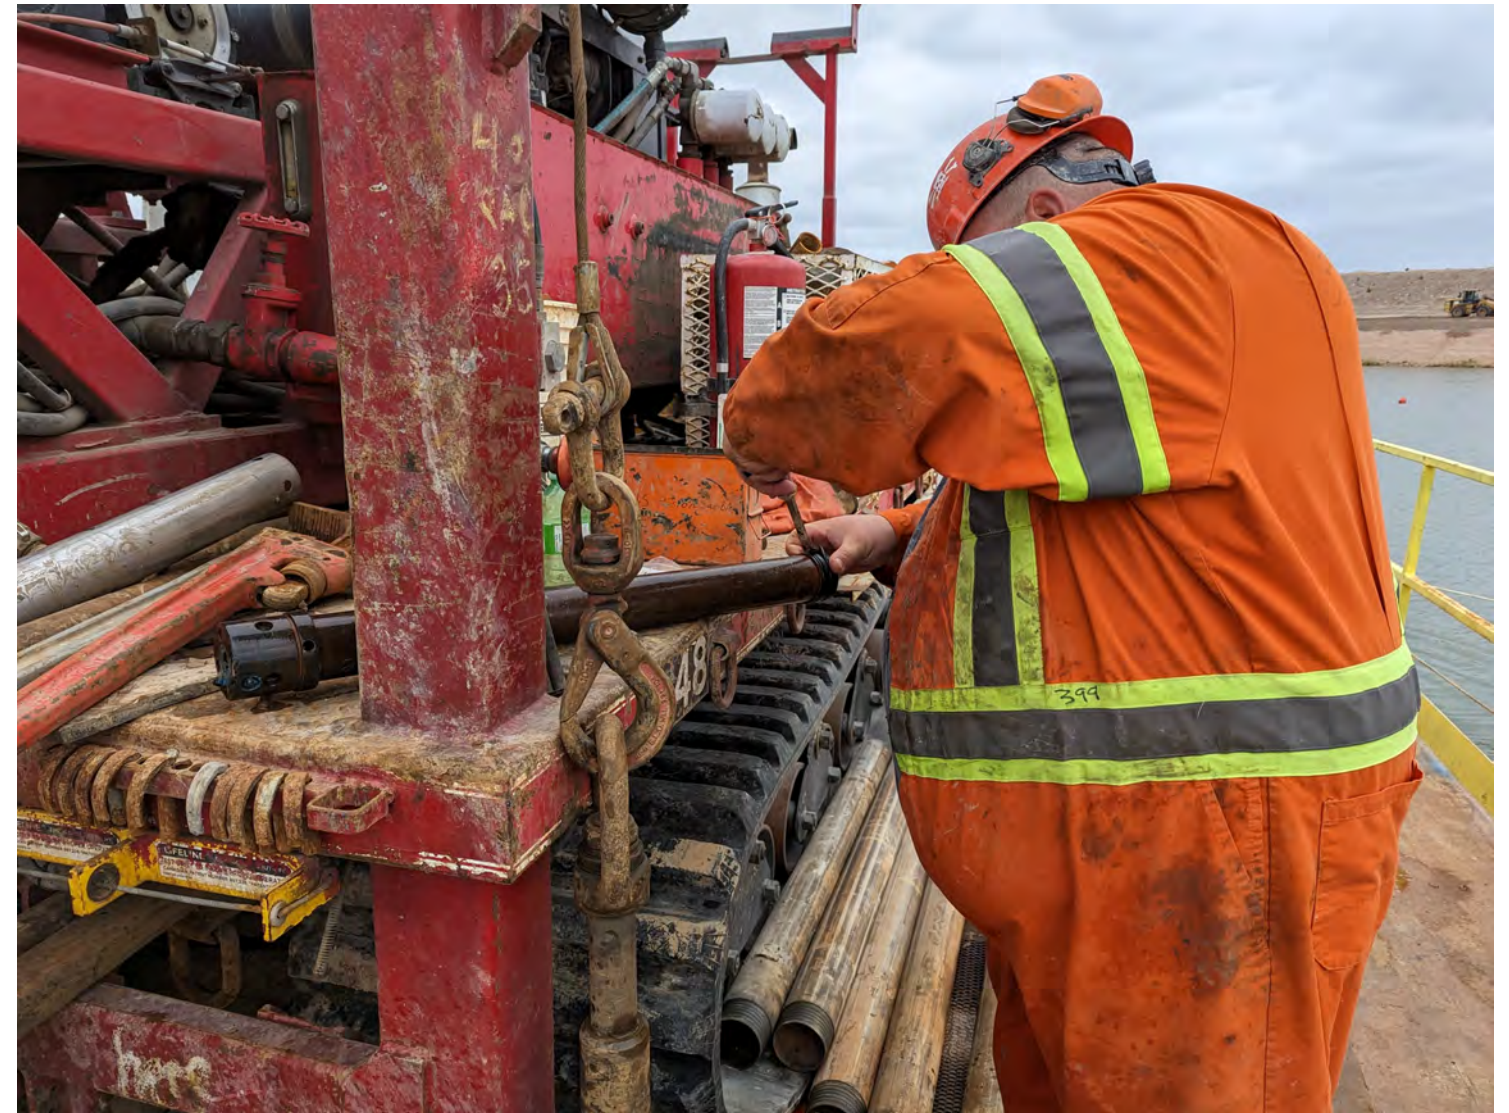
Photo 1: Subsample collected from TMF23-02-SA14. Grey silty sand. Lower than normal insitu moisture content.

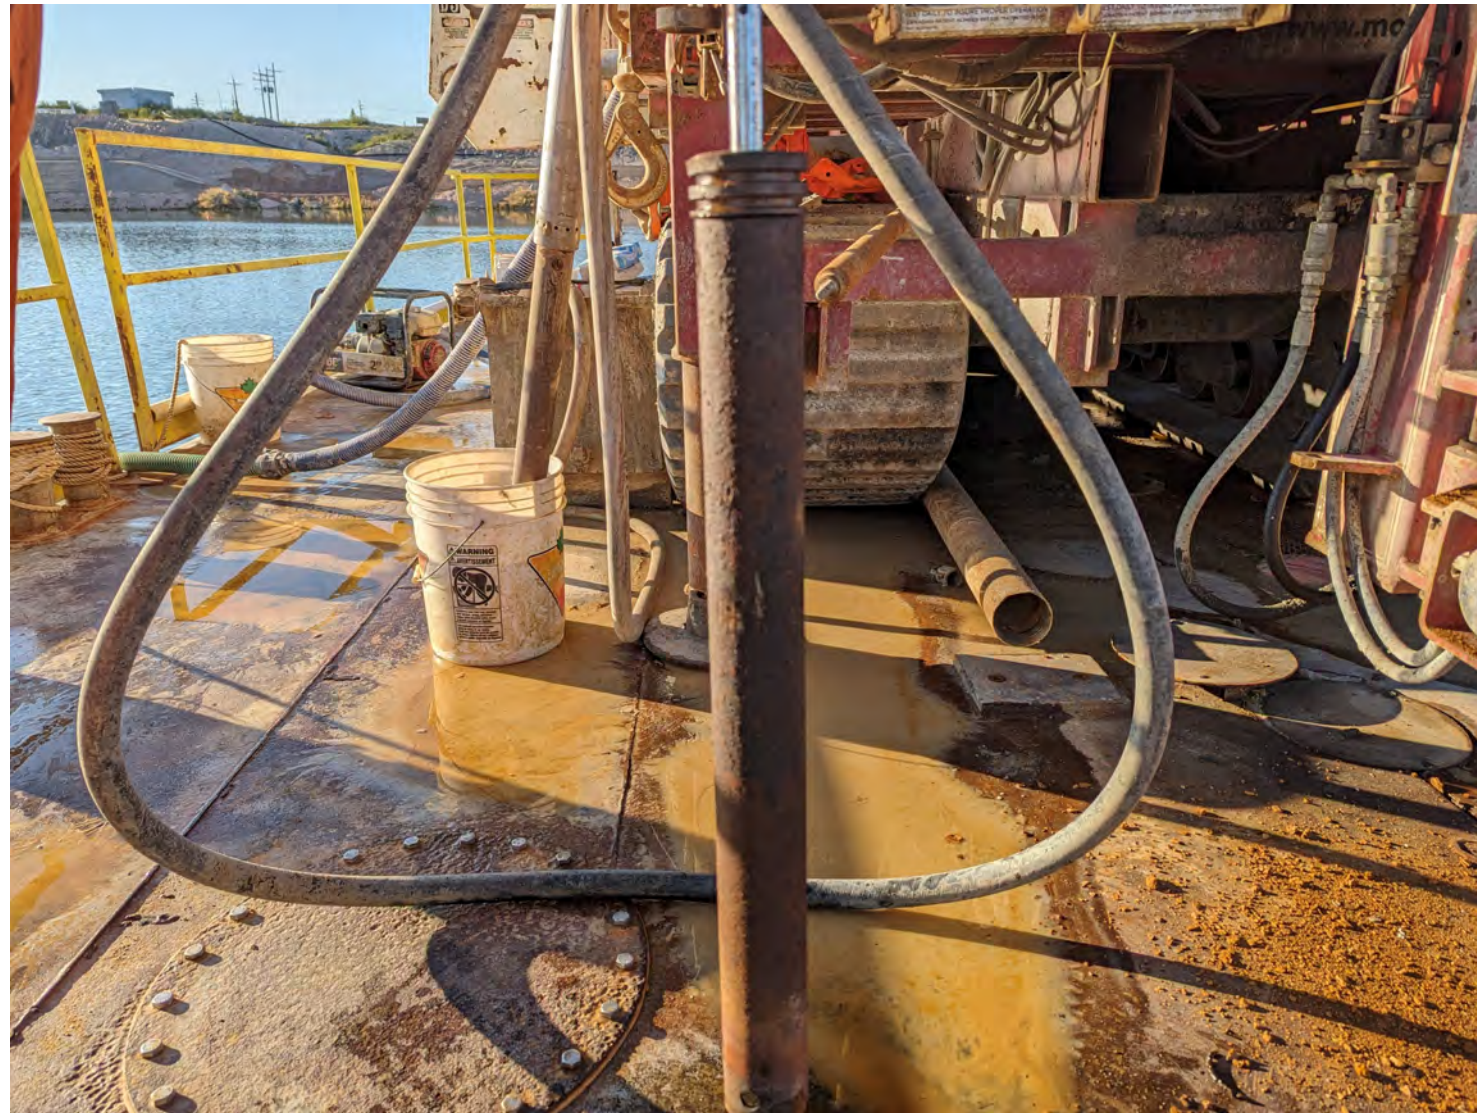
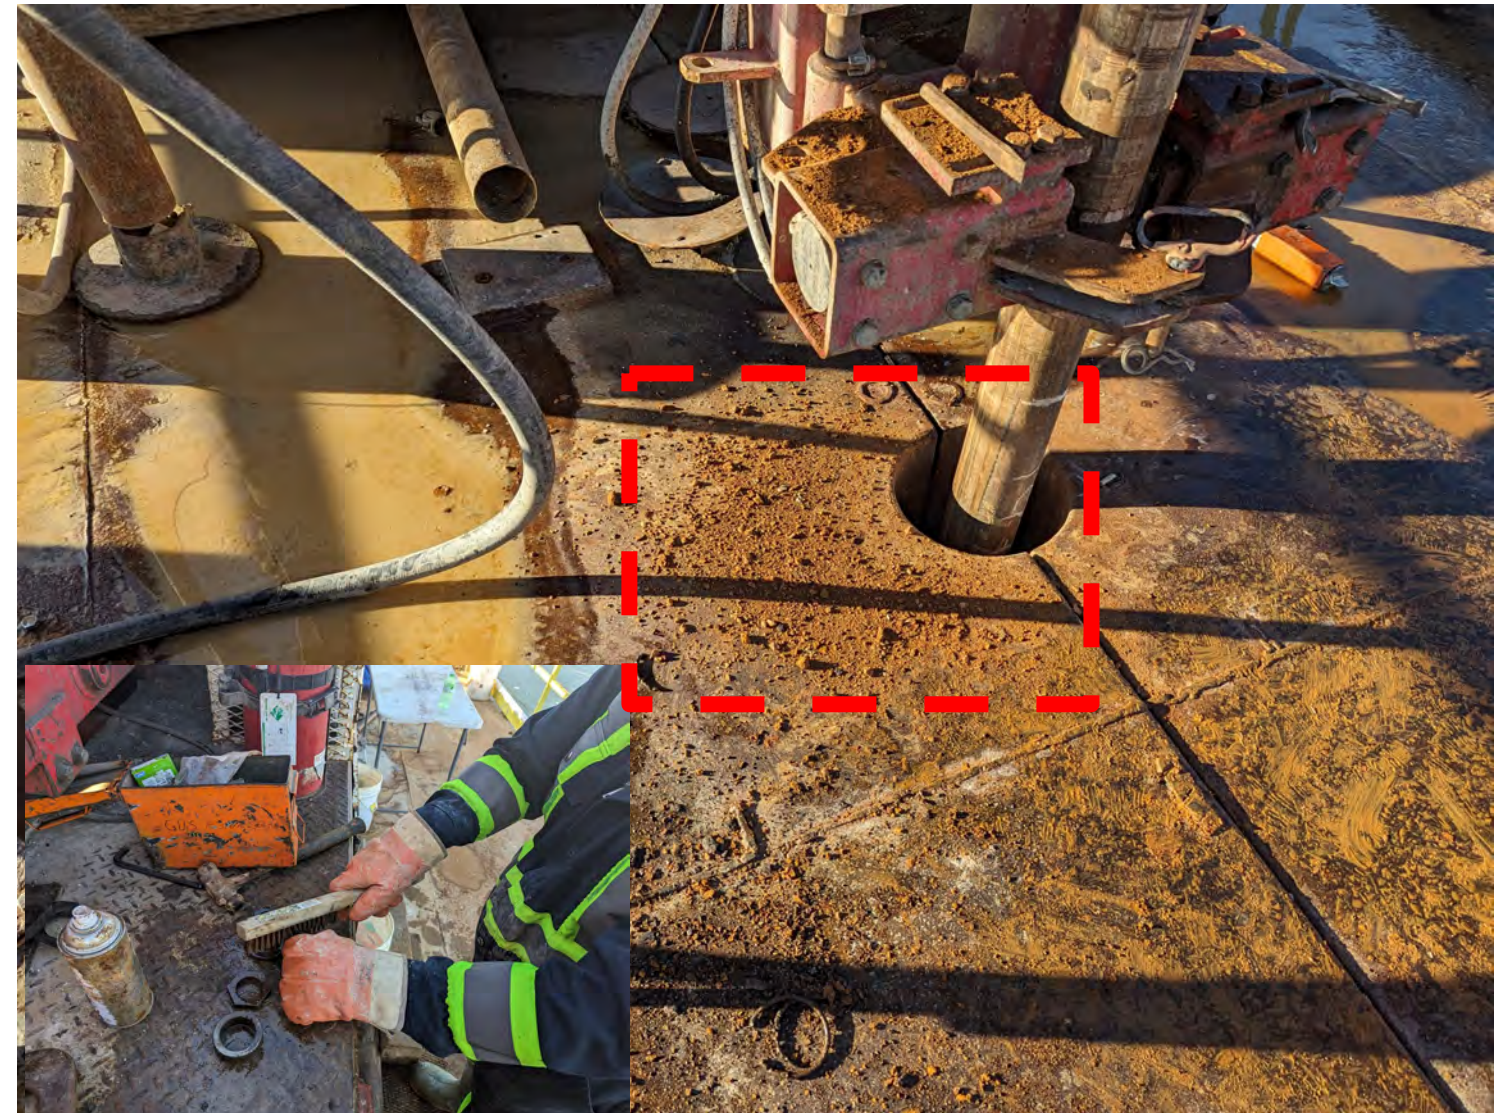
Photo 1: 2018 TOVP GUS piston sampler after removing outer housing.

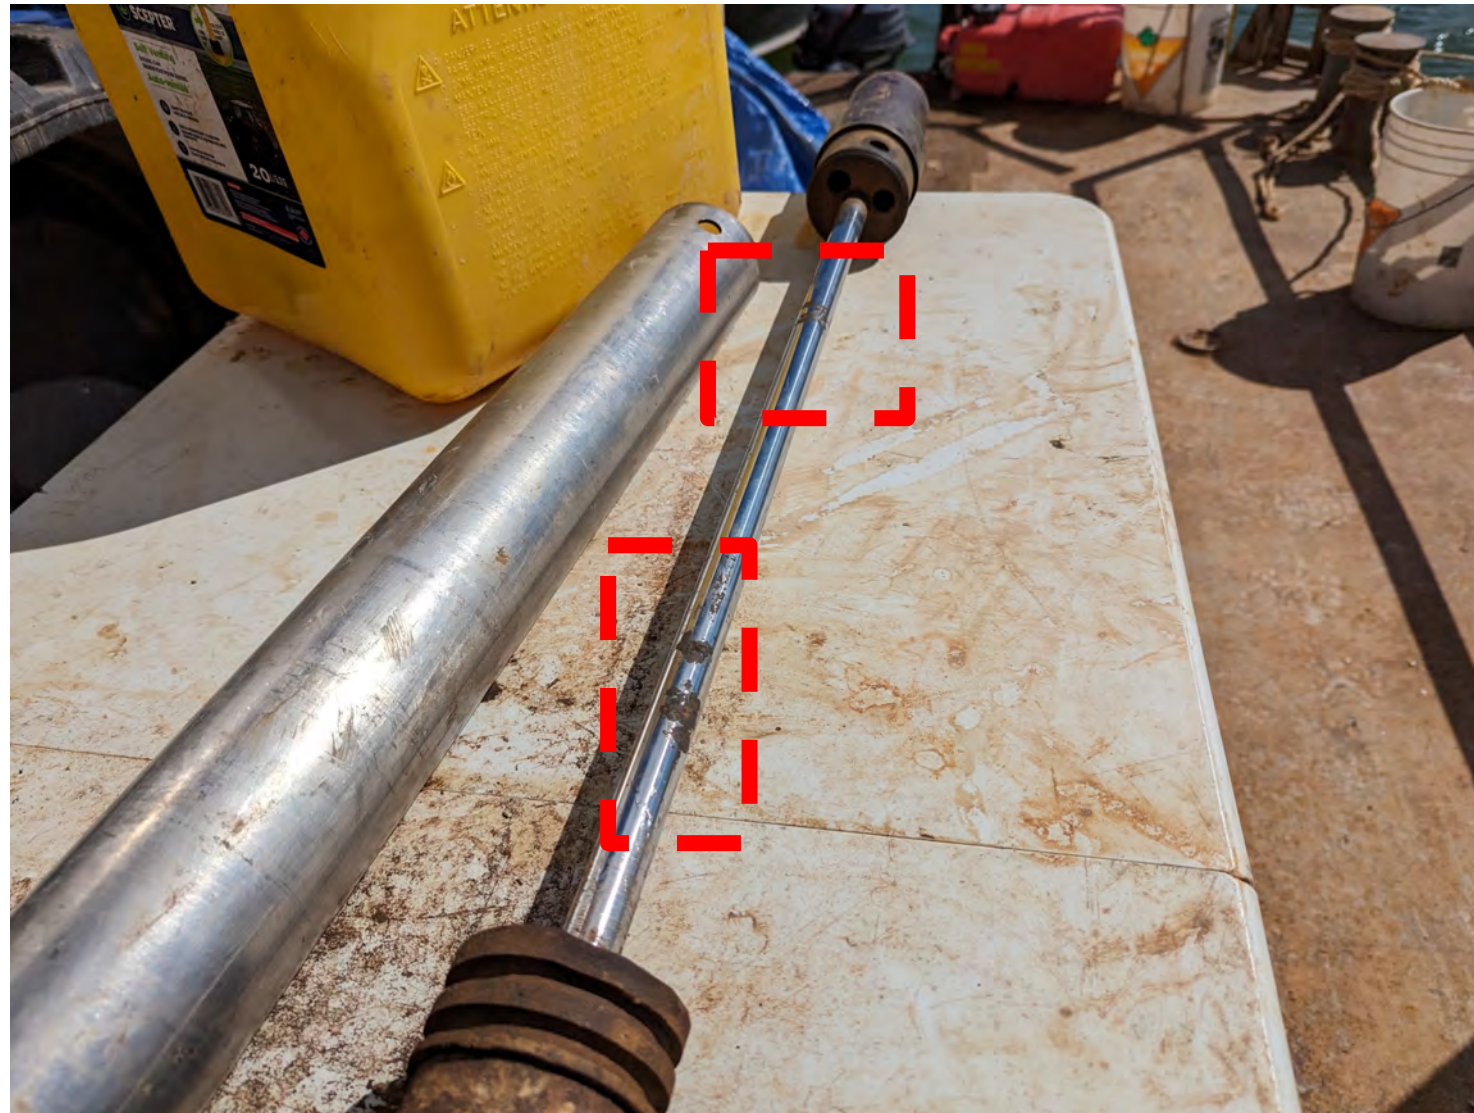
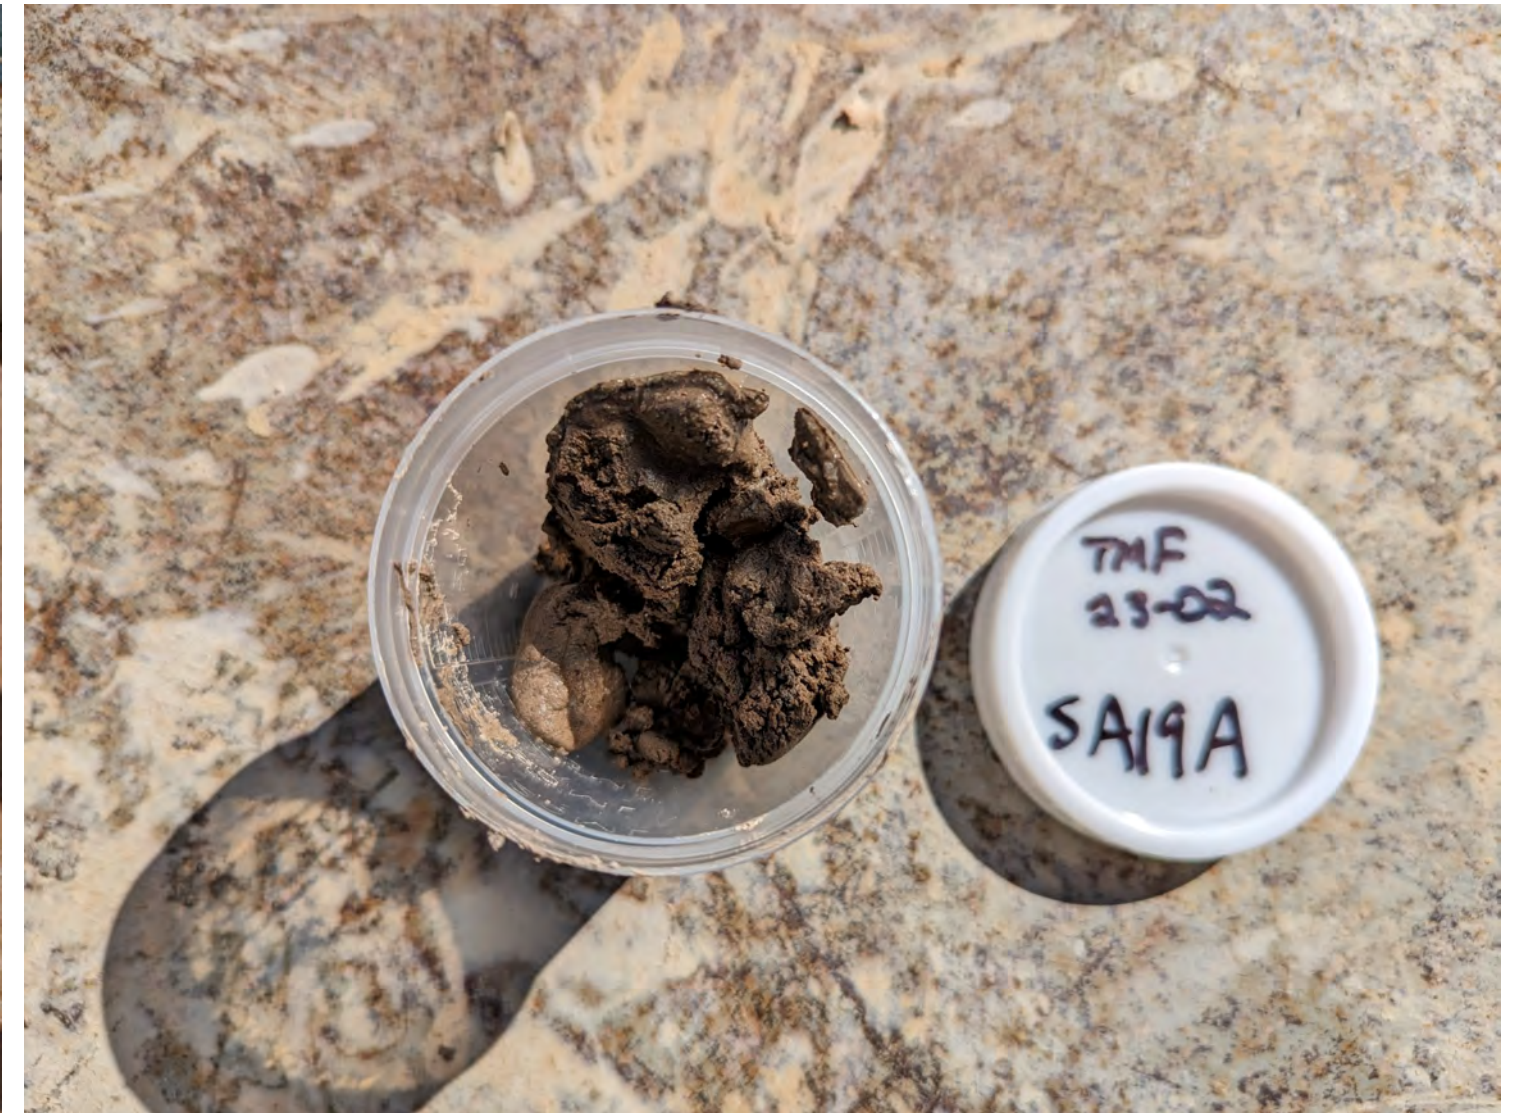
Photo 3: Pitting on the piston rod from the 2018 TOVP GUS sampler.

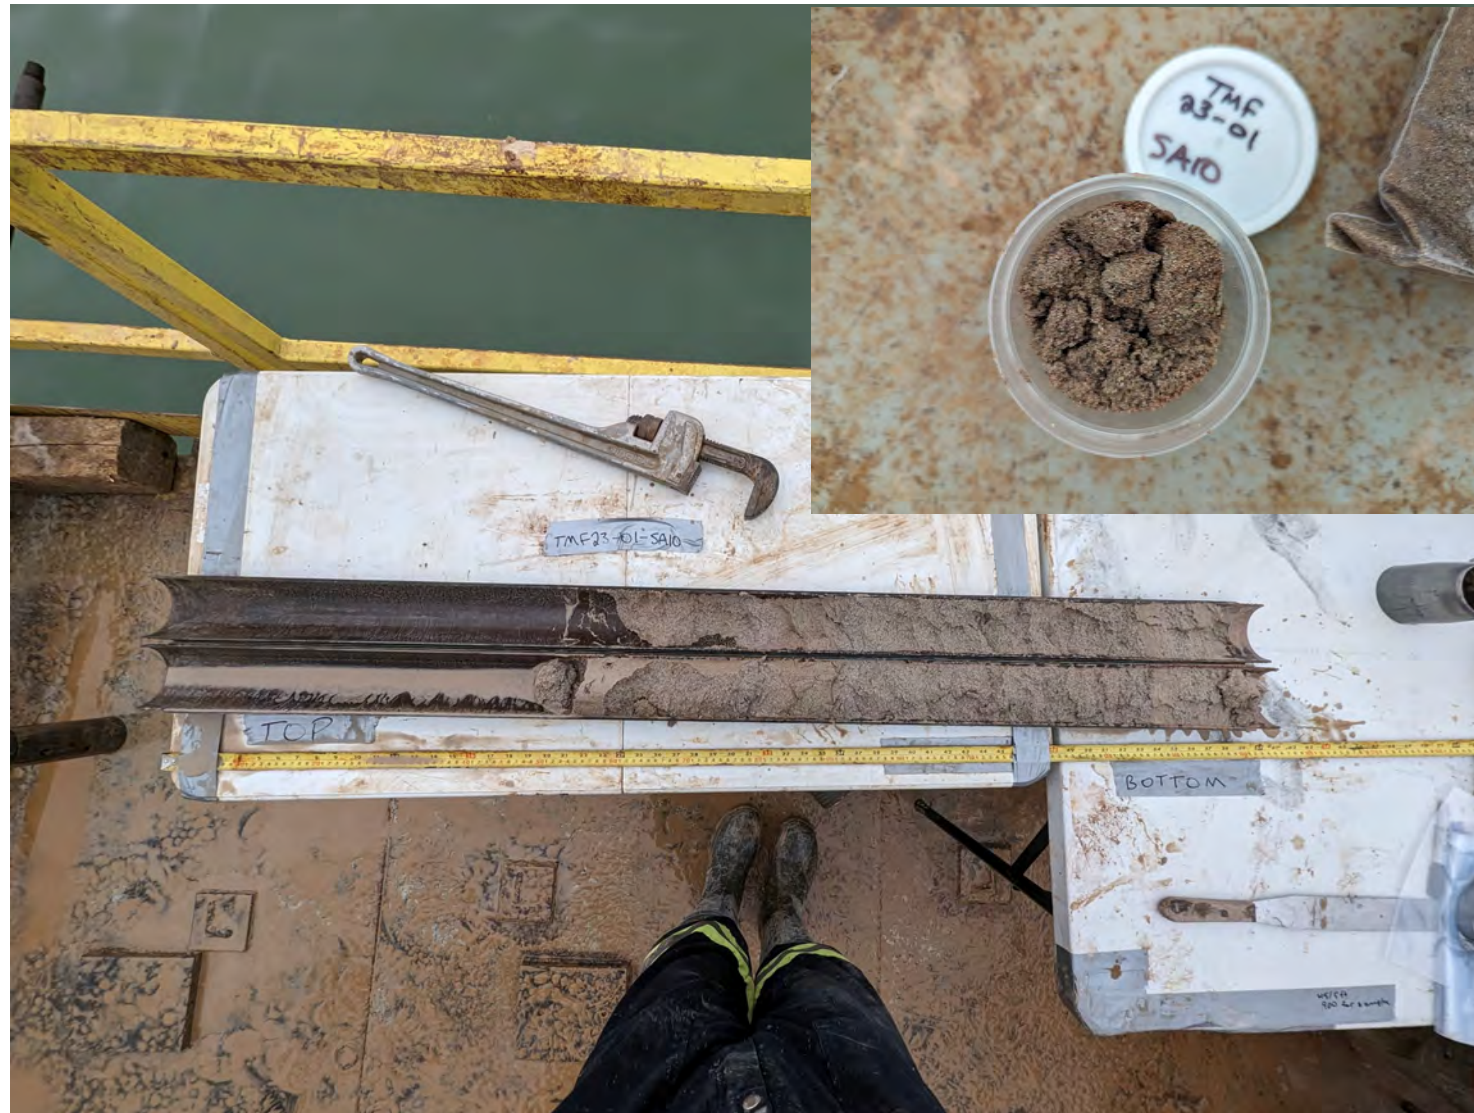
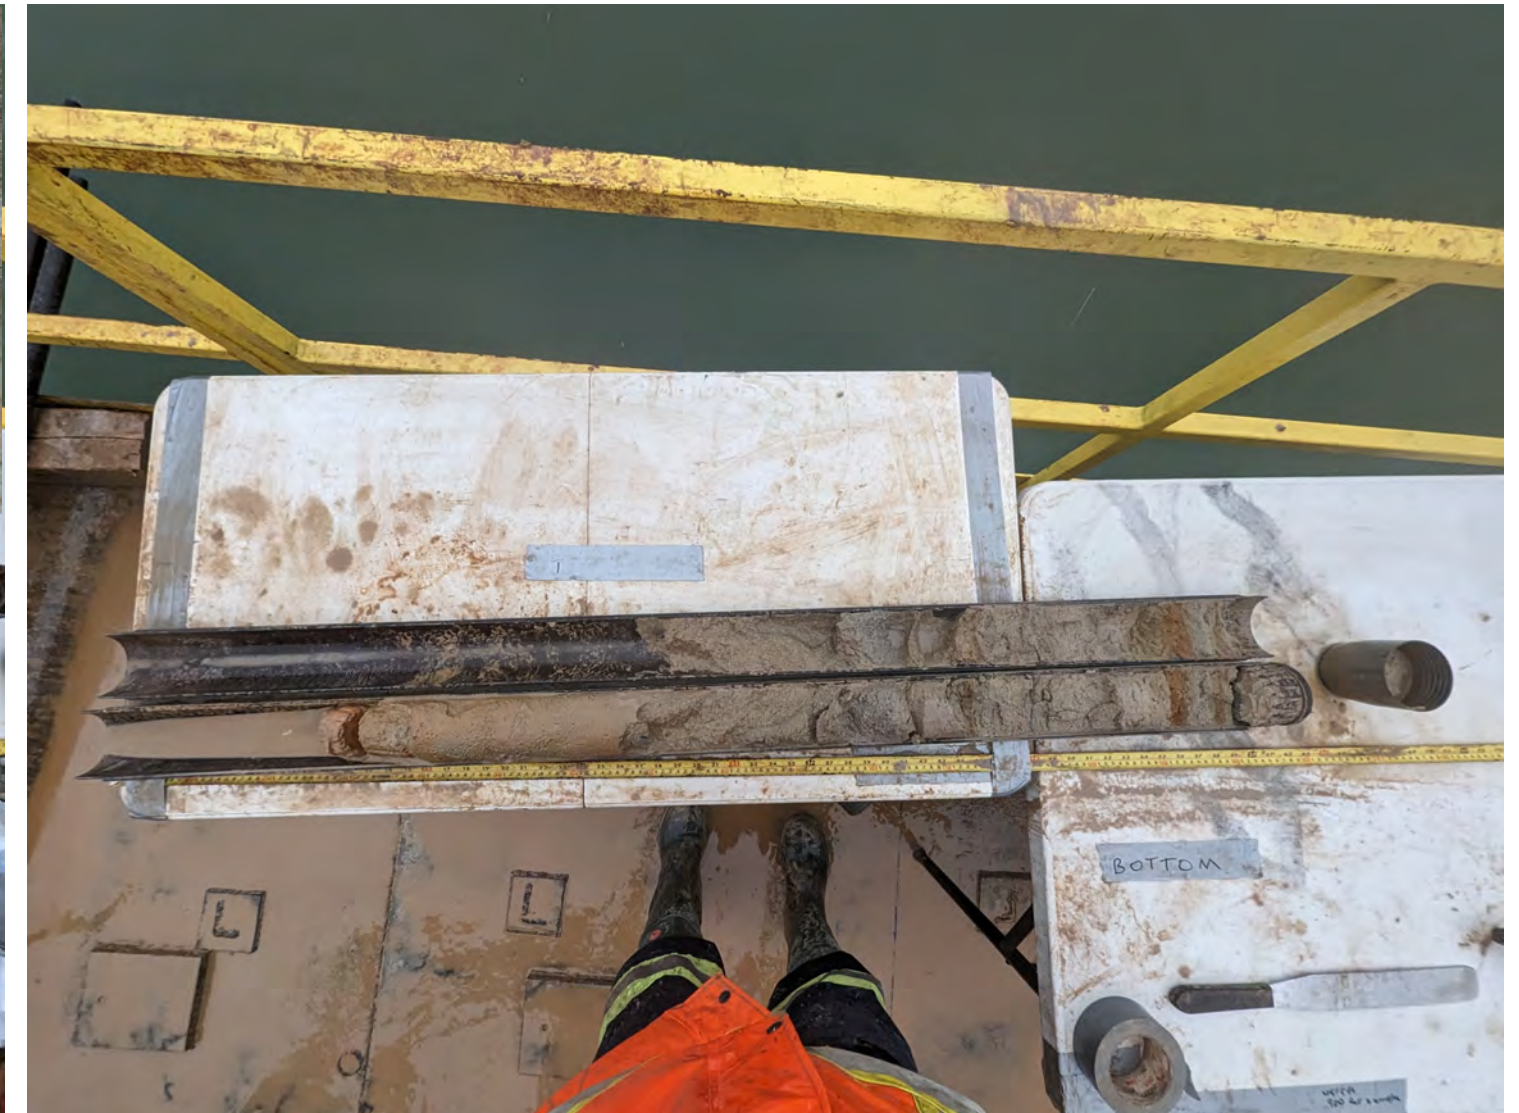
Photo 1: Core and subsample from TMF23-01-SA10. Light brown, non-plastic sand. Non-plastic silt found at the bottom of the sample. As shown, the upper 2ft of the sample appears to have been washed out while retrieving the sample.

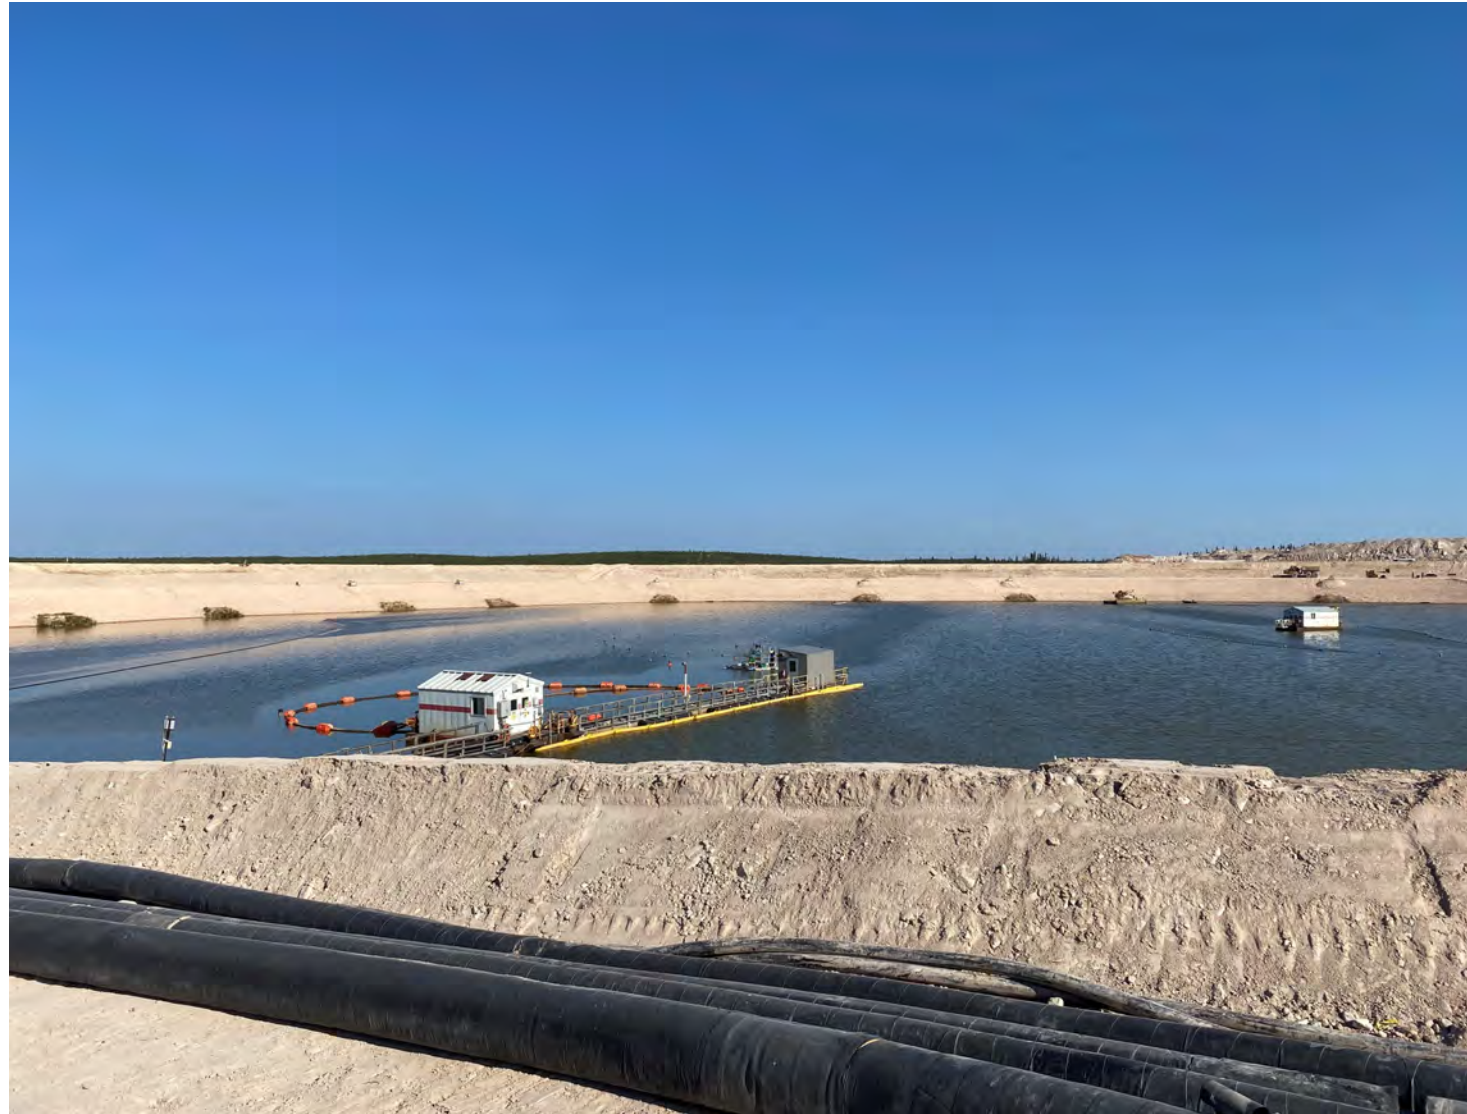
Photo 1: Site overview at the beginning of the day

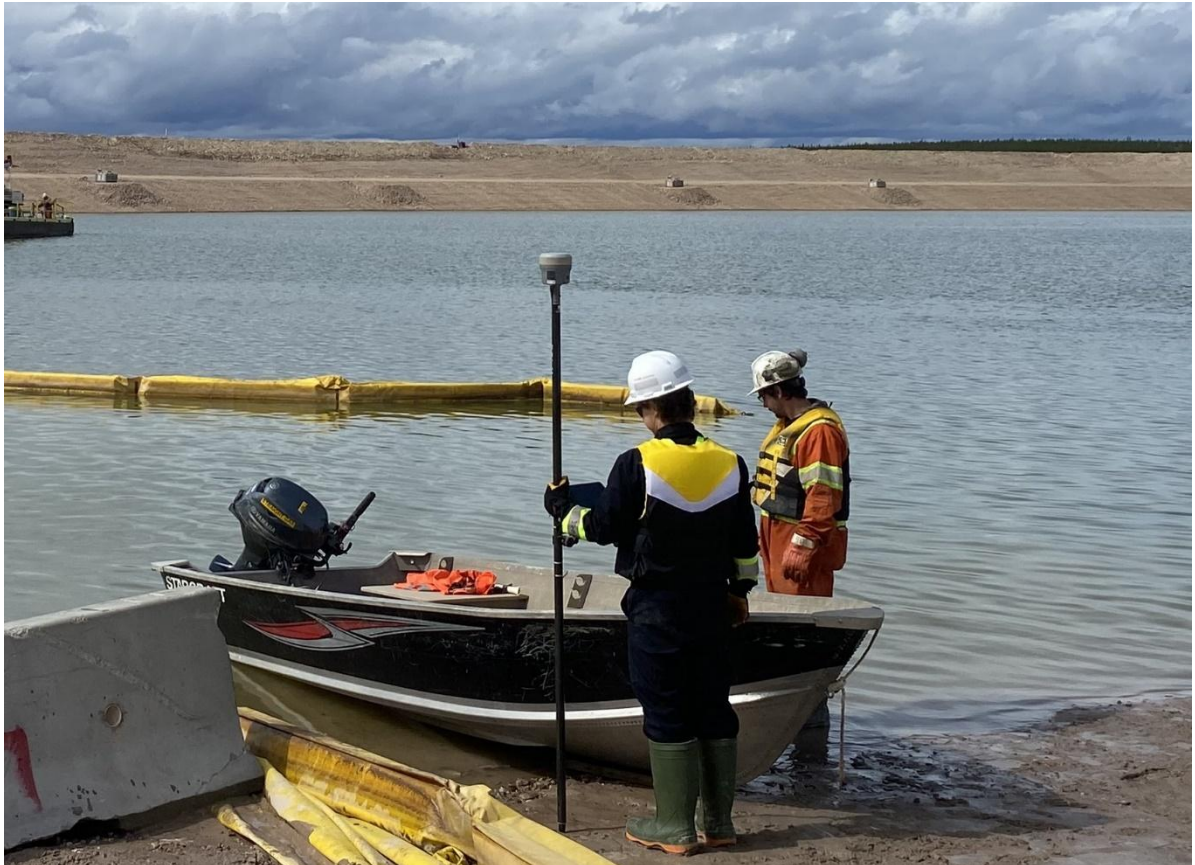
After relocating the barge to within 3 m of the proposed location, it was secured with Claw/Bruce 33-lb (15.0 kg) anchors. Before drilling, the barge was monitored for passive movements for a few minutes, after which the location was confirmed again using the survey unit. If the drill opening on the barge was found to be within 3 m of the proposed location after this period, drilling commenced. Otherwise, the position of the barge was adjusted by tightening or loosening various anchors. Once the barge was secured, the depth to tailings was recorded using a weighted tape reel.

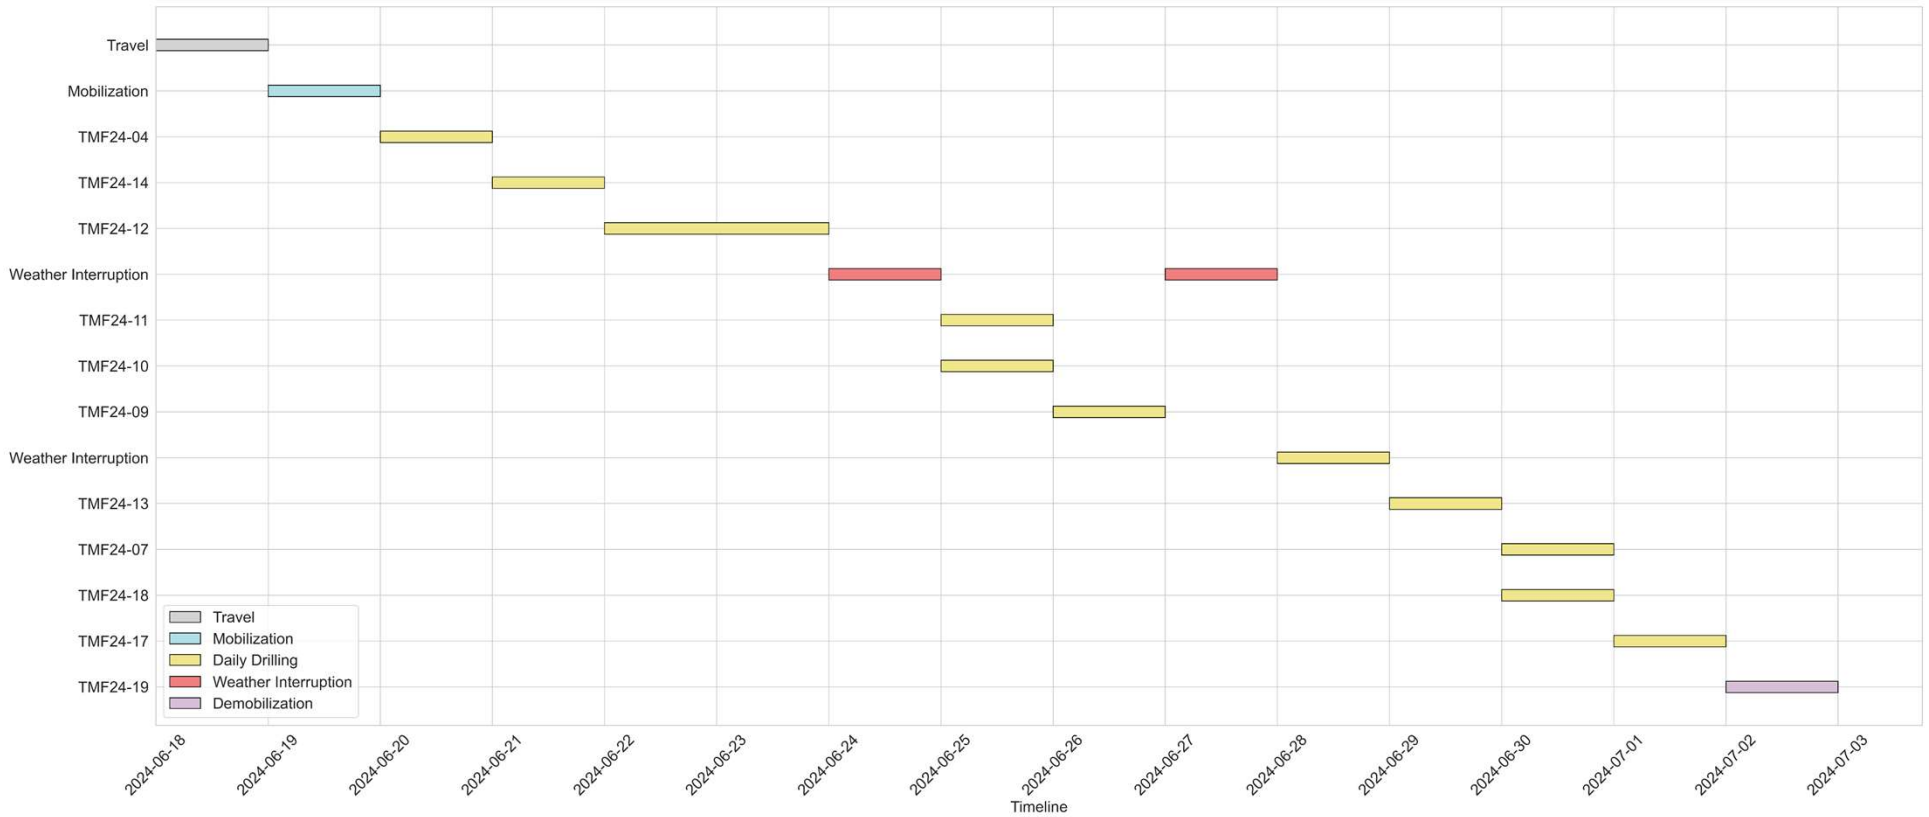
Figure 5 provides a Gantt Chart with the final timeline of TOVP 2024.

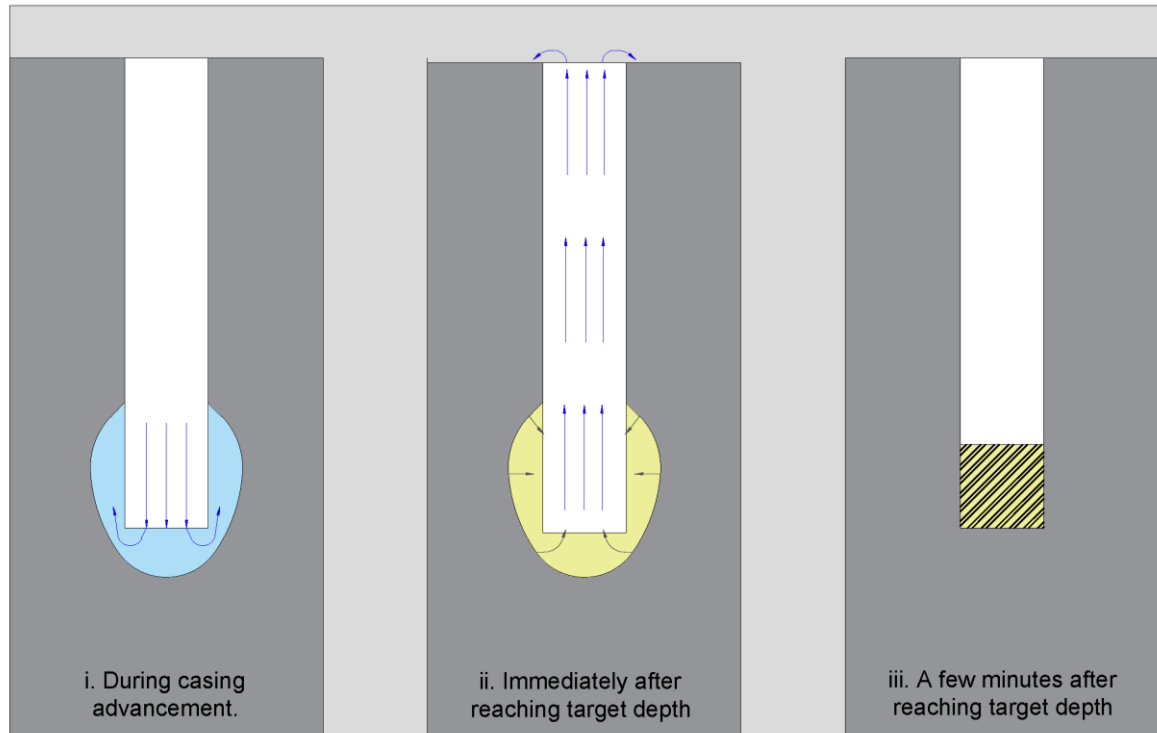
Sources: SRK (2024).
