Date: 2026-06-29

**Written Submission from
Orano Canada Inc.**

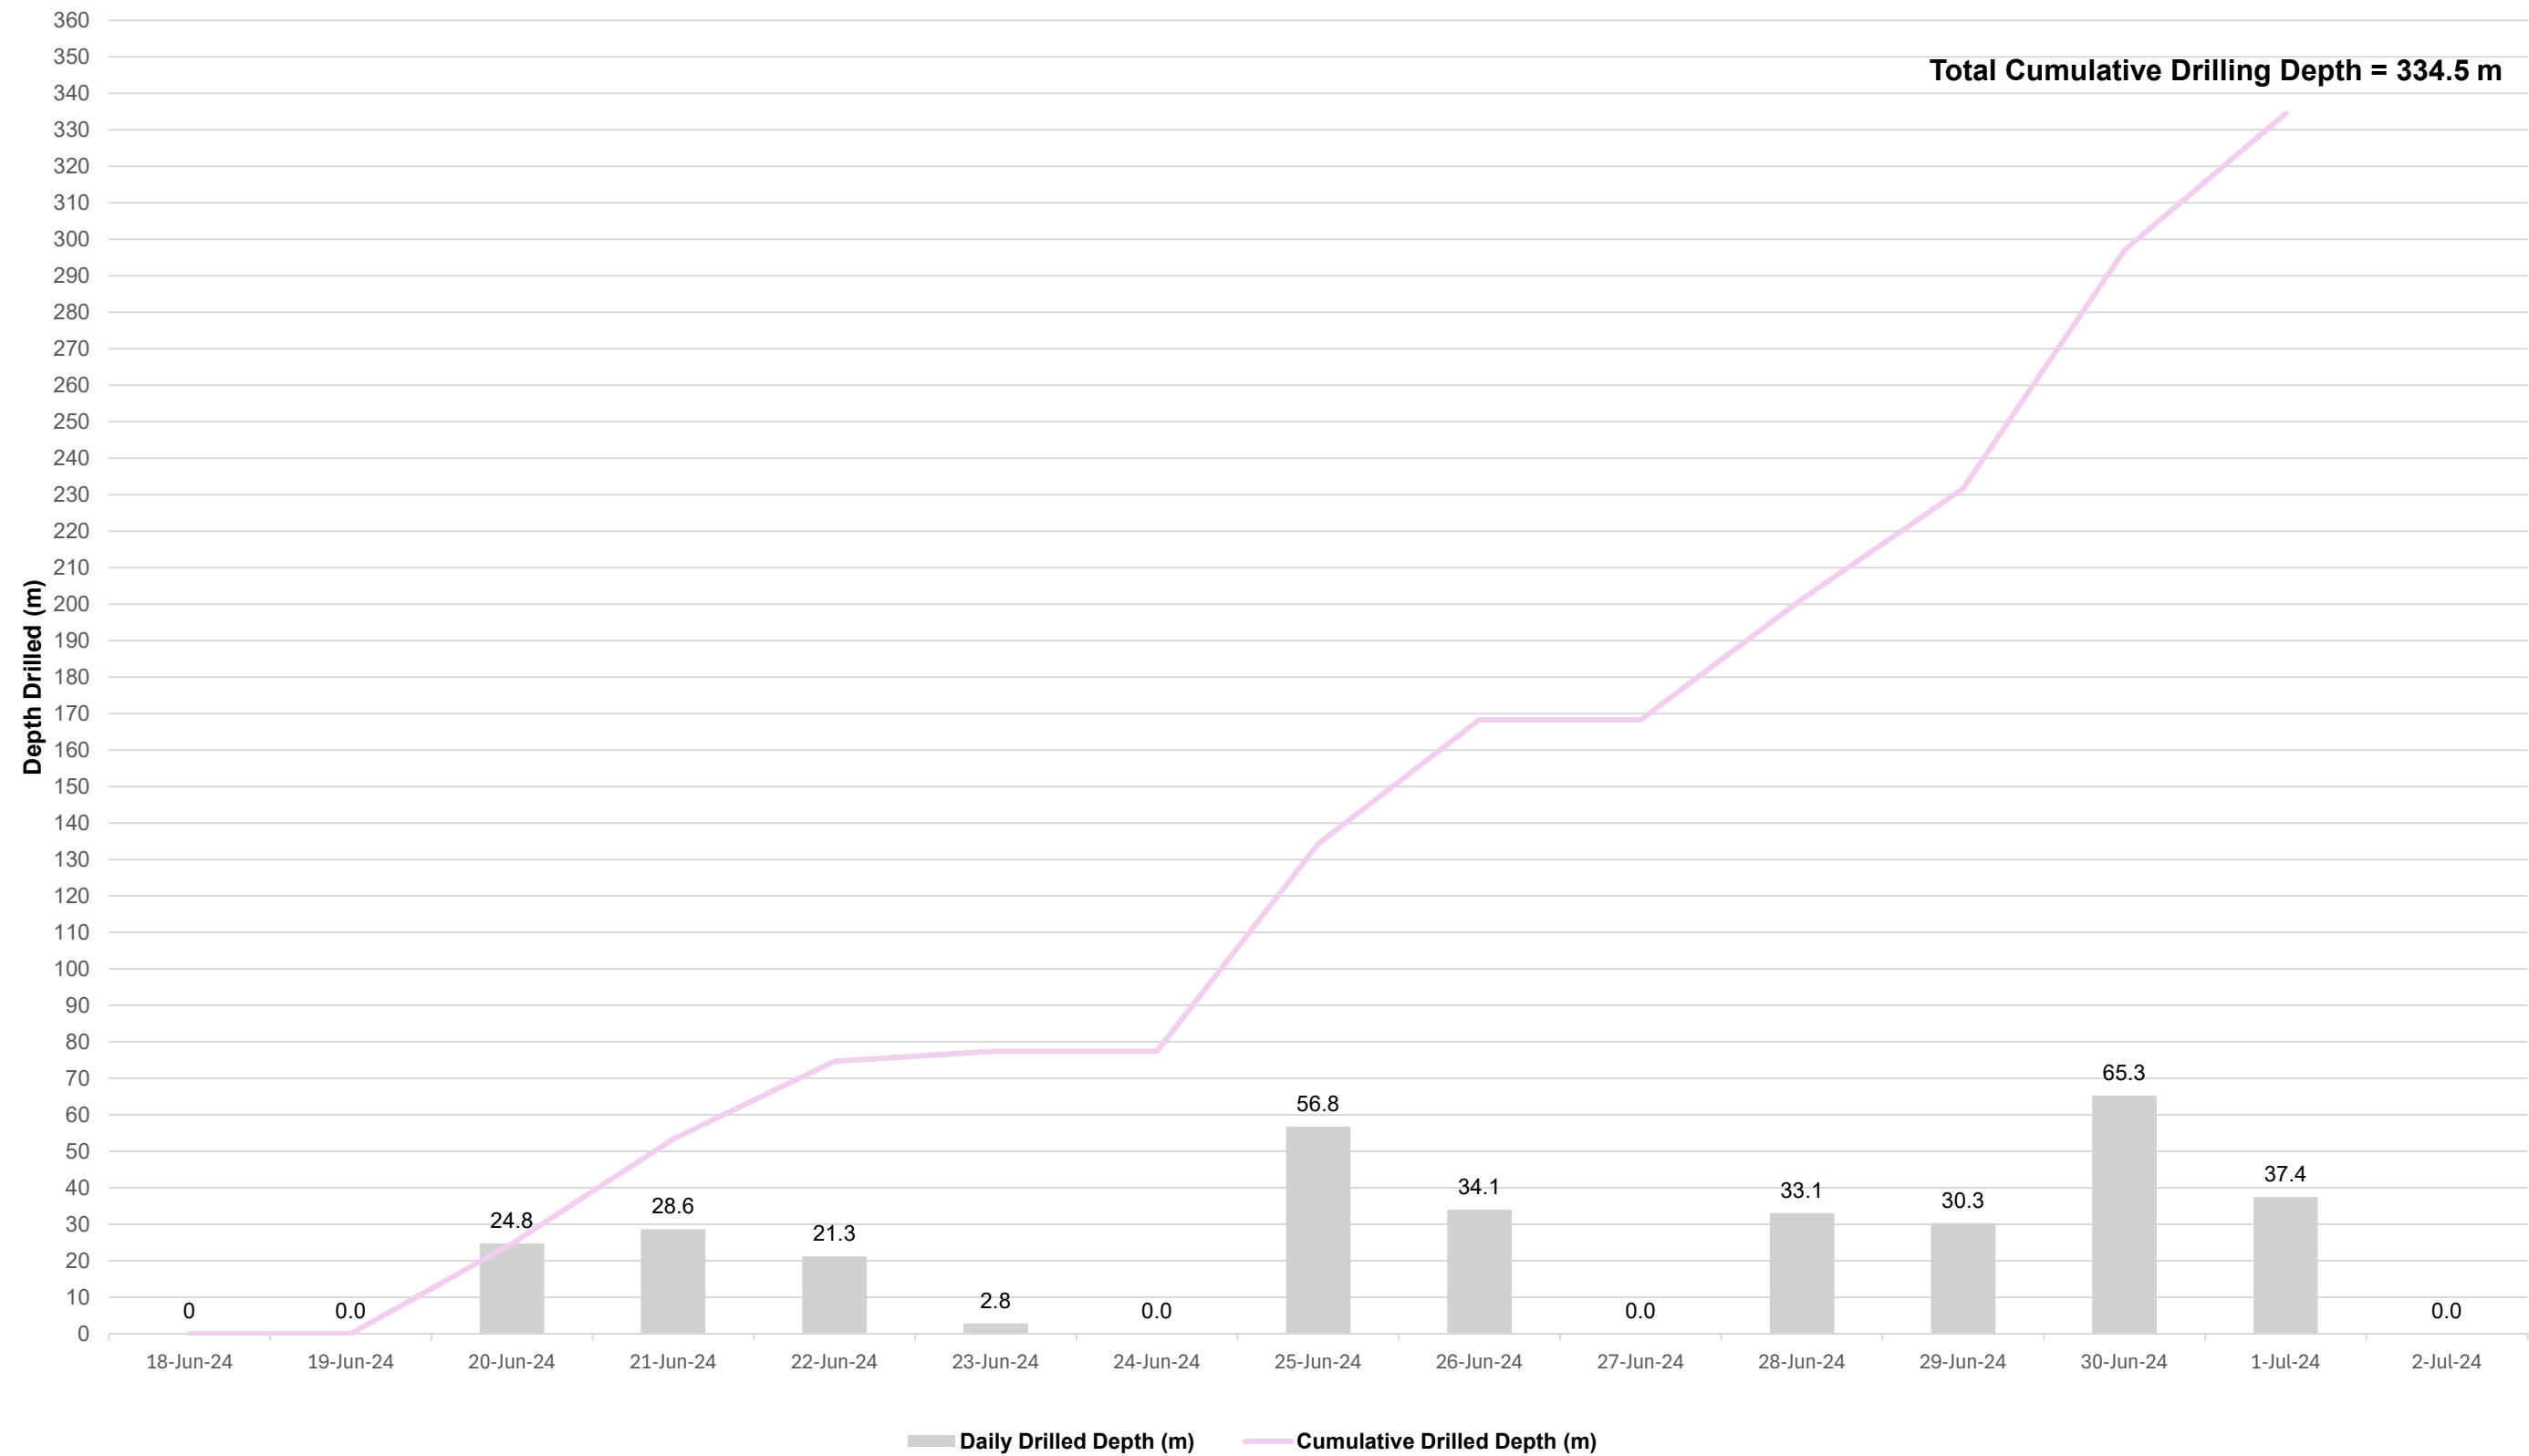
Appendix A Daily Drilling Progress Summary

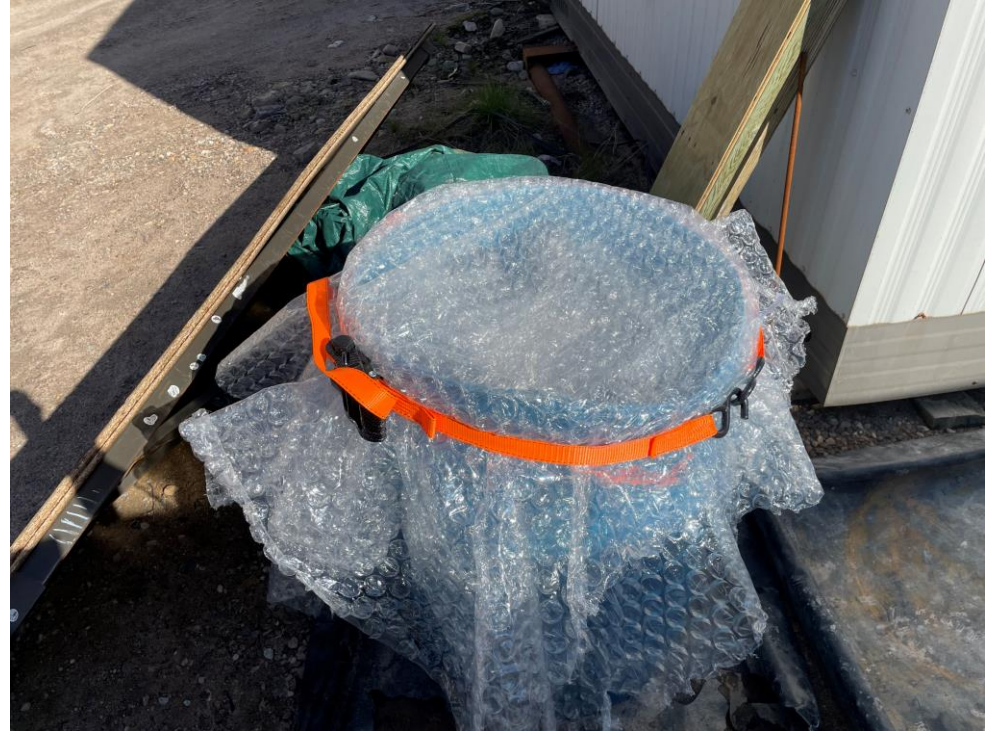
Photo 16: Shelby tubes from TMF24-04 stored in the container with bubble wrap and tarped with bubble rap (secured by ratchet strap) to prevent weather damages.

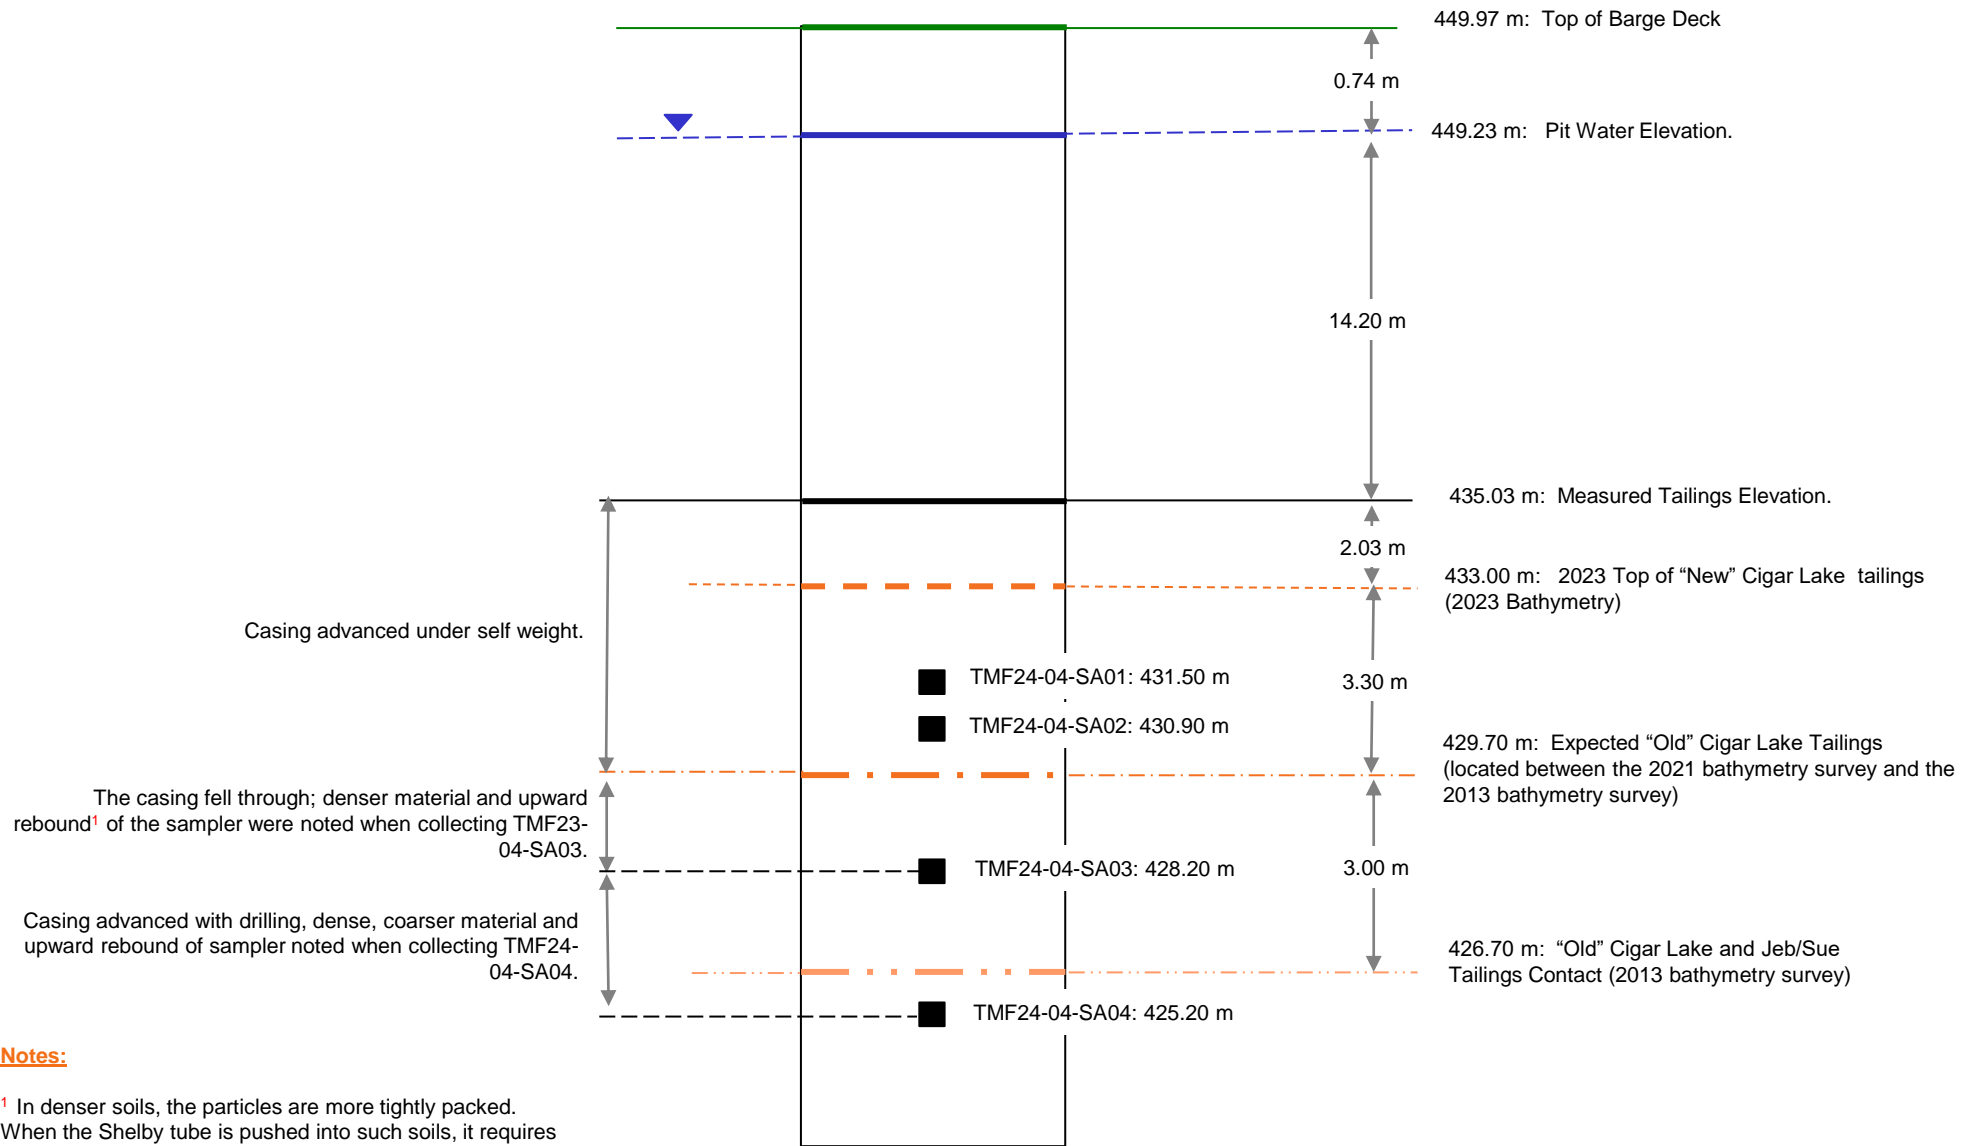
TMF24-04 (Schematic)

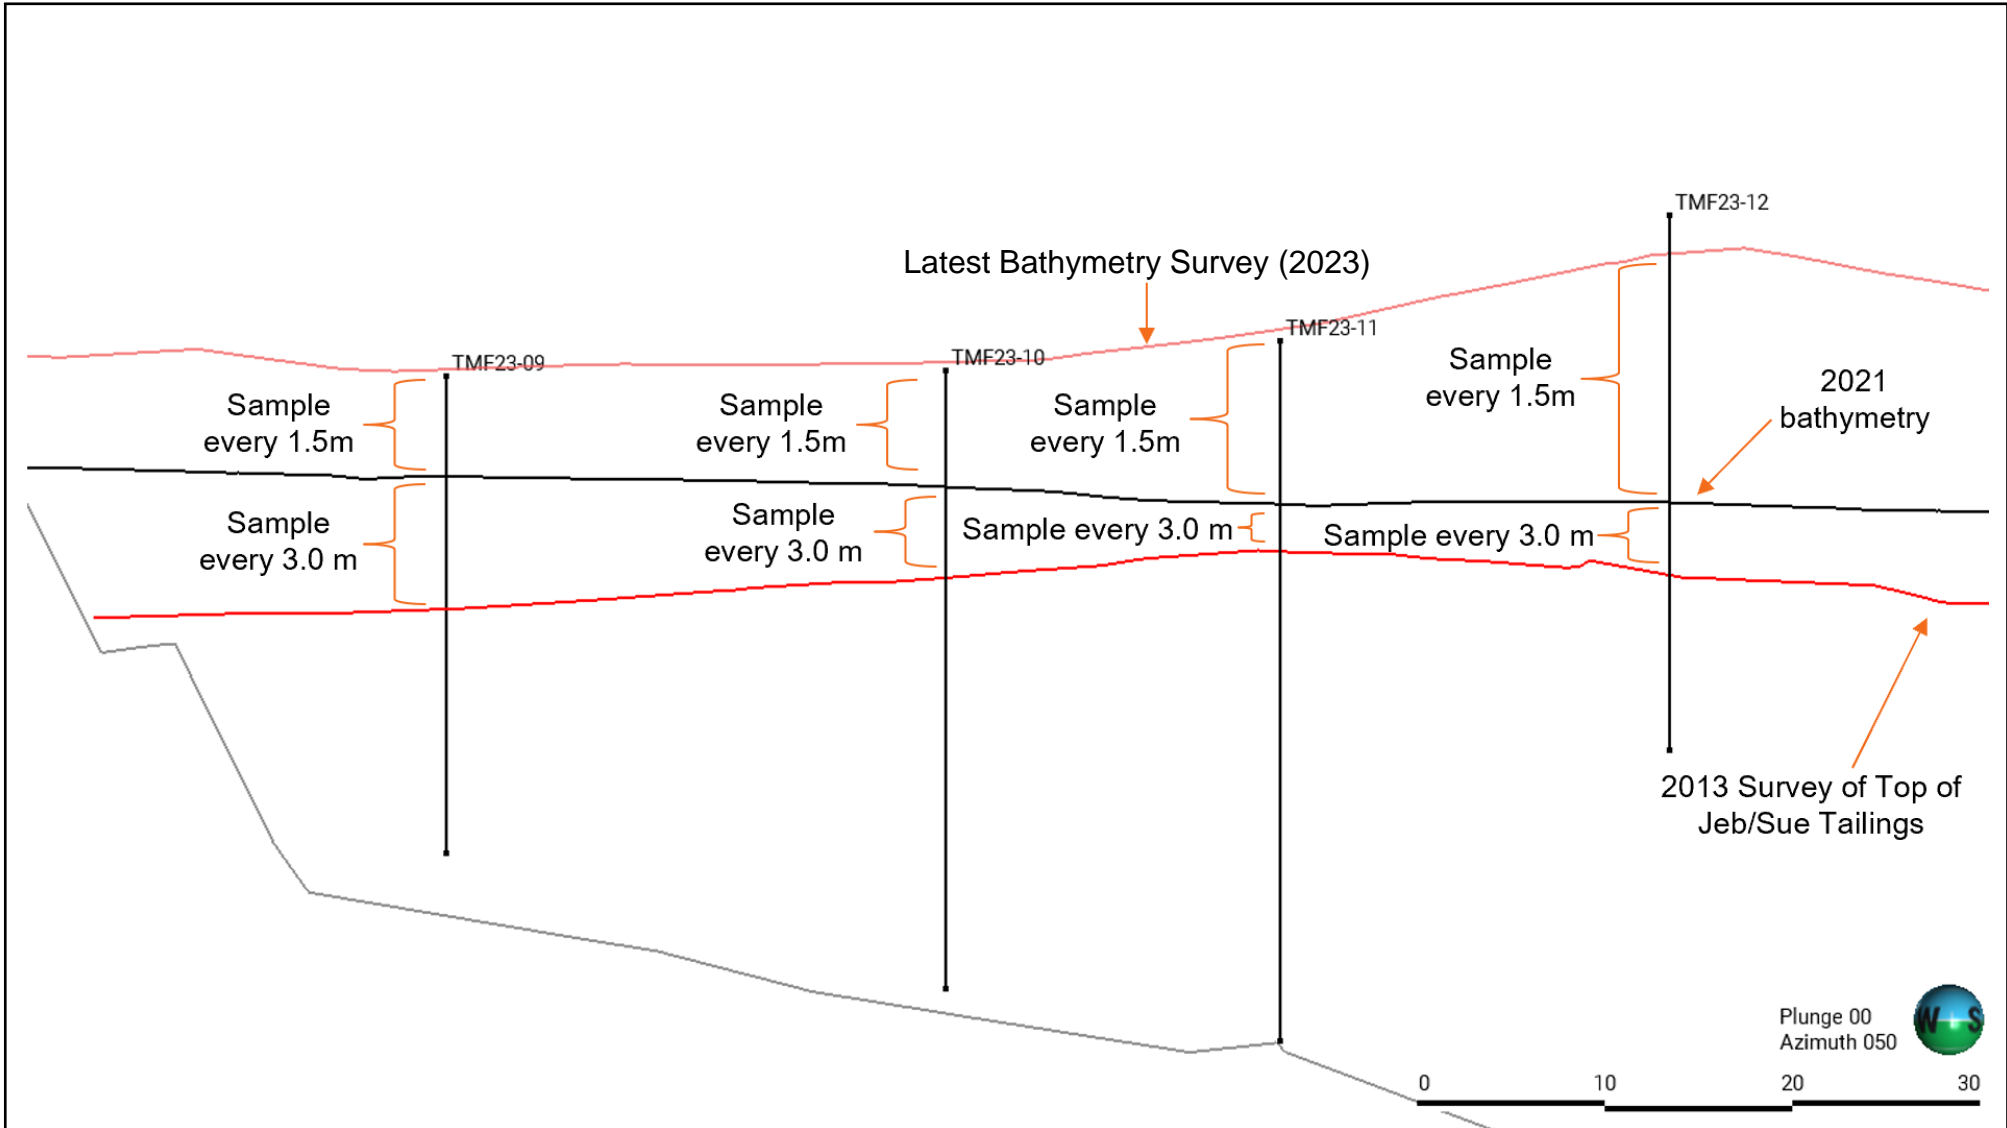
TOVP 2024 Geotechnical Drilling

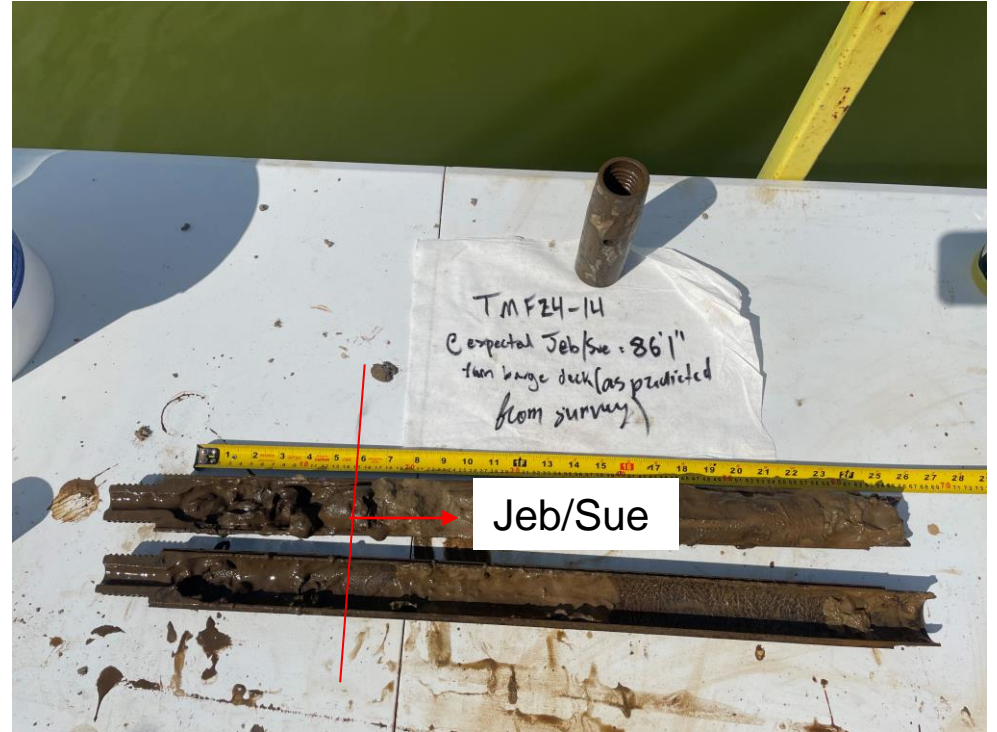
Photo 18: Split spoon sample at expected Jeb/Sue boundary from 2013 bathymetry survey (423.7 masl), showing the found Jeb/Sue boundary 15 cm lower.

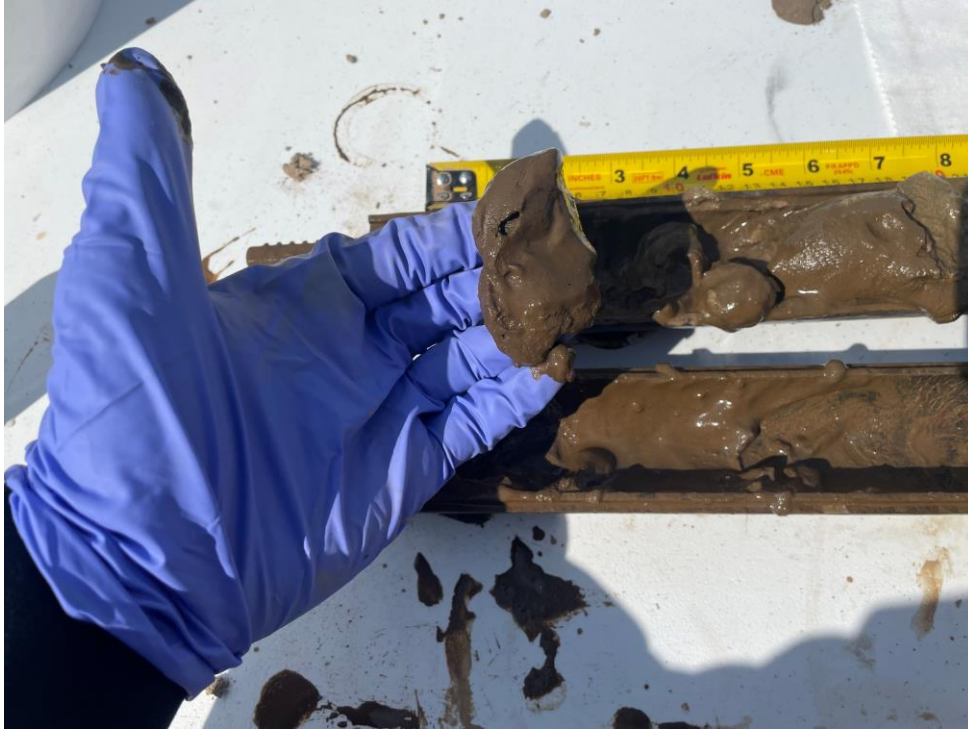
Photo 19: "Old" Cigar lake tailings (between 2021 and 2013 bathymetry surveys) obtained from 2-ft split spoon sampler.

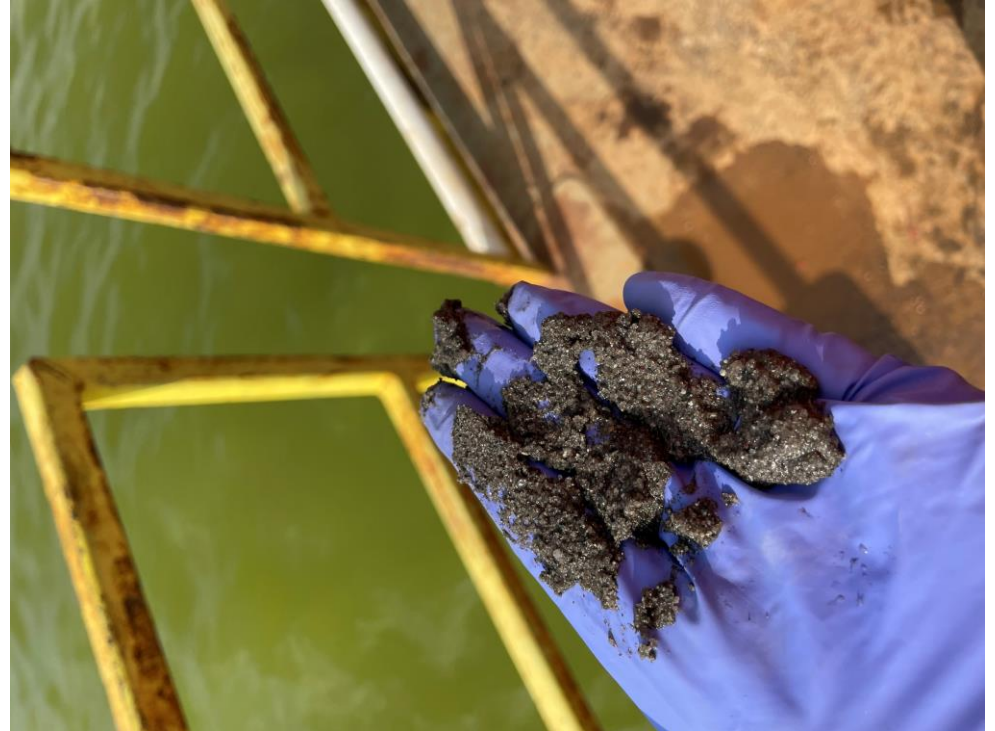
Photo 16: TMF24-12-SA06 attempt with no recovery (broken apart).

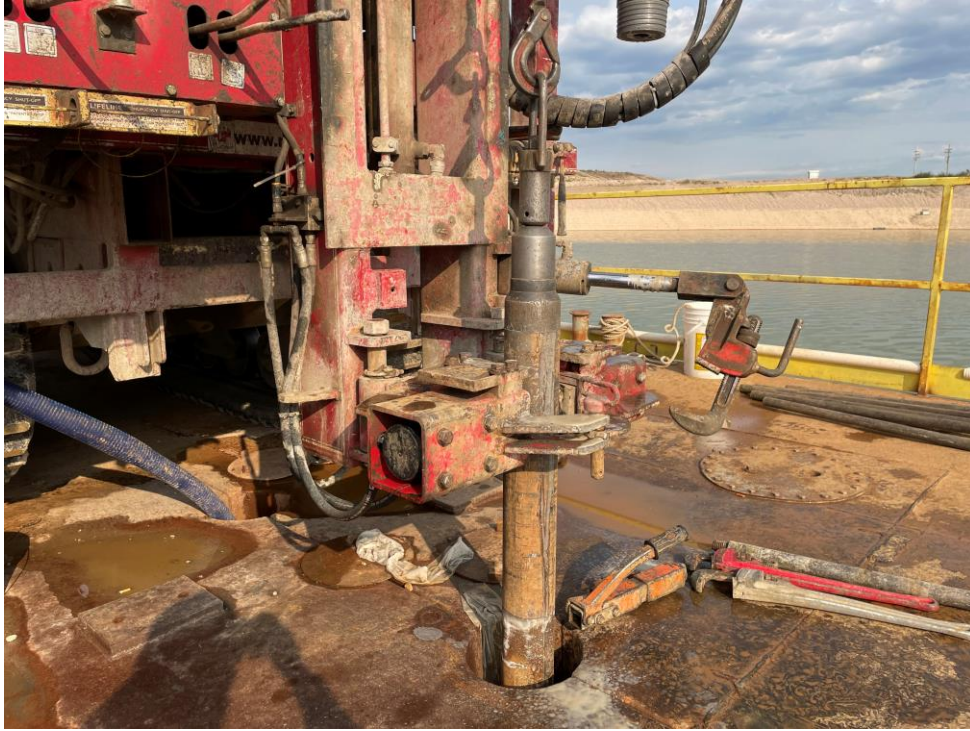
Photo 17: Casing left in the ground overnight at 426.6 masl (at planned TMF24-12-SA06).

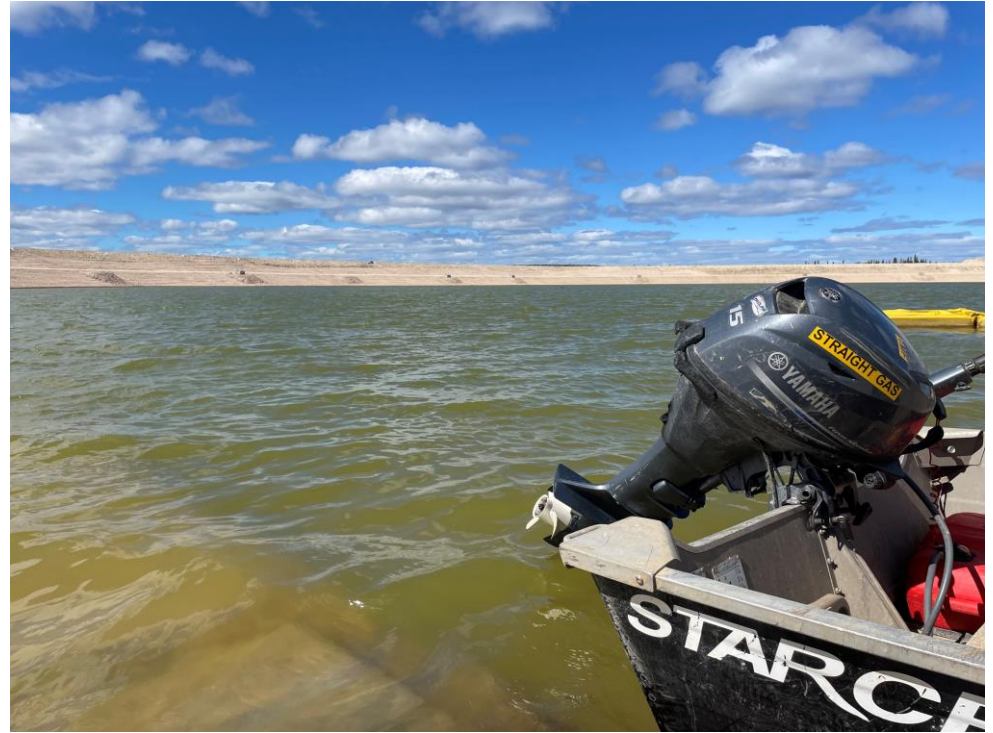
Photo 4: Waves in the TMF causing unstable moving and drilling conditions.

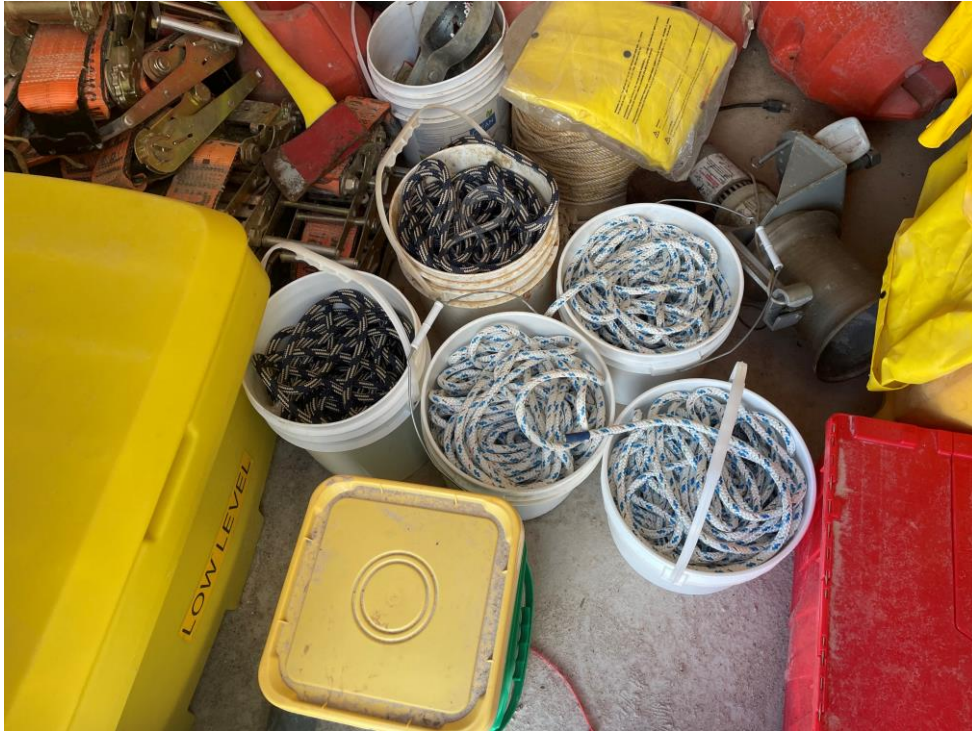
Photo 4: New anchor ropes prepared for drilling tomorrow.

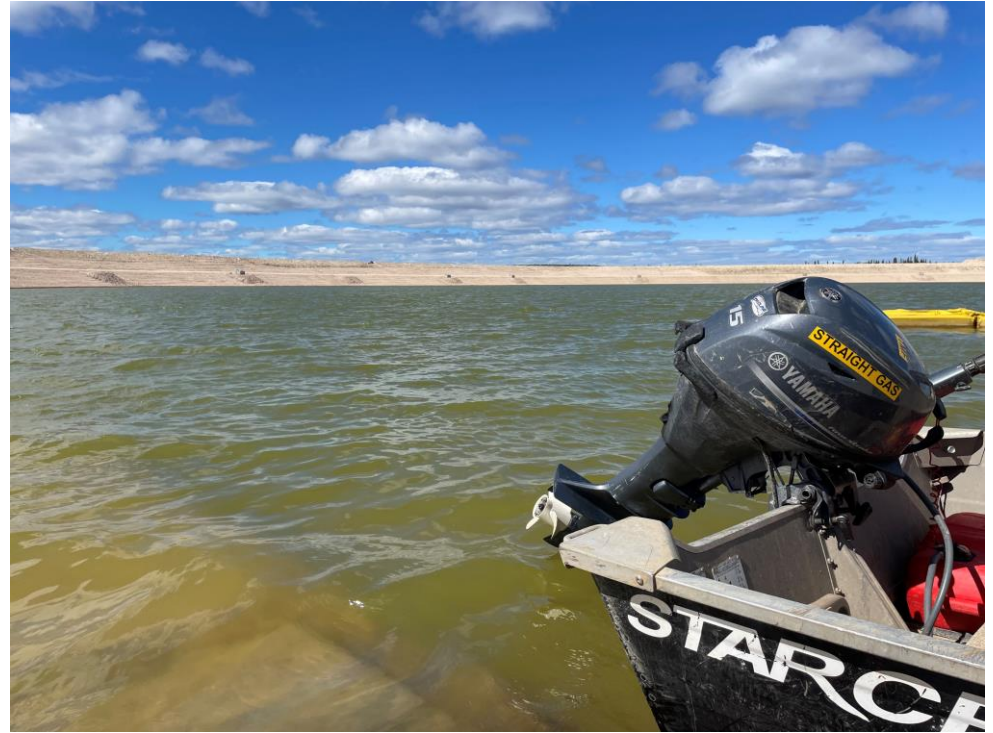
Photo 4: Waves in the TMF causing unstable moving and drilling conditions.

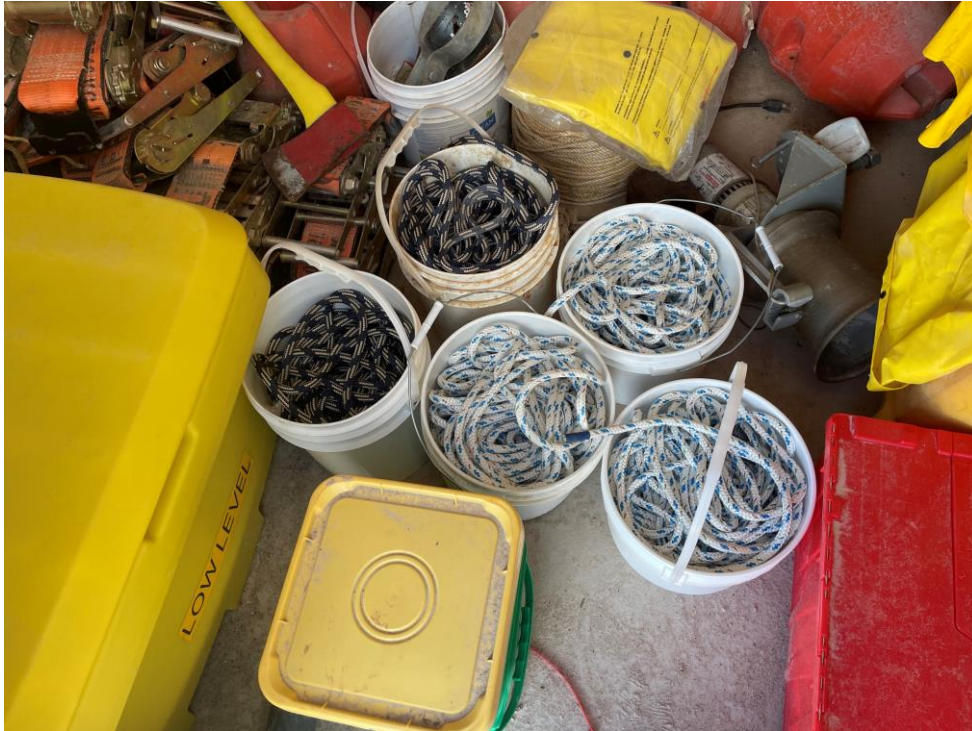
Photo 4: New anchor ropes prepared for drilling tomorrow.

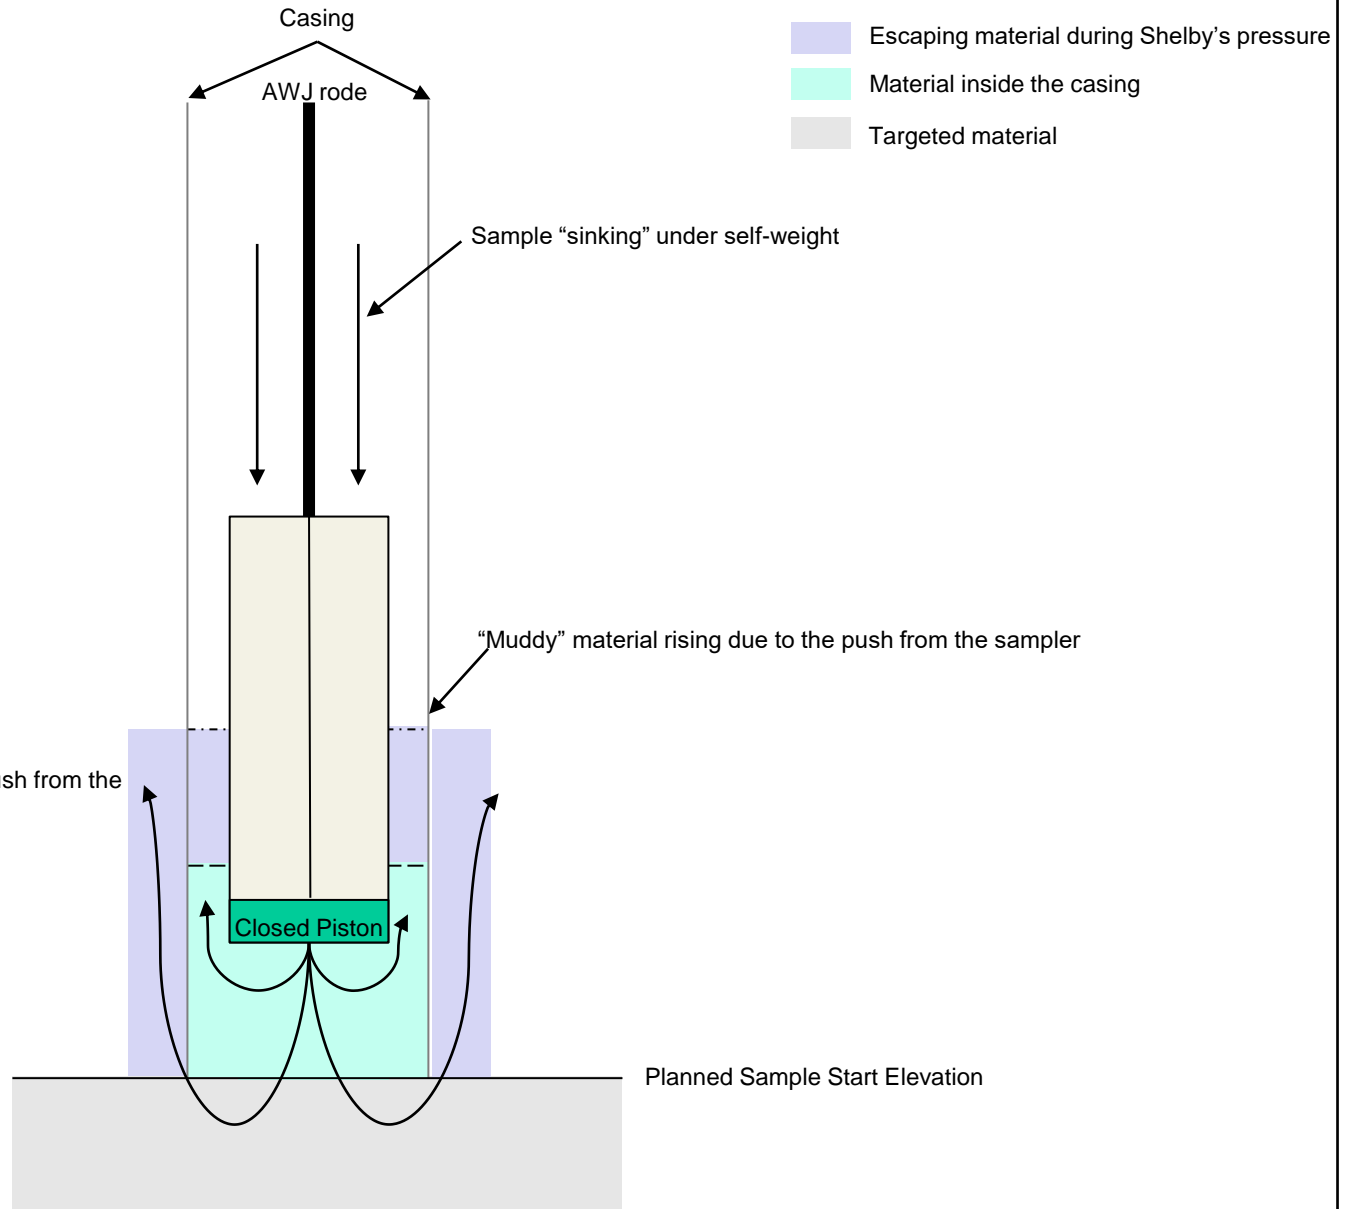
TOVP 2024 Geotechnical Drilling		
		Soft / Loose Material Sampling		
Job No: CAPR003271	McClellan Lake	Date: June 28, 2024	Approved: AN	Figure: 16

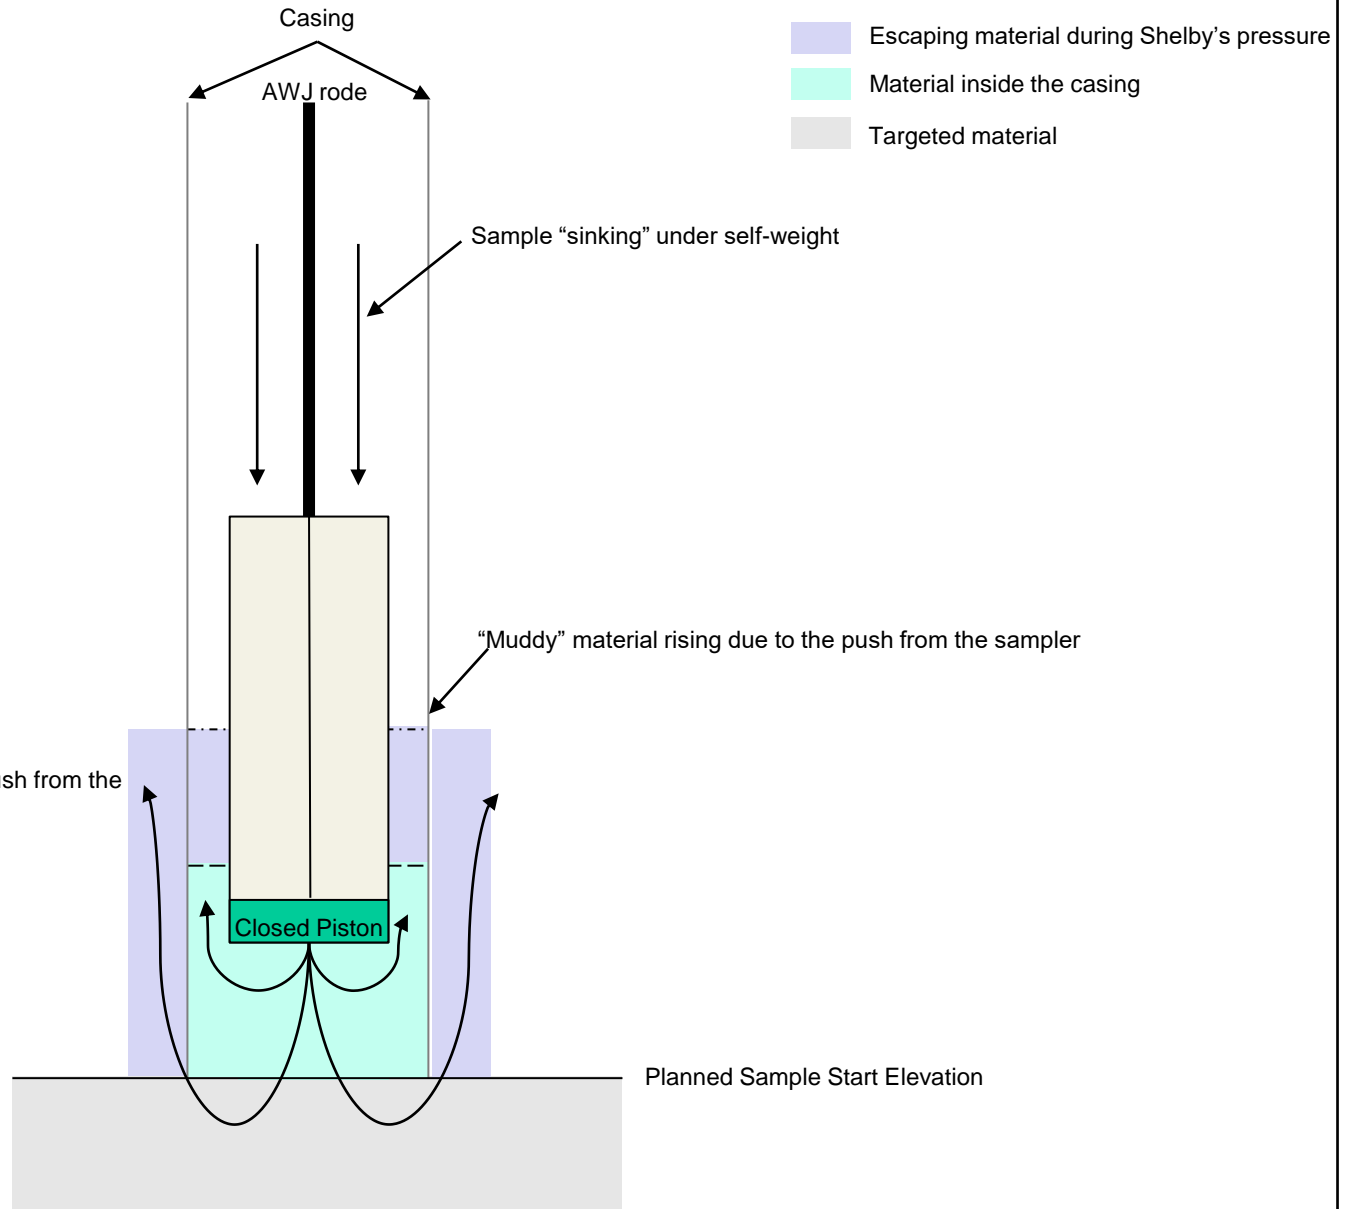
TOVP 2024 Geotechnical Drilling		
		Soft / Loose Material Sampling		
Job No: CAPR003271	McClellan Lake	Date: June 30, 2024	Approved: AN	Figure: 13

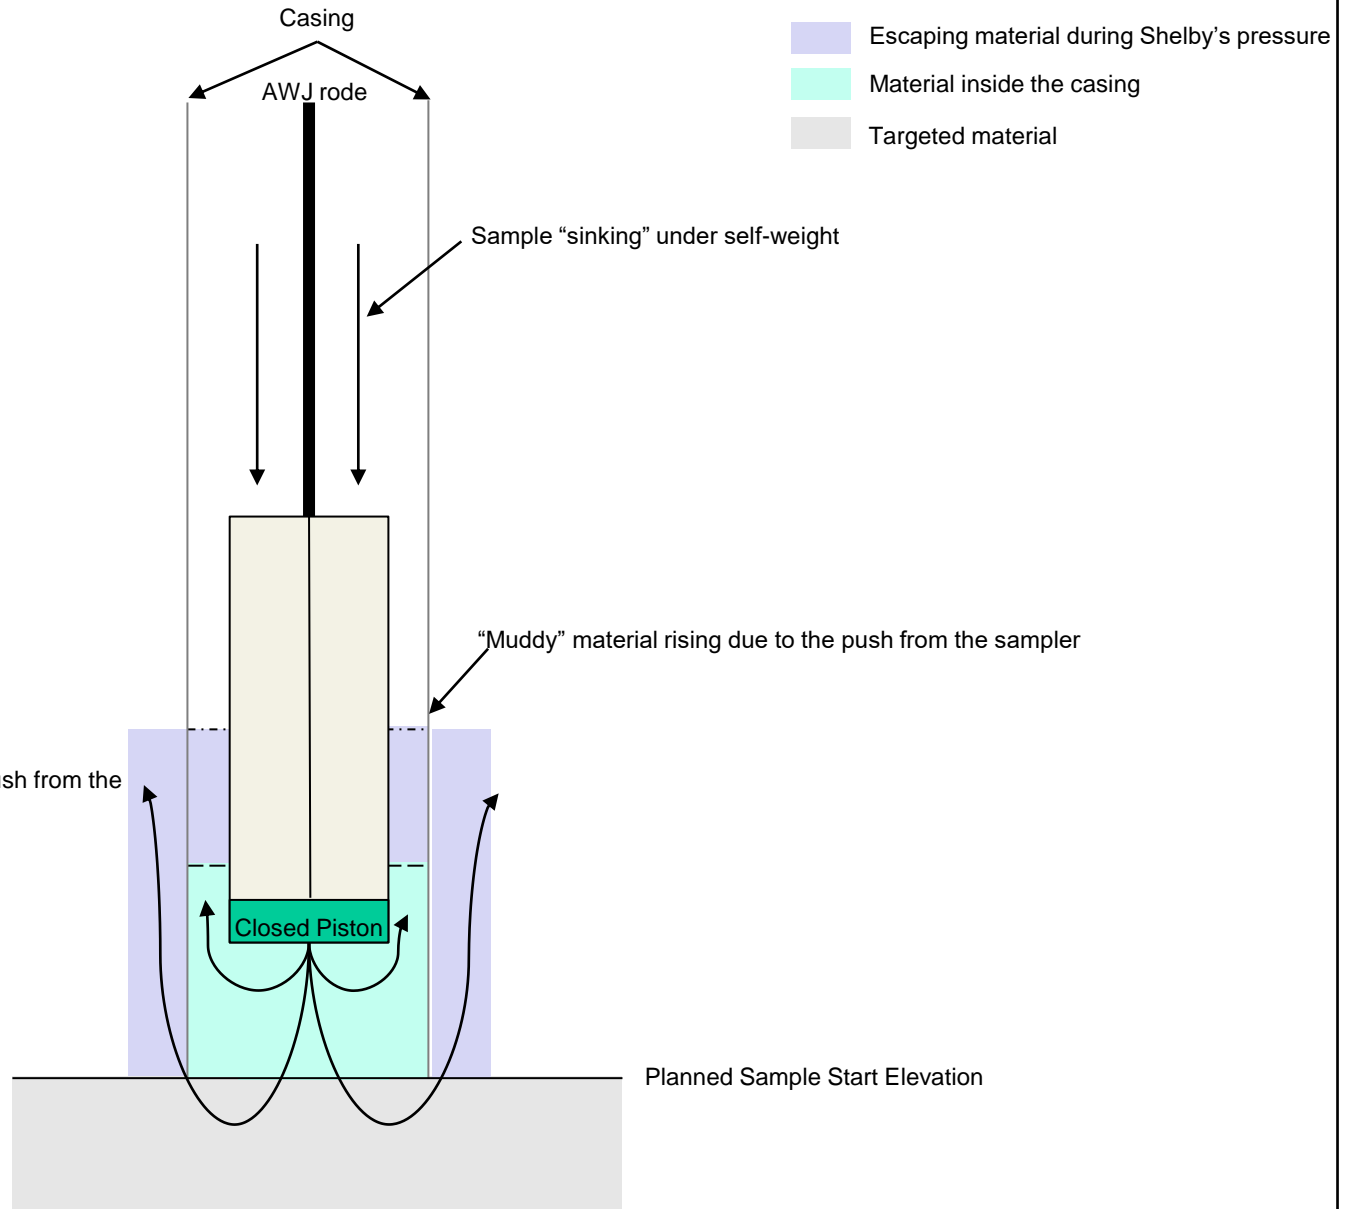
TOVP 2024 Geotechnical Drilling		
		Soft / Loose Material Sampling		
Job No: CAPR003271	McClellan Lake	Date: July 1, 2024	Approved: AN	Figure: 13
