**Presentation from
Orano Canada Inc.**

Orano Canada Inc. – Cluff Lake Project

Application for the renewal of the Uranium
Mine Decommissioning Licence for the
Cluff Lake Project

Request to Renew and Amend
Decommissioning License

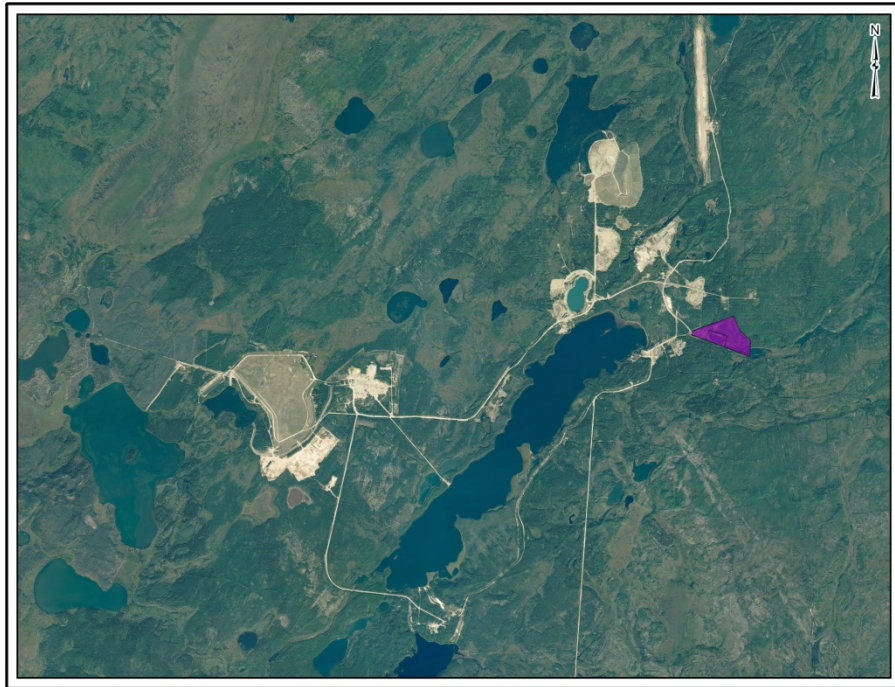
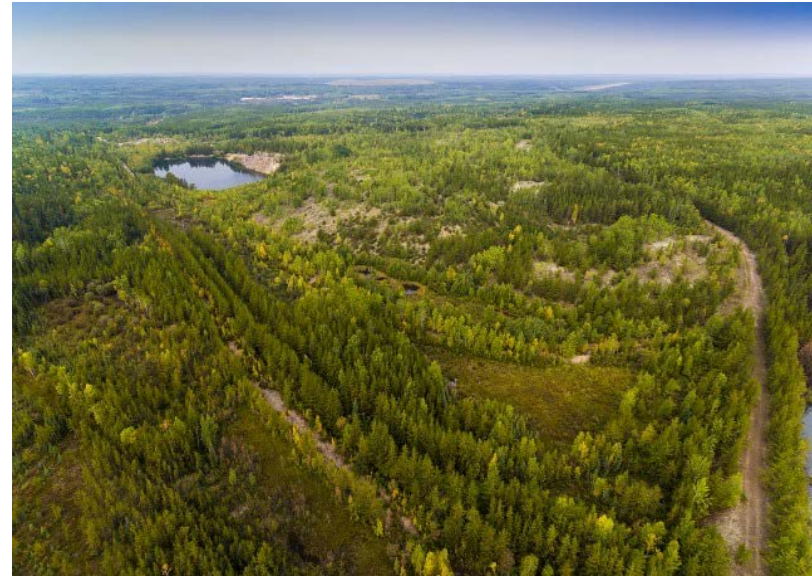
D Mining Area

- **First deposit mined**
- **Decommissioned as pit lake, flooded in 1983**
- **Stable chemocline, surface water quality objectives being achieved now and in the long-term**

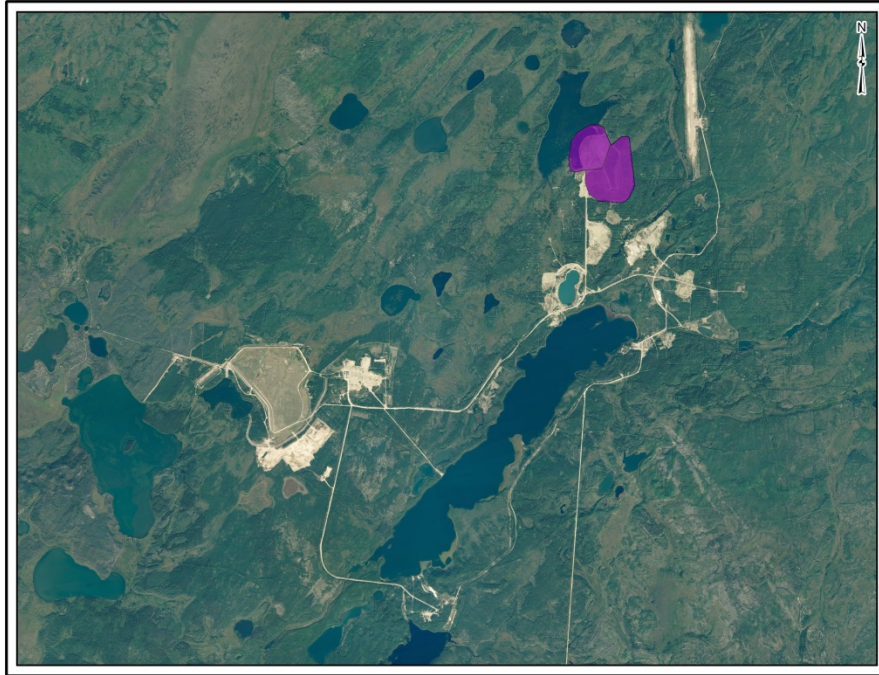
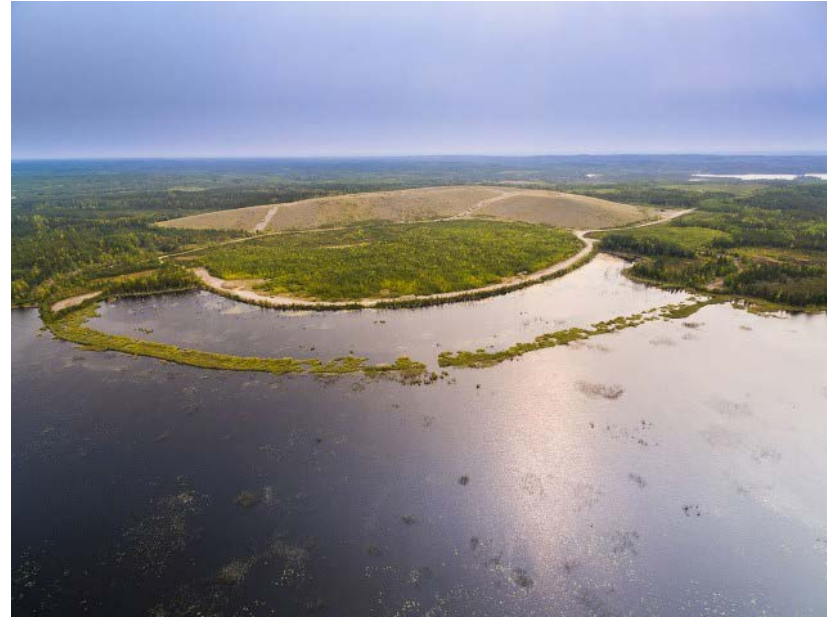
Claude Mining Area

- **Pit was backfilled with waste rock and demolition debris, covered, planted with trees**
- **Waste rock pile was shaped, compacted, covered with a ‘moisture store-and-release’ till layer, and seeded**
- **Vegetation is self-sustaining, pile is stable, and successfully minimizing net percolation rates**
- **Achieving surface water quality in Claude Lake now and in the long-term**

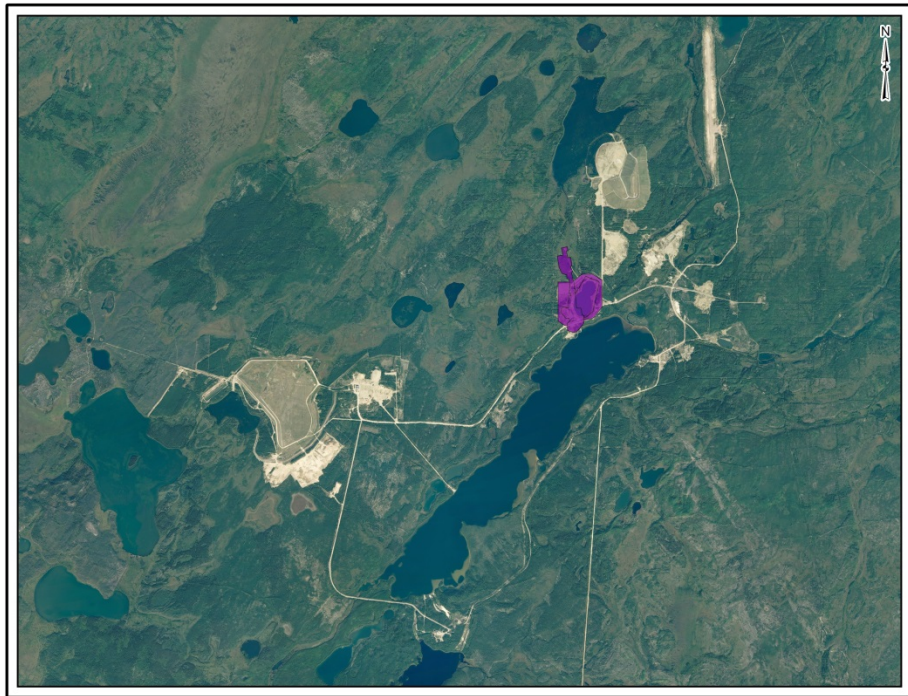
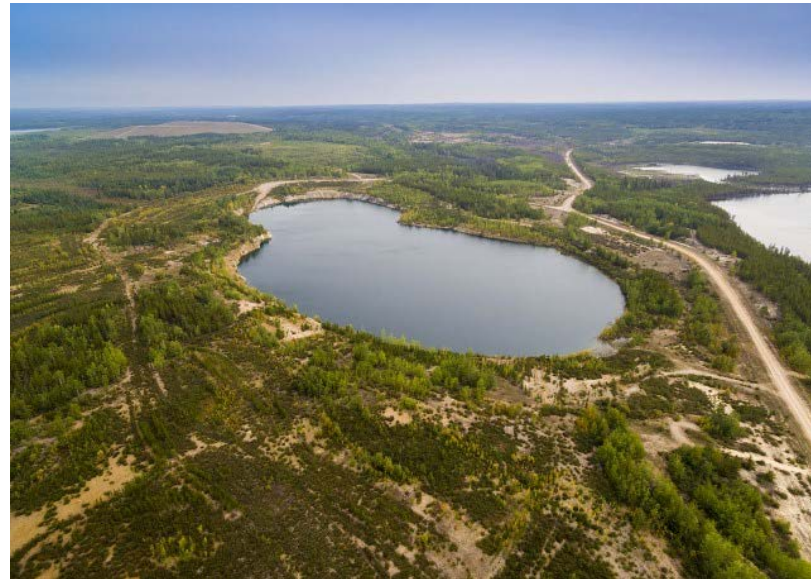
DJ Mining Area

- DJX waste rock placed at bottom of DJN pit and covered with bentonite
- Decommissioned as pit lake, flooded in 2005-06
- Stable chemocline, surface water quality objectives being achieved now and in the long-term

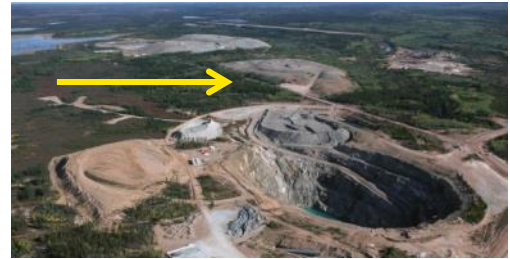
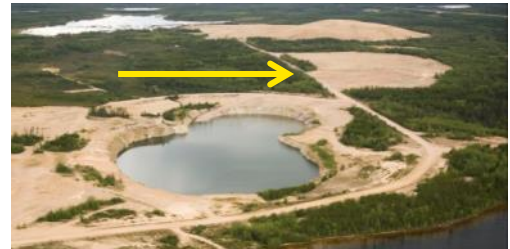
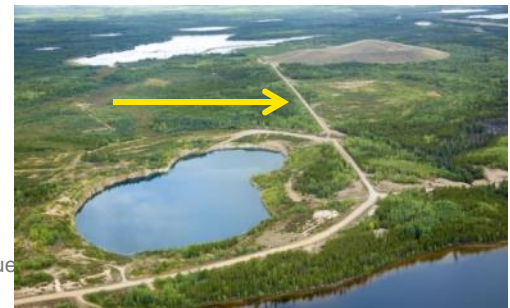
DJ Mining Area Waste Rock and Overburden

- *Former* locations of waste rock and overburden
- DJN waste rock entirely relocated to Claude pit; overburden used as cover material in Claude Waste Rock Pile decommissioning
- Areas regraded and revegetated

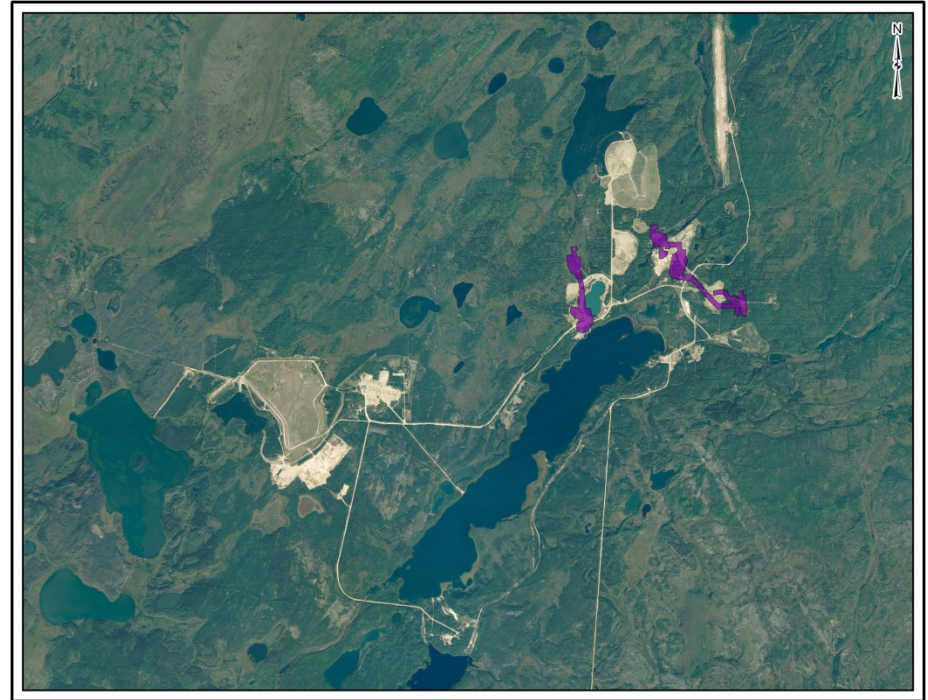
Underground Mining Areas DJ & OP/DP

- Raises (8) entirely backfilled, reinforced concrete caps placed, additional 1m till cover
- Declines (2) backfilled about 180m down the ramp, concrete plug placed, covered with till
- Underground mining was by the cut-and-fill method; long term stability
- Stable

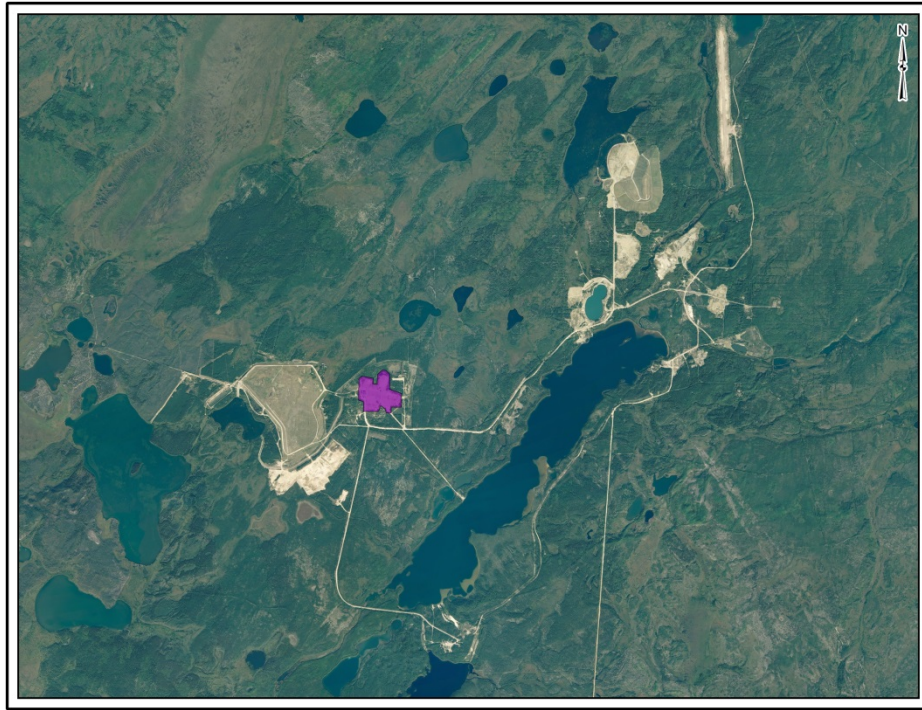
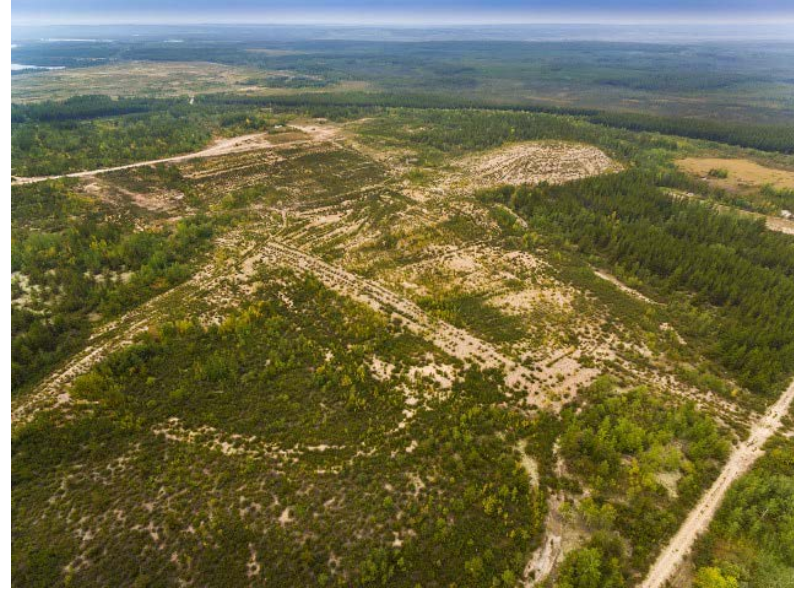
Mill Complex Area

- **Mill and warehouses demolished**
- **Demolition debris placed in Claude pit**
- **Area covered with clean till, graded, and revegetated**

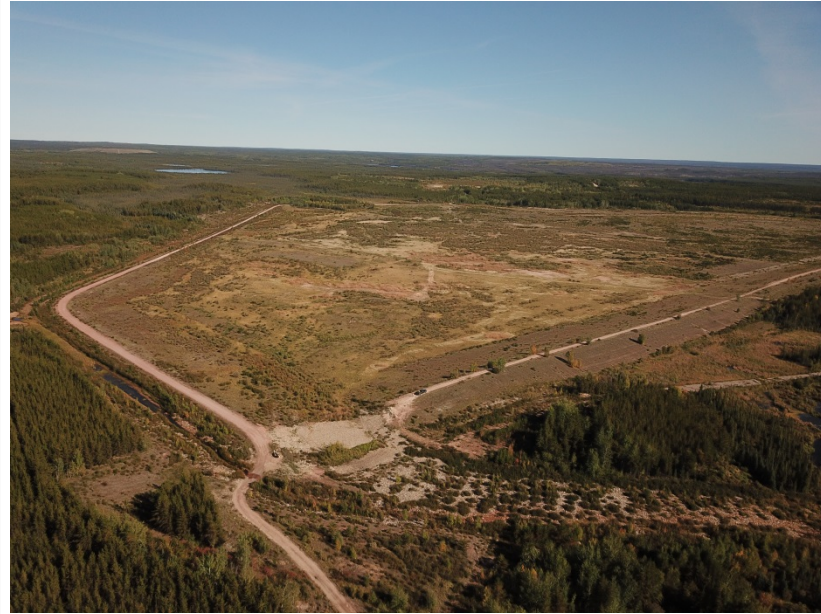
Tailings Management Area

- **Low permeability tailings consolidated to remove pore water**
- **Till ‘moisture store-and-release’ cover placed, graded, and seeded**
- **Storm water management: north and south diversion ditches, collector channel, surface grading; designed to route Probable Maximum Flood**
- **Vegetation is self-sustaining, storm water management achieved under passive care, design successfully minimizing net percolation rates**
- **Achieving surface water quality in Snake Lake now and in the long-term**

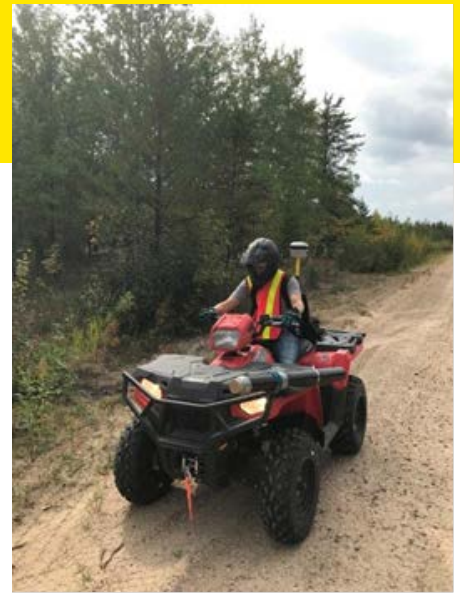
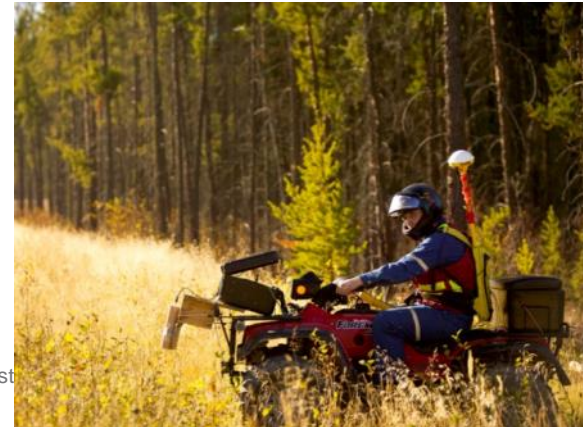
Radiological Clearance

- Radiation sources that once existed on site have either been removed or managed as part of the decommissioning activities
- Disturbed areas of the site have been surveyed and confidently pass radiological clearance
- Radon concentrations at background levels
- Potential dose to future users is well within regulatory limits for members of the public, similar to background

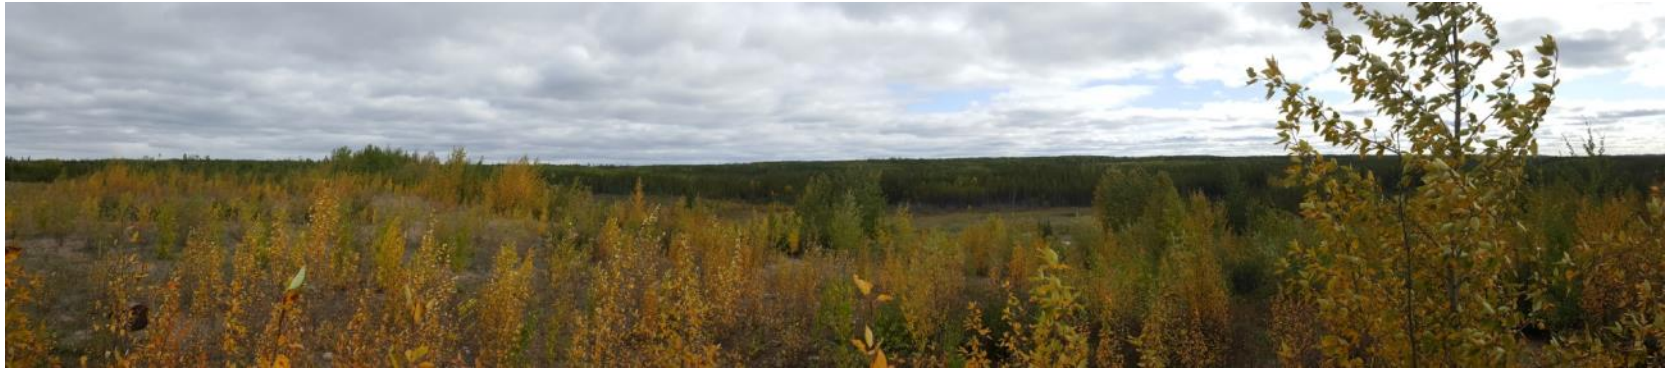
Vegetation is Self-Sustaining

- re-establishment of native species of grasses, forbs, and woody species to accelerate the process of natural ecological succession
- >750,000 trees planted
- trajectory towards a forested environment similar to that which existed prior to mining
- wildlife species can and are reclaiming the mine footprint
