# CMD 25-H3.REF - CNSC Staff Submission

### Reference Package for CMD 25-H3 Submission from CNSC Staff on Cameco Corporation Request to Revoke the Current Licence and Release the Beaverlodge Project to the Institutional Control Program

# **Final Closure Report**

URA 7, URA 1, BOLGER 1, Tailings Management Area Properties

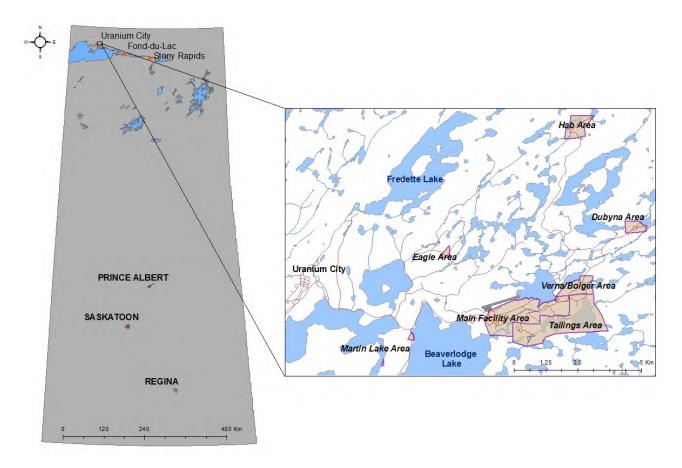
Figure 2: Beaverlodge Site Area

Uranium bearing mineralization was first discovered in the Beaverlodge area of northern Saskatchewan in 1934 (**Figure 2**). Since there was little demand for uranium at that time, further prospecting and development in the region was delayed for almost ten years until 1944 when Eldorado Mining and Refining Ltd. (Eldorado), a crown corporation owned by the Government of Canada, commenced detailed exploration in the area of Fishhook Bay on the north shore of Lake Athabasca. Between 1944 and 1948 Eldorado continued to explore the area around Beaverlodge Lake, discovering the Martin Lake and Ace Zones in 1946. In 1947, a prospecting incline shaft was developed to explore the Ace ore body and the Dubyna claims were staked.

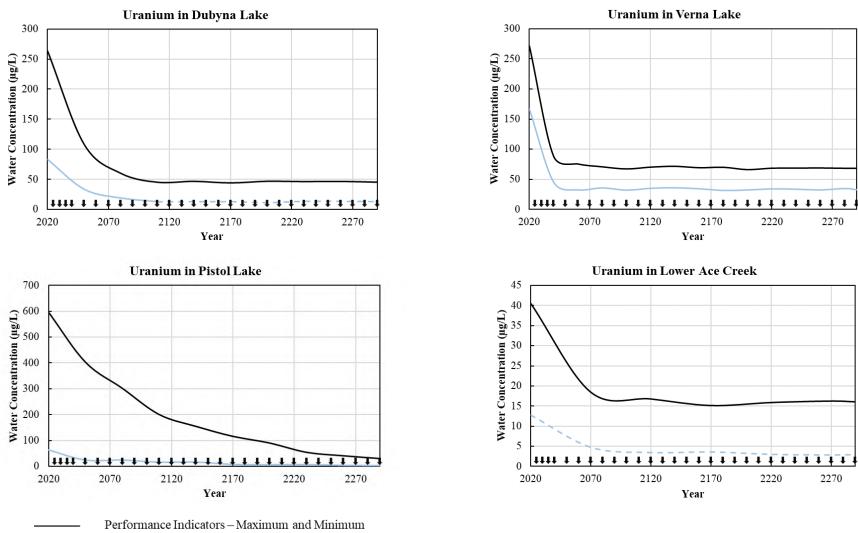
For some locations (e.g., uranium in Dubyna and Verna lakes), recovery is predicted to occur more quickly in the near-term, the higher initial sampling frequency will allow these concentration decreases to be observed more closely.

#### Figure B.1 Example predicted recovery and sampling frequency

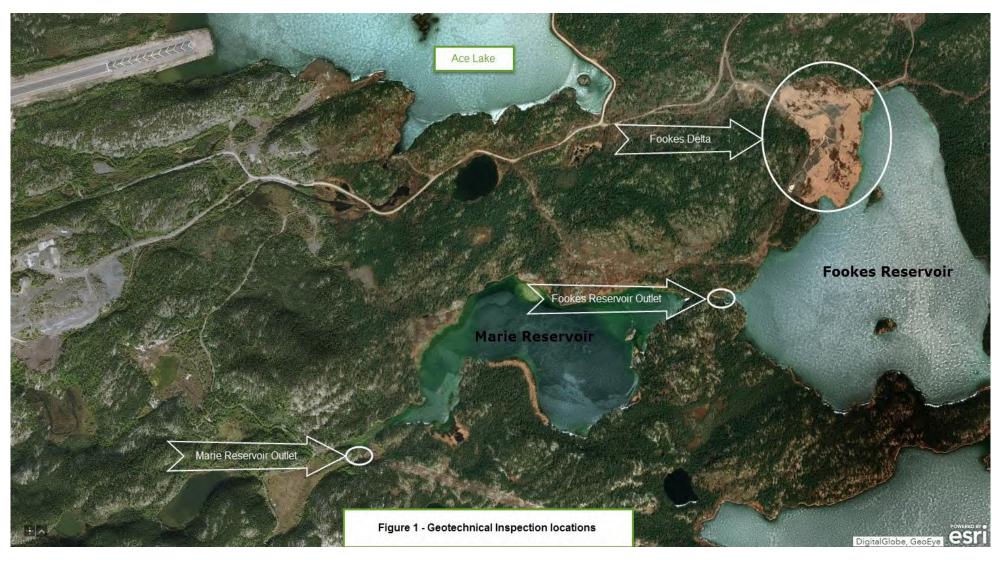
**Figure 1. Geotechnical Inspection Locations**

**Figure 1** provides the locations of the Fookes Delta and the outlet structures. Additional details are provided in **Section 5.0**, including **Figure 4**, **Figure 5**, and **Figure 6**, which provide the locations of applicable crown pillar monitoring.

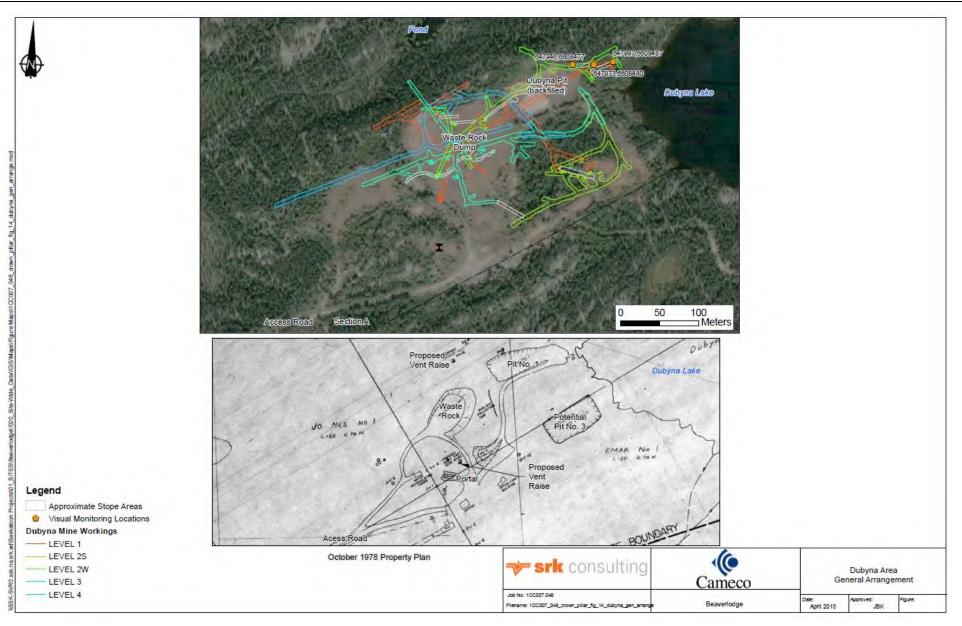
Figure 4. Dubyna area general arrangement

It was noted at Dubyna that recent beaver activity resulted in significant clearing along the crown pillar inspection area. As well, a beaver lodge was constructed along the shore of Dubyna Lake near furthest extent of the crown pillar.

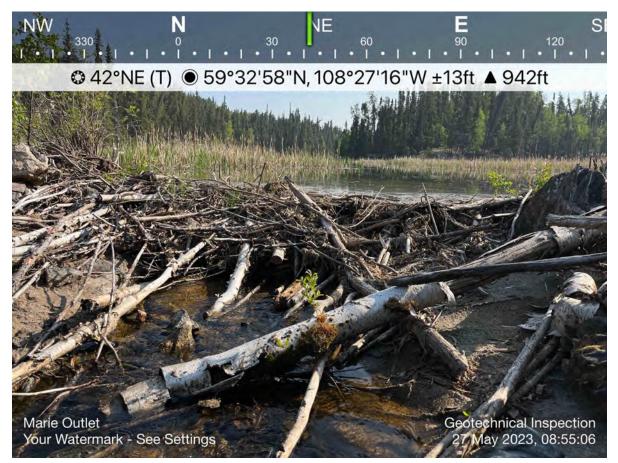
Photo A2 - Marie Reservoir Spillway inlet; beaver dam first noted in 2018

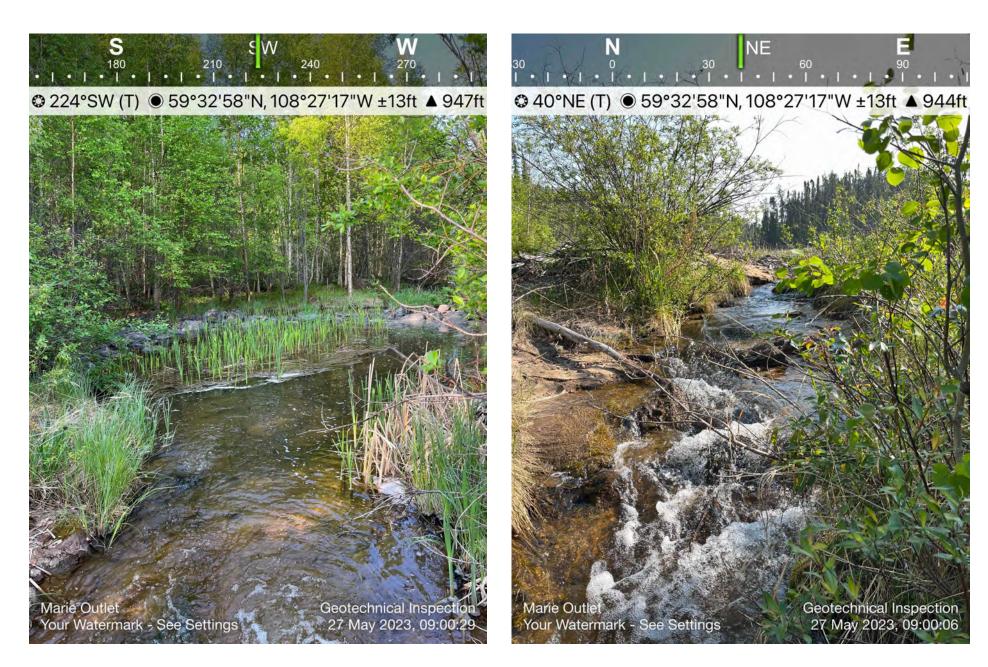
Photo A3 – Marie Reservoir Spillway (water flowing into stilling basin) (May 2023)

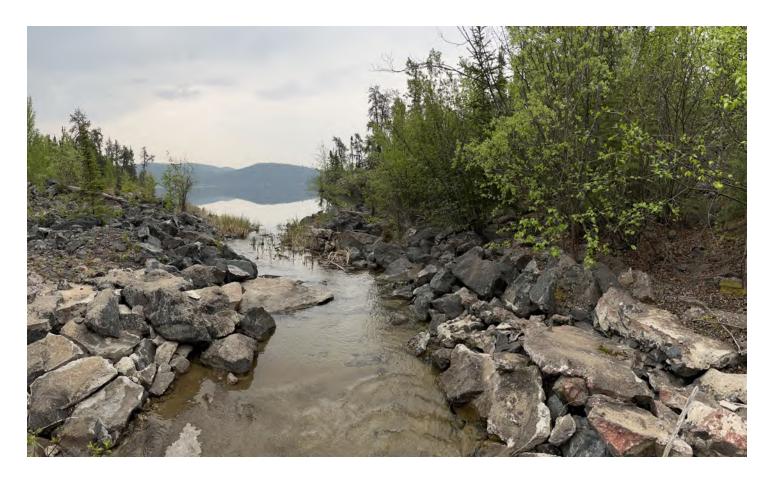
Photo B5 – Fookes Reservoir Spillway showing broken rip-rap on north and south sides of channel. Note debris has been removed since 2022 inspection.

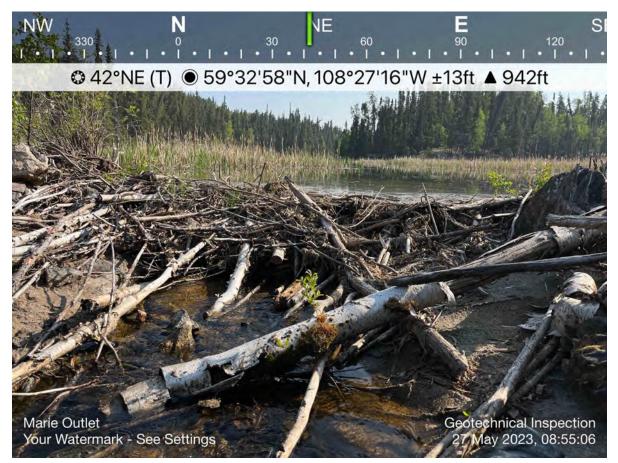
Photo A2 - Marie Reservoir Spillway inlet; beaver dam first noted in 2018

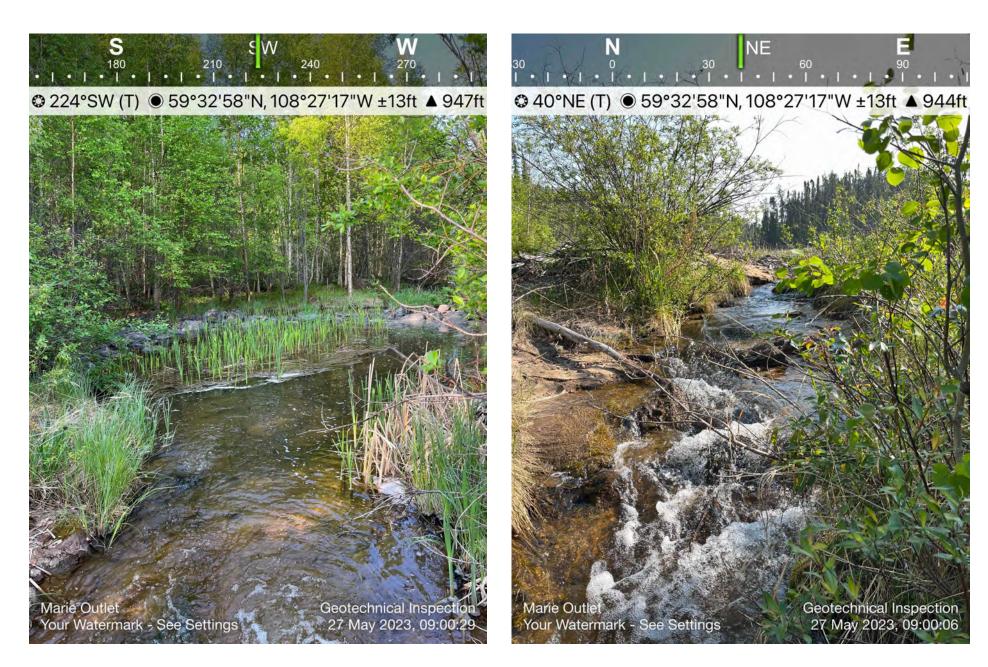
Photo A3 – Marie Reservoir Spillway (water flowing into stilling basin) (May 2023)

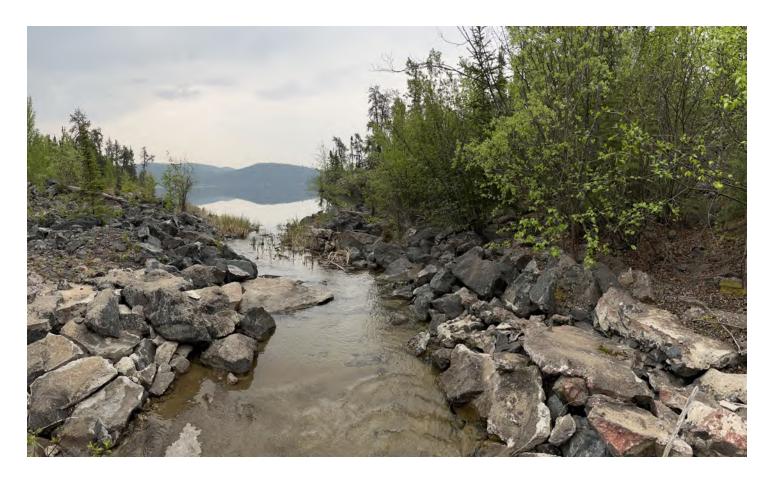
Photo B5 – Fookes Reservoir Spillway showing broken rip-rap on north and south sides of channel. Note debris has been removed since 2022 inspection.

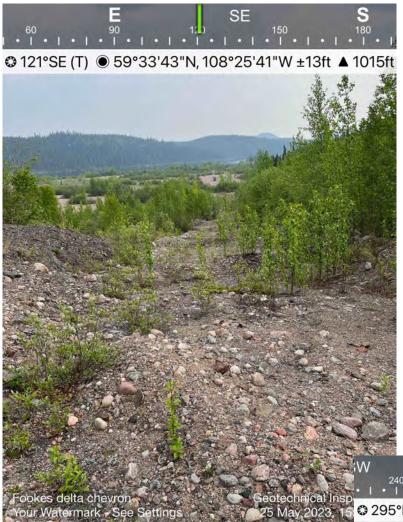
Photo C1 – Chevrons in place on north access point to the Fookes delta looking south (May 2023)

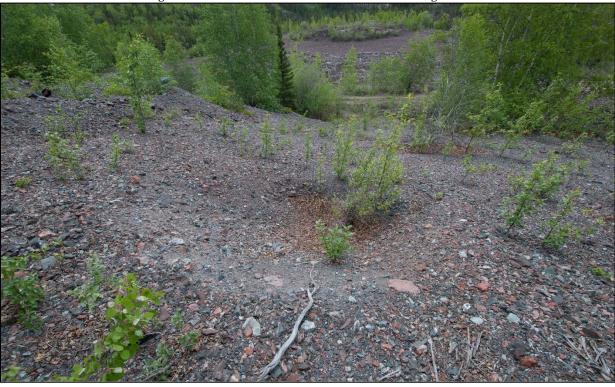
Figure 1: Subsidence Observed Above the Waste Haulage Adit

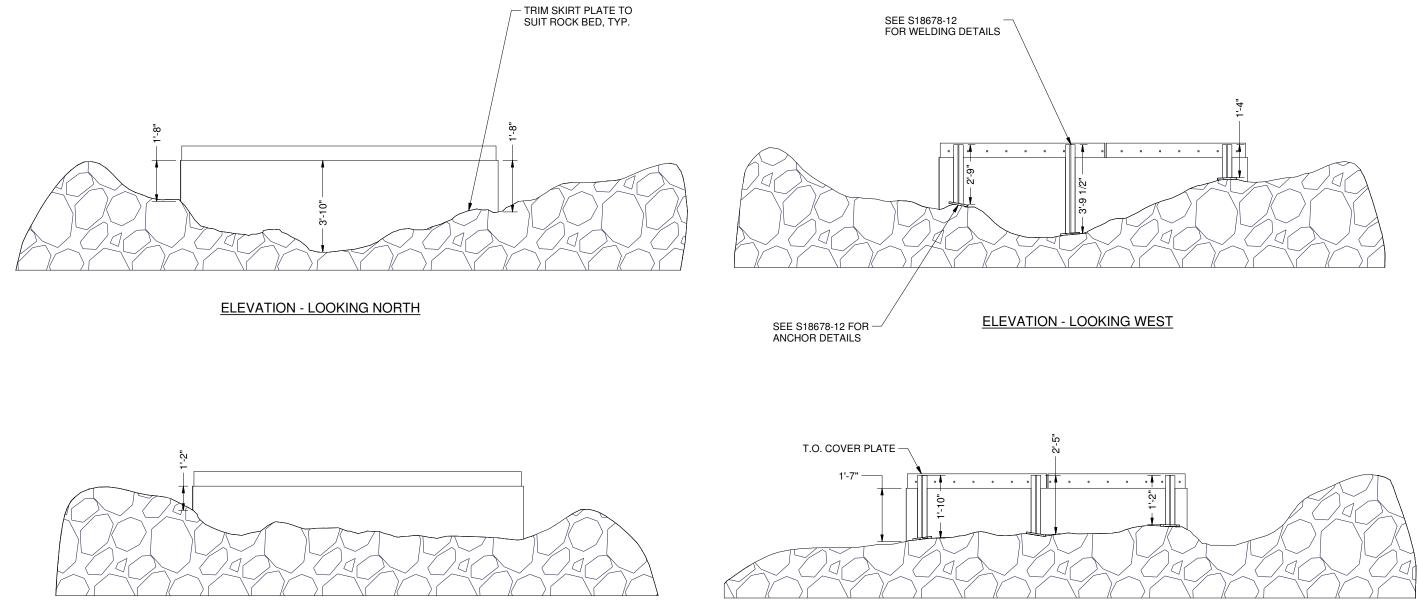
**ELEVATION - LOOKING SOUTH**

# ESTIMATED TOTAL COLUMN LENGTH 220" WITHOUT SCRAP OR EXTRA. KOVA RECOMMENDS COLUMN LENGTH TO BE SUPPLIED PER GUIDANCE OF INSTALLATION CONTRACTOR. SIX (6) COLUMN ASSEMBLIES REQUIRED OF VARYING LENGTHS.

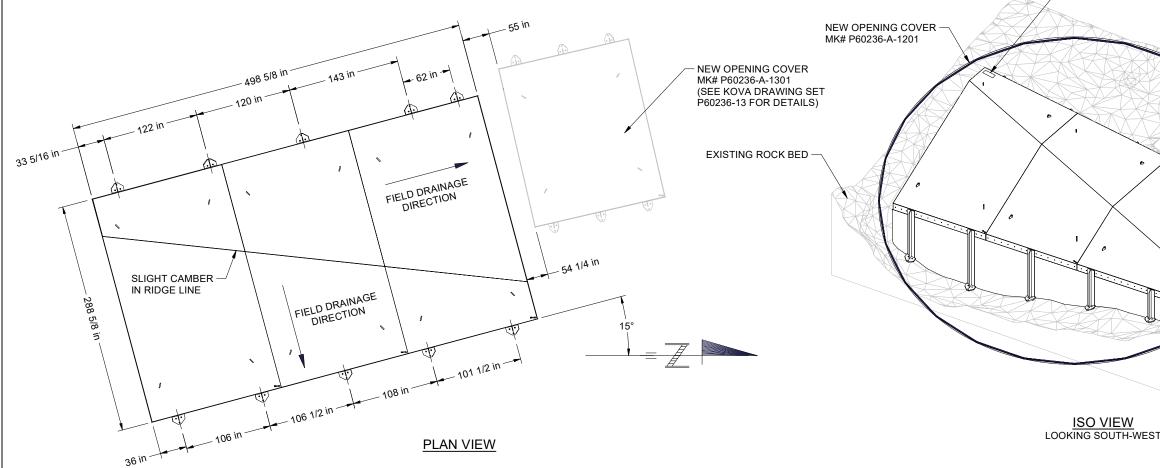
- SAFE WORKING LOAD CAPACITY OF COVER IS 12 kPa (250 psf) EVENLY DISTRIBUTED VERTICAL LIVE LOAD, COVER WILL SUSTAIN FOUR VERTICAL WHEEL LOADS OF 21.3 kN 1. (4,800 LBS) WITHOUT CATASTROPHIC FAILURE.
- 2. RESEARCH PERFORMED BY THE BRITISH STAINLESS STEEL ASSOCIATION ESTIMATES THAT 316 STAINLESS STEEL WILL SUSTAIN A 1200 YEAR LIFE PRIOR TO PITTING CORROSION RESULTING IN A 1mm DEPTH IN A RURAL SETTING WITH MILL FINISHED SURFACES. CONSIDERING THE RESULTS OF THIS RESEARCH AND A CORROSION ALLOWANCE OF 1mm ON ANY SURFACE, THE COVER DEPICTED HAS AN ESTIMATED USEABLE LIFESPAN OF 1200 YEARS, PRIOR TO THE POTENTIAL NEED FOR REPLACEMENT. KOVA RECOMMENDS PERIODIC INSPECTIONS BE PERFORMED AS RECOMMENDED IN THE QA/QC PROTOCOL.
- 316 STAINLESS STEEL CAN NOT BE CLEANLY CUT WITH AN OXYACETYLENE TORCH.
- APPROX. COVER TOTAL WEIGHT = 44,200 LBS. 4.
- DO NOT BACK FILL WALLS OF COVER. 5
