# CMD 25-M26 - CNSC Staff Submission

## Workplace Injury at Cameco Corporation's McArthur River Operation

<b>EIR: Workplace Injury at Cameco Corporation's McArthur River Operation</b>	
<b>Prepared by:</b> Brenda Duhaime UMMD, DNCFR	
<b>Licensee:</b> Cameco Corporation	<b>Location:</b> McArthur River Operation
<b>Date Event was Discovered:</b> 2025-01-19	<b>Have Regulatory Reporting Requirements been met?</b> Yes <input checked="" type="checkbox"/> No <input type="checkbox"/>  <b>Proactive Disclosure:</b> Licensee: Yes <input checked="" type="checkbox"/> No <input type="checkbox"/> CNSC: Yes <input checked="" type="checkbox"/> No <input type="checkbox"/>
<b>Overview</b>	
<b>Reporting Criteria:</b> <i>General Nuclear Safety and Control Regulations (SOR/2000-202)</i>  29 (1) Every licensee who becomes aware of any of the following situations shall immediately make a preliminary report to the Commission of the location and circumstances of the situation and of any action that the licensee has taken or proposes to take with respect to it:  h) A serious illness or injury incurred or possibly incurred as a result of the licensed activity

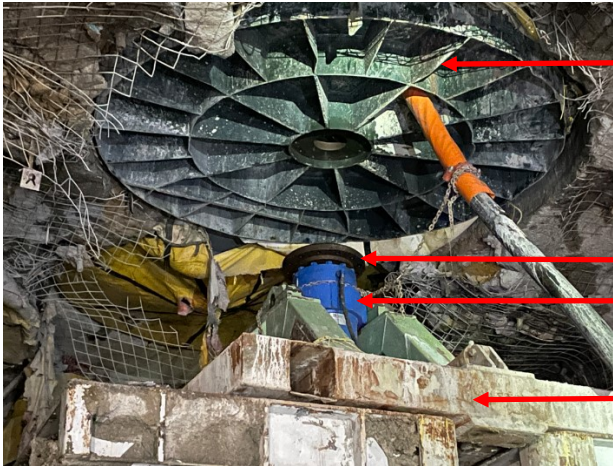
<b>Description:</b> The event occurred on January 18, 2025, at approximately 10:45 pm.  On January 19, 2025, Cameco McArthur River Operation personnel contacted the CNSC duty officer to report a serious hand injury to a worker involved in the removal of a back-fill plug assembly.  McArthur River is an underground mine where the raise bore mining method results in the creation of cylindrical cavities in the orebody. These cavities are open at the bottom to a horizontal tunnel which is used to retrieve the ore. These cylindrical cavities must be backfilled with concrete to stabilize the ground, to allow further mining. This is achieved by plugging the cavity from the bottom with a back-fill plug assembly. The back-fill plug assembly is placed on top of a back-fill gantry, which consists of a hydraulic cylinder attached to a large circular metal plate (commonly referred to as the "pizza pan"). Once the back-fill plug assembly is raised into place, concrete can then be pumped into the cavity. Following curing of the concrete plug, the back-fill plug tool and back-fill gantry are removed for future use.  On January 18, 2025, workers at McArthur River were attempting to remove a back-fill plug assembly. During this operation, the back-fill plug assembly was found to be stuck to the freshly-cured concrete – effectively the "pizza pan" was stuck to the ceiling of the tunnel. Several unsuccessful attempts to remove the "pizza pan" were carried out. Eventually it was decided to remove the bolts on the flange of the backfill plug tool, which would disconnect the "pizza pan" from the hydraulic cylinder. As the worker loosened and removed the bolts, the flange on the hydraulic cylinder assembly suddenly and unexpectedly retracted from the "pizza pan", which remained in place. The workers' hands were struck and injured (but not pinned) by the flange during the unexpected and sudden retraction of the hydraulic cylinder.

<b>Figure 1: Image of the back-fill plug assembly on-top of back-fill gantry following the event. The "pizza pan" is stuck in place by the freshly cured concrete (Source: Cameco)</b>

<div style="display: flex; justify-content: flex-end; margin-top: 10px;"> <div style="margin-right: 20px;"> <p><b>Pizza Pan</b></p> <p><b>Flange (Black)</b></p> <p><b>Hydraulic Cylinder (Blue)</b></p> <p><b>Back-fill Gantry</b></p> </div> </div>

**Cause(s):** The direct cause of the injury was the contact between the injured workers hands and the flange on a hydraulic cylinder assembly during an unexpected and sudden retraction of the hydraulic cylinder during the removal and loosening of bolts.

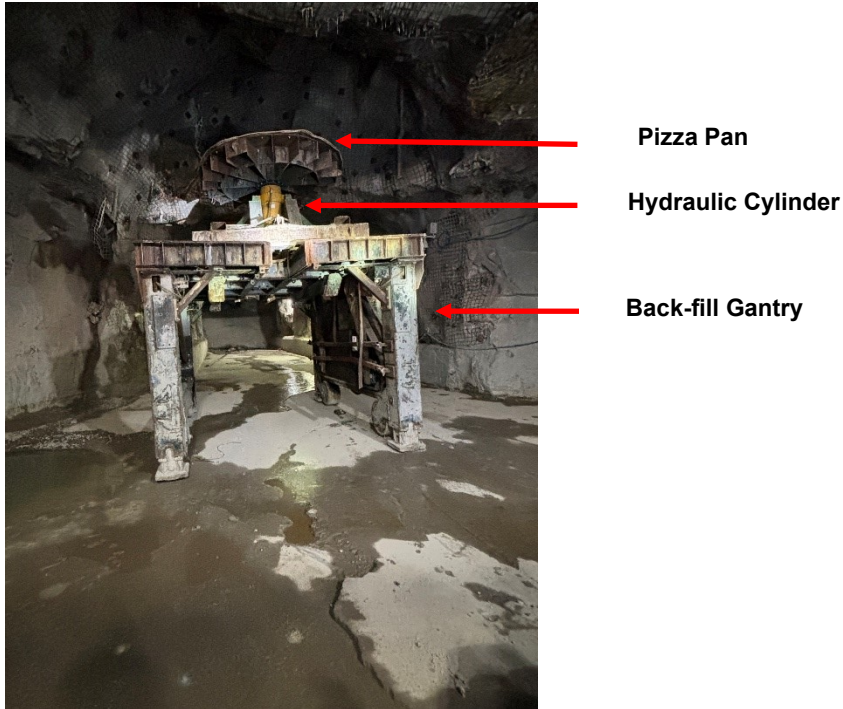
**Figure 2: Mock setup of a back-fill plug assembly placed on top of a back-fill gantry (Source: SK LRWS)**

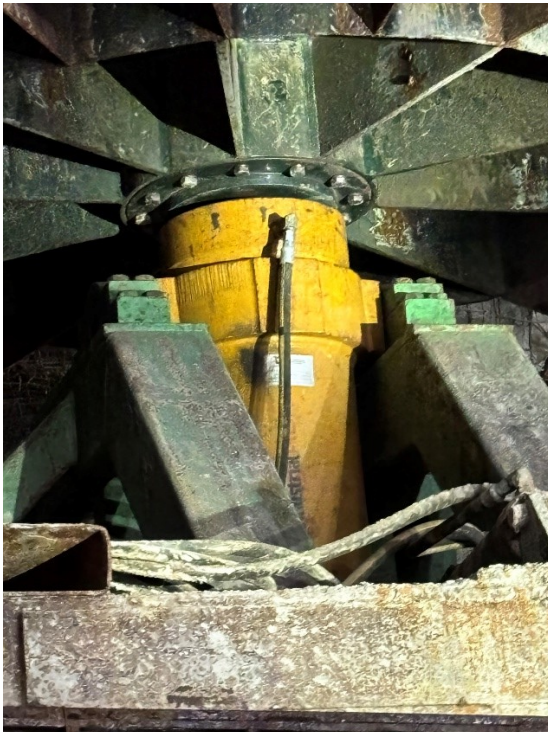
**Figure 3: Close-up view of the bolts located on the flange of the 'pizza pan' above the hydraulic cylinder (Source SK LRWS)**
