**Written submission from
Orano Canada Inc.**

Orano Canada Inc. – Cluff Lake Project

Application for the renewal of the Uranium
Mine Decommissioning Licence for the
Cluff Lake Project

Request for a Licensing Decision: Renew and Amend
Decommissioning Licence

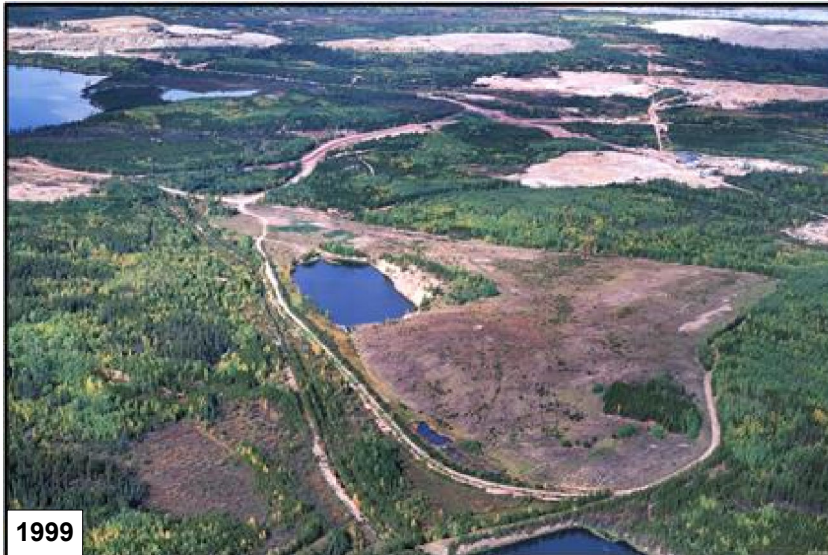
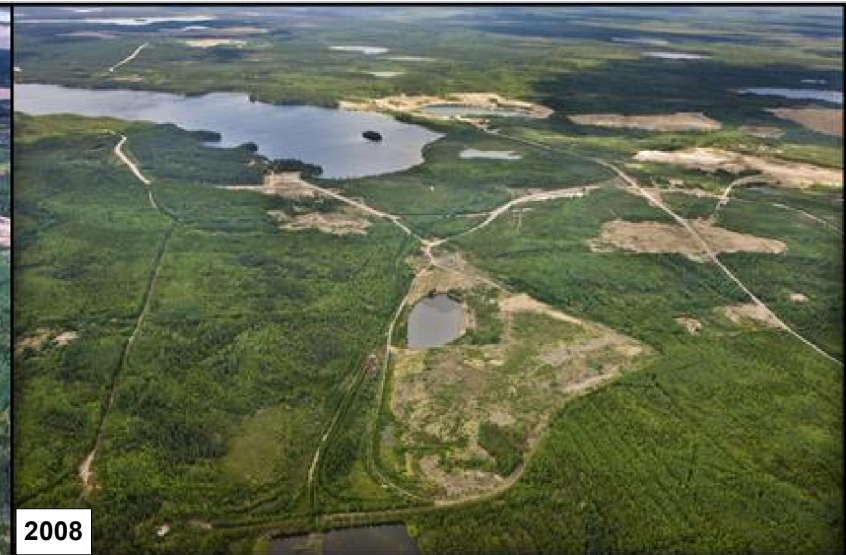
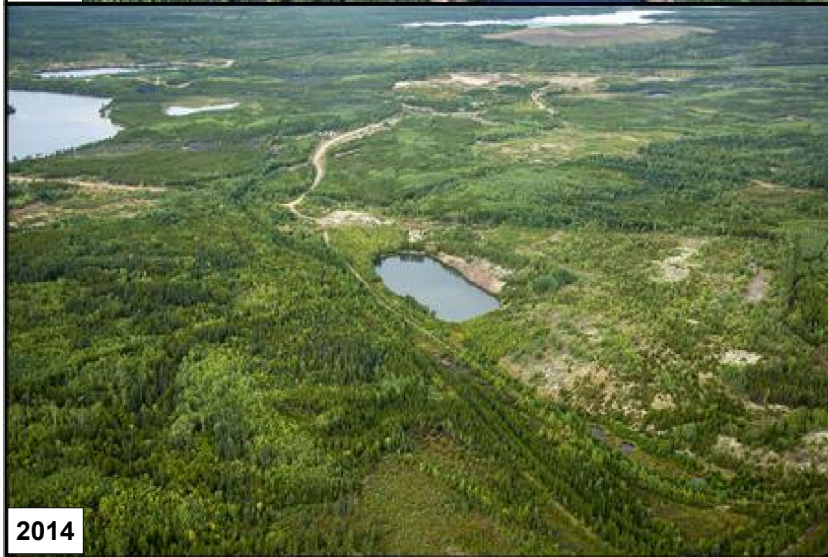
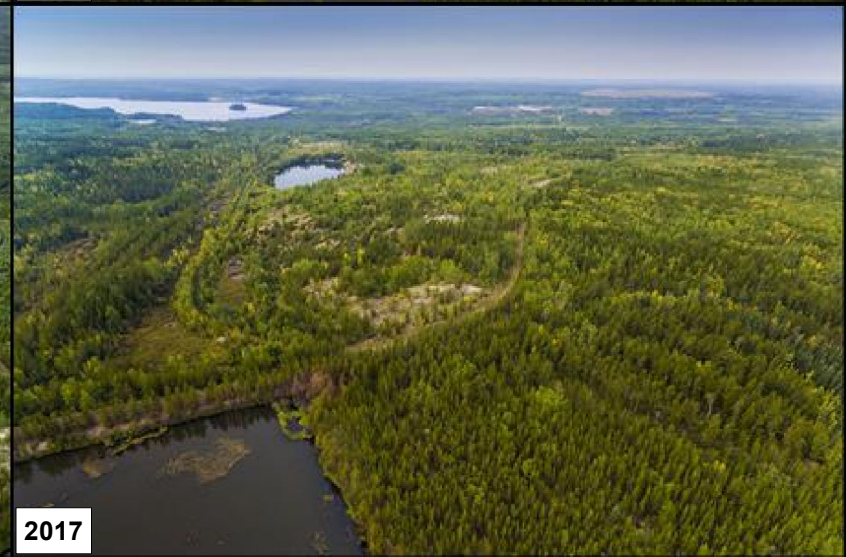
Aerial photographs of key areas which show operational, decommissioned, and recent conditions are presented in Figures 2.4 to 2.9.

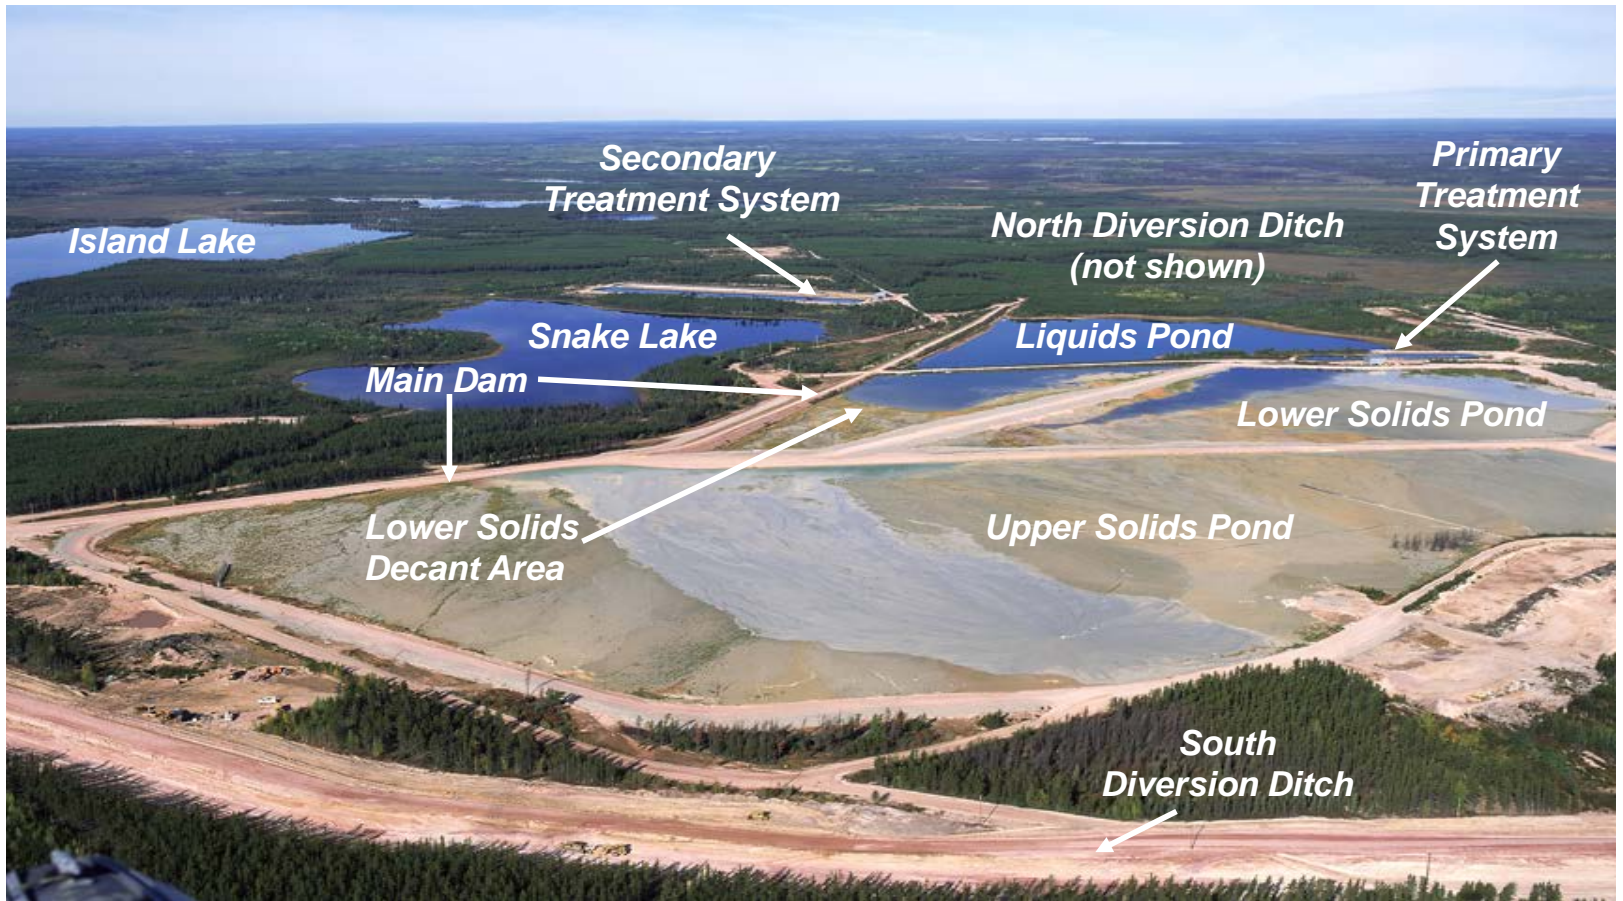
Figure 1 Features of the TMA as of 2000 (COGEMA, 2000a)

The South Diversion Ditch (SDD) and North Diversion Ditch (NDD) were constructed in 1999 and 2000, respectively, to divert uncontaminated water (from the drainage basin surrounding the TMA) to Snake Lake (AREVA, 2014b). These ditches minimize run-on of clean water into the TMA and ensure that area runoff from a major precipitation event, including the Probable Maximum Flood (PMF), can be safely diverted around the TMA. The PMF was generated from the 24-hour point probable maximum precipitation (PMP) event for the Site, prescribed by Hopkinson (1994) as 497 mm acting on an aerial catchment of 1 km² or less. SRK (2018b) assessed performance of the SDD and NDD under vegetation conditions as well as breach of an upgradient beaver dam for the NDD. SRK (2018b) concluded surface water management for the TMA, under normal circumstances, is expected to function as intended based on the original design intent, without the need for further remedial works.

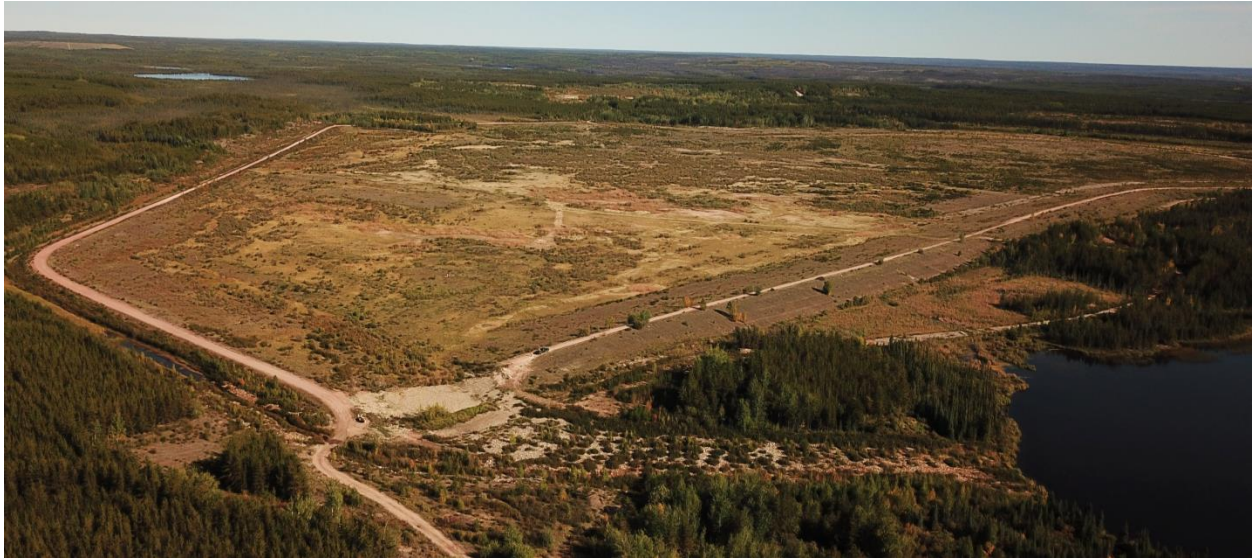
Figure 3 Photo of the decommissioned TMA (looking east) as of September 2018 with Snake Lake on the right-side of the image (photo courtesy of Orano)

Orano retained SRK in 2018 to assess the potential effects of vegetation developments in the SDD and NDD on their design discharge capacity and a potential breach of the beaver dam upstream of the NDD. SRK (2018b) concluded the following based on their assessment:

- › The increase in vegetation produces a minor reduction in capacity but does not cause the diversion ditches to overtop into the TMA in the event of a PMF, and therefore are considered cable of meeting design flow criteria;
- › The scenario of a PMF event coupled with the presence of a beaver dam greater than 2.0 m in height could overtop the banks of the NDD; however, this scenario may be appropriately considered in risk assessment accidents and malfunctions, long-term monitoring, or institutional control funds; and
- › Surface water management for the TMA is expected to function as intended under normal circumstances based on the original design intent.
