**Canadian Nuclear Laboratories
(CNL)**

**Worker injured on January 9, 2019
at CNL Port Granby Project**

EVENT INITIAL REPORT (EIR)

EIR: January 9, 2019 Worker Injury at Canadian Nuclear Laboratories Ltd. Port Granby Project

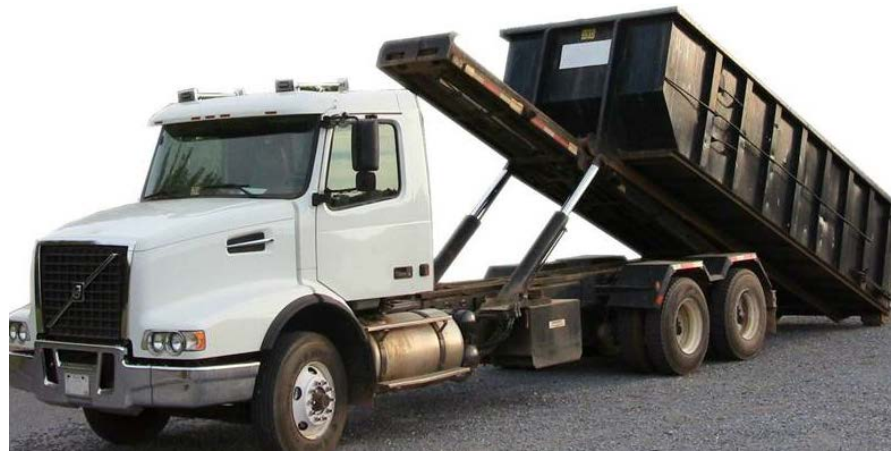
A worker employed by a contractor for Canadian Nuclear Laboratories Ltd. (CNL) at the Port Granby Project site was injured on January 9, 2019, around 11:00 am, while preparing to unload a roll-off bin from a truck. The roll-off bin was being used to transfer solid waste from the waste water treatment plant to the long-term waste management mound. Figure 1 is an example of a truck with a roll-off bin.

Figure 1: Example of a truck with a roll-off bin.

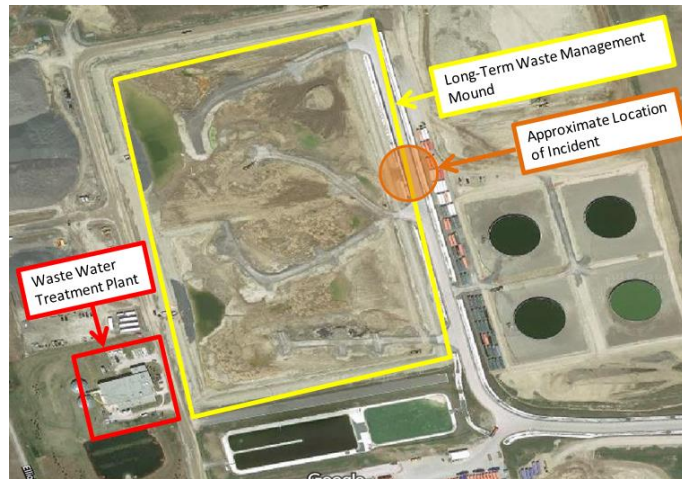
The location of the waste water treatment plant is in close proximity to the long-term waste management mound to which the waste was being transferred by the worker. The area where the incident occurred was a non-radiological area with dose rates consistent with background. Figure 2 shows the proximity of the waste water treatment plant to the mound and the approximate location where the incident occurred.

Figure 2: Layout of the site showing the location of the incident
