BP-CORR-00531-02326

Bruce A Unit 3:
Designated Officer Order Issued to Bruce Power:
Elevated Hydrogen Equivalent Concentrations and Delayed Hydride Cracking Initiation

ASSESSMENT OF MARGINS AGAINST CRACK INITIATION AT CWEST SCRAPE FLAWS IN REGIONS OF INTEREST WITH HIGH LEVELS OF HYDROGEN EQUIVALENT CONCENTRATION IN OUTLET ROLLED JOINTS IN BRUCE UNITS 3 AND 7

Kinectrics Report No. B2083/RP/0001 R00

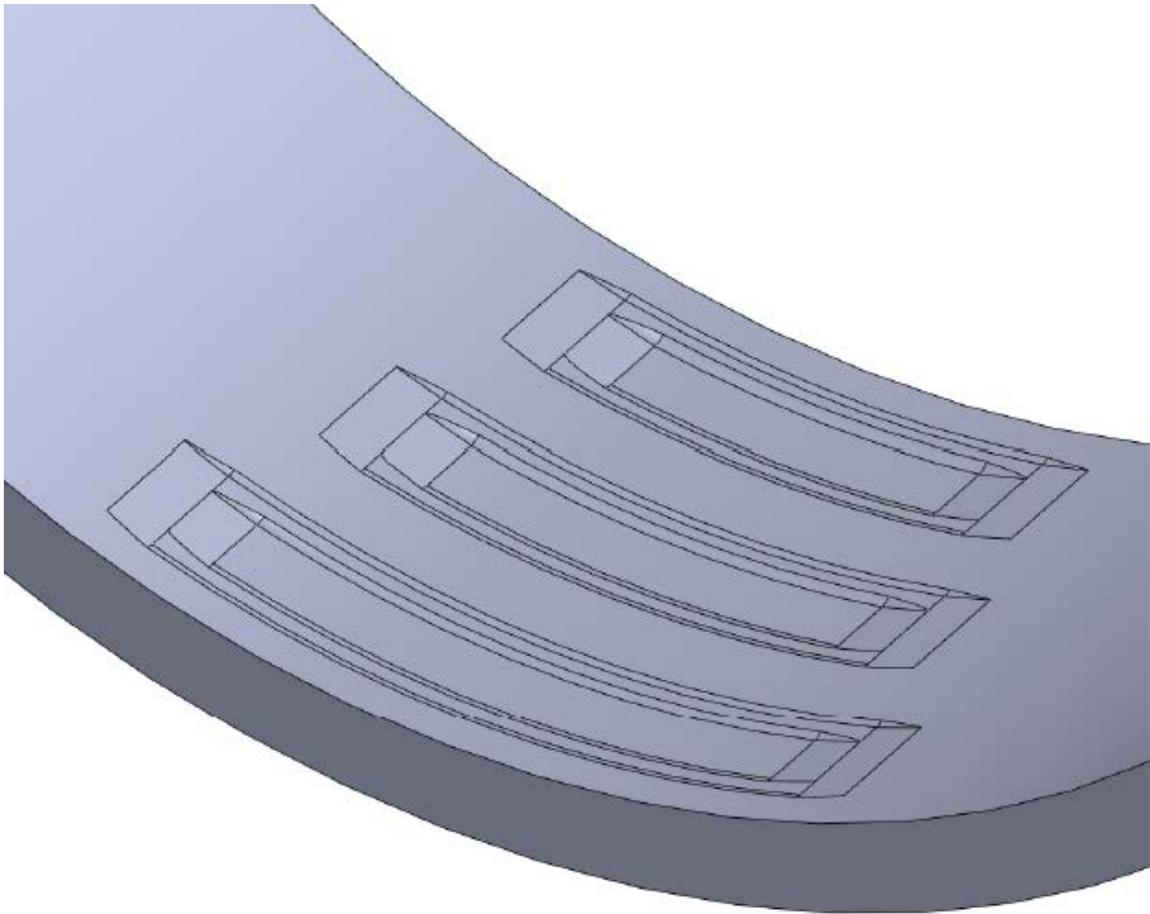
Figure 3-1: Illustration of CWEST Scrape Flaws

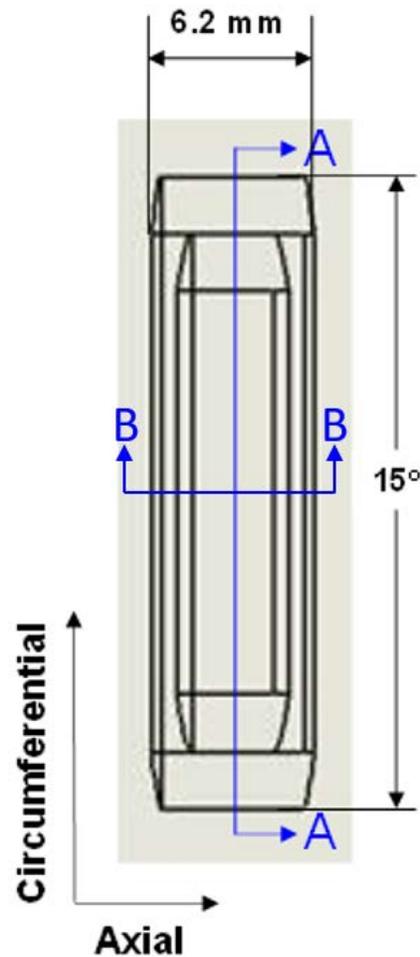
Figure 3-2: Top View of CWEST Scrape Flaw

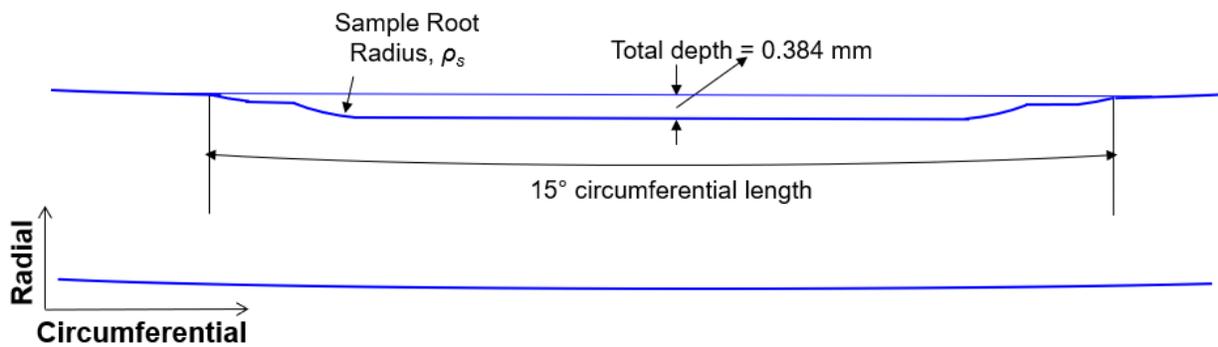
The cross-section of a scrape flaw in the radial-circumferential plane of the pressure tube, corresponding to Section A-A in Figure 3-2, is shown in Figure 3-3. The scrape tool is designed to remove material up to a total depth of 0.384 mm [5,6]. Accordingly, the maximum scrape flaw depth used in the evaluations in this report is 0.384 mm. The actual total cut depths by the tool are expected to be less than the maximum depth of 0.384 mm. Before deploying the CWEST tool on channel, 60 cuts are performed as part of Tool Demonstration Testing [6] and the measured total depths were found to be not deeper than 0.323 mm. A scrape flaw depth of 0.323 mm was also used in the sensitivity evaluation of DHC initiation using the process-zone model in Sections 6 and 8 of this report to determine the sensitivity of the evaluation results to the scrape flaw depth. A circumferential arc length of 15° has been specified in [6] and has been used as the length of the circumferential component of the scrape flaw in the evaluations in this report.

Figure 3-3: CWEST Scrape Flaw Geometry in the Radial-Circumferential Plane of the Pressure Tube (Section A-A of Figure 3-2)

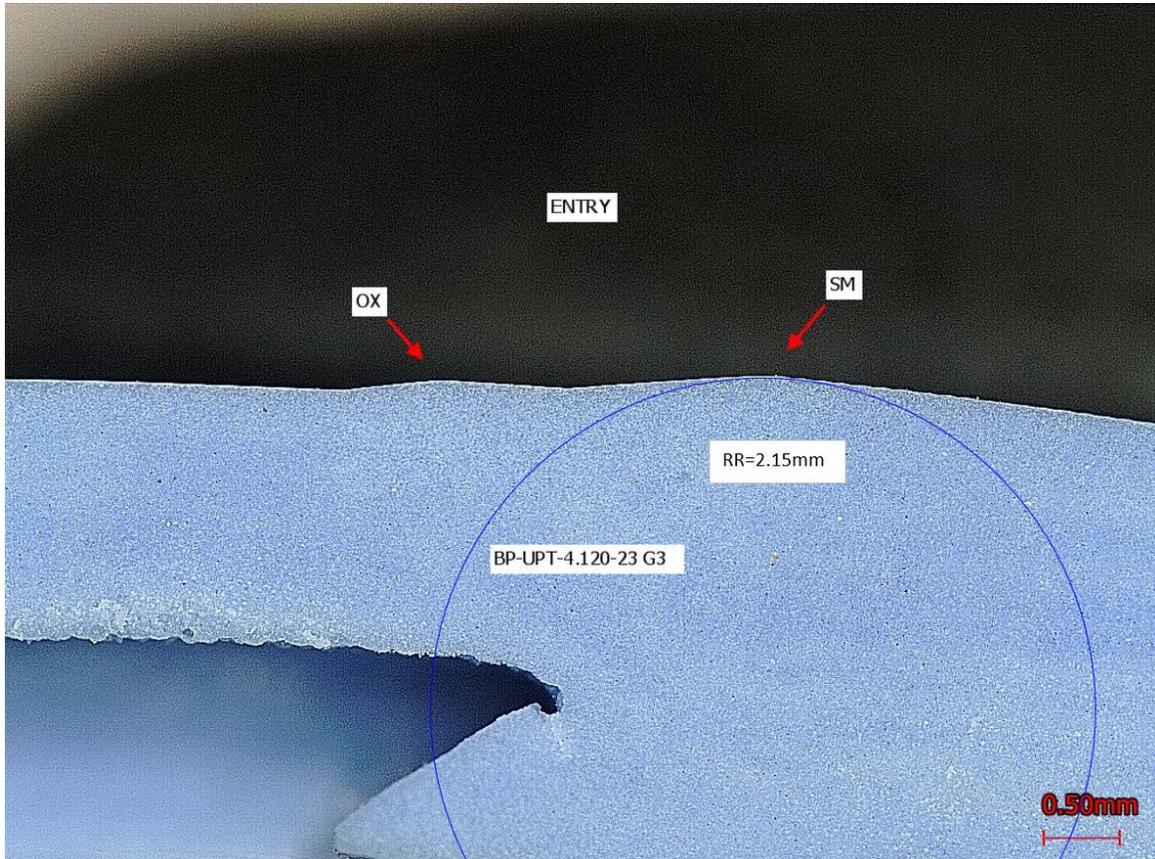
OX: Oxide cut
SM: Sample cut
RR: Root radius
The image shows the measured entry root radius of the sample cut.

Figure 3-4: Replica of CWEST Scrape Flaw with Fitted Corner Root Radius of the Sample Cut
(Figure 13 of Reference [7])

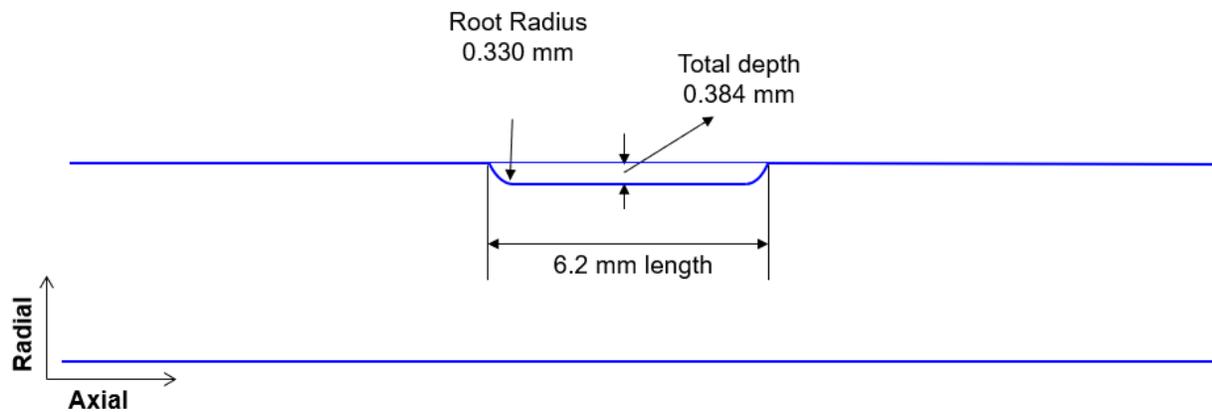
Figure 3-5: CWEST Scrape Flaw Geometry in the Radial-Axial Plane of the Pressure Tube (Section B-B of Figure 3-2)

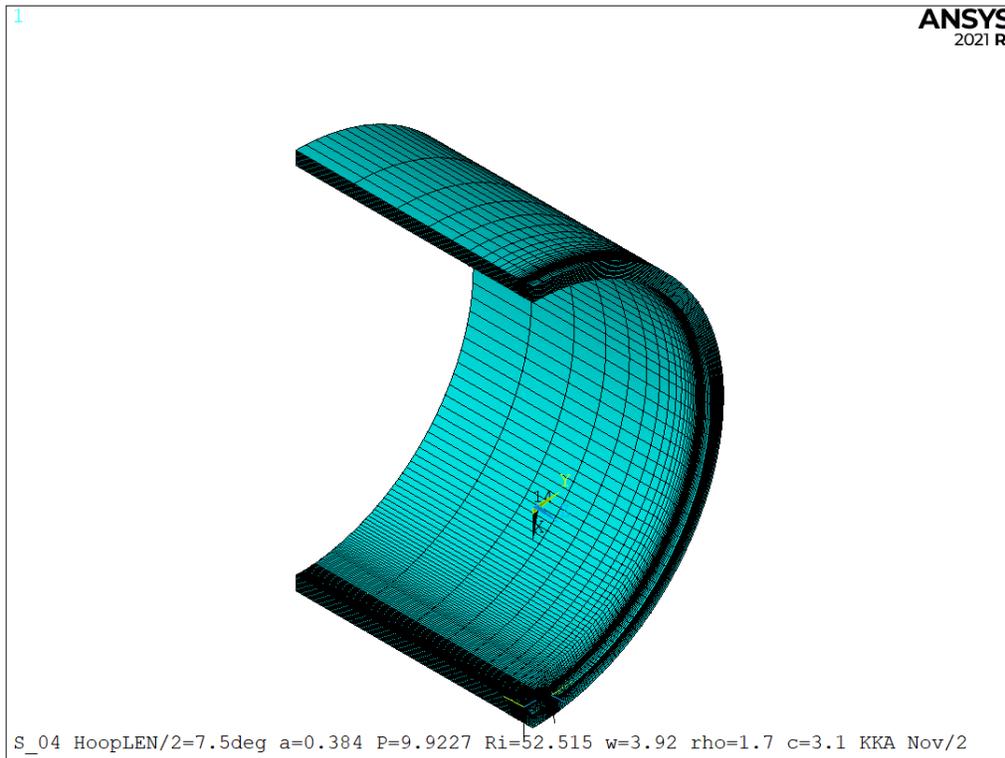
A three-dimensional, one-quarter symmetry finite element model with two planes of symmetry was used for each case. The end fitting was not included in the finite element model, and there was no credit for end fitting support, which is conservative. The three-dimensional one-quarter symmetry finite element model of pressure tube with the CWEST scrape flaw in Bruce Unit 3 for the baseline Case B3-1 with a depth of 0.384 mm and a corner root radius of 1.7 mm is shown in Figure 6-1. A view of the CWEST scrape flaw in Bruce Unit 3 for the baseline Case B3-1 in the three-dimensional one-quarter symmetry finite element model is shown in Figure 6-2. Convergence was assessed by replacing the 20-node hexahedral elements with 8-node hexahedral bricks [22]. The number of elements was identical, but the number of nodes was decreased from 380,416 to 97,246. The peak flaw-tip stress was within 0.3%, and convergence was demonstrated.

Figure 6-1: Three-Dimensional One-Quarter Symmetry Finite Element Model of Pressure Tube with the CWEST Scrape Flaw in Bruce Unit 3 for the Baseline Case B3-1 with a Flaw Depth of 0.384 mm and a Corner Root Radius of 1.7 mm

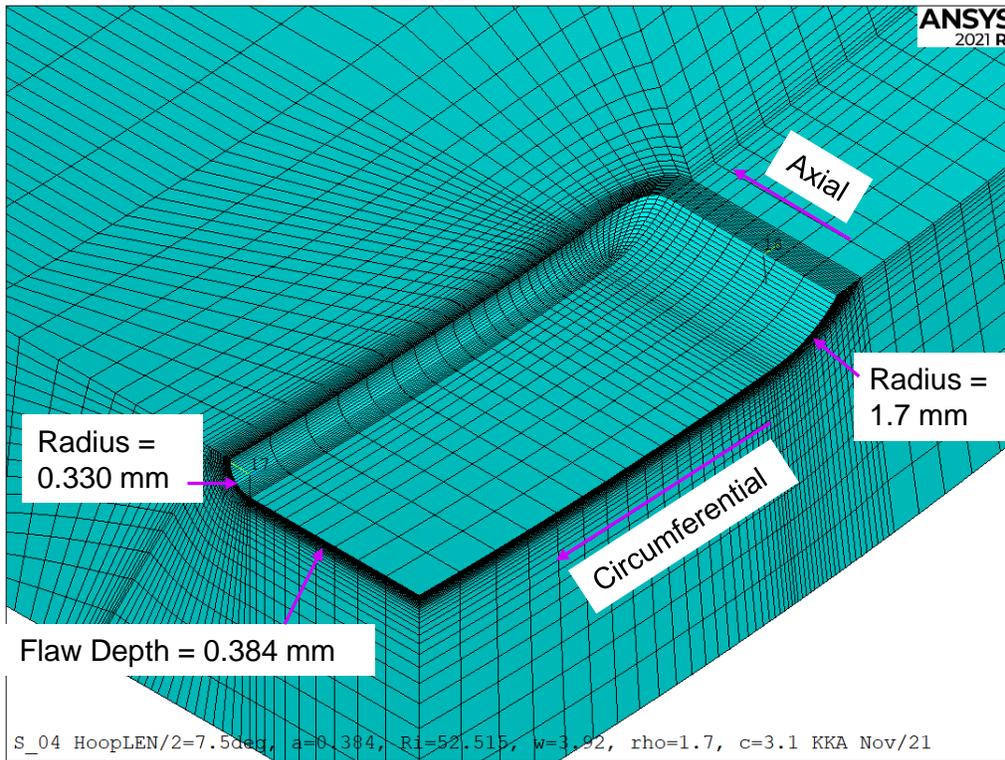
The maximum principal stress contours at the CWEST scrape flaw in Bruce Unit 3 for the baseline Case B3-1 with a depth of 0.384 mm, a corner root radius of 1.7 mm, and a total nominal hoop stress during hydride precipitation of 142.9 MPa including pressure on the flaw face, is shown in Figure 6-3. The peak principal stress occurs at the entry and exit corners of the scrape flaws. A close-up view of maximum principal stress contours at the corner of the axial component of the CWEST scrape flaw in Bruce Unit 3 for the baseline Case B3-1 is shown in Figure 6-4. From this figure, the peak flaw-tip principal stress at the corner, midway along the axial length and on the radial-circumferential plane of symmetry (lower right-hand plane in Figure 6-2), for the baseline Case B3-1 is 225.7 MPa.

Figure 6-2: View of CWEST Scrape Flaw in Bruce Unit 3 for the Baseline Case B3-1 with a Flaw Depth of 0.384 mm and a Corner Root Radius of 1.7 mm in the Three-Dimensional One-Quarter Symmetry Finite Element Model

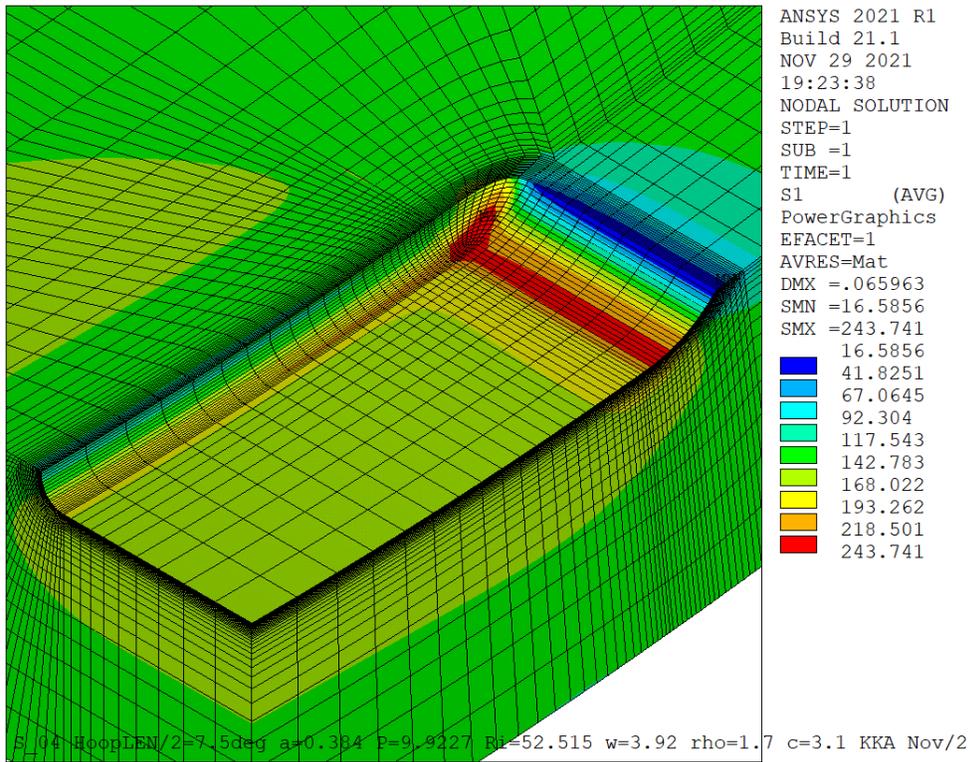
Figure 6-3: Maximum Principal Stress Contours at CWEST Scrape Flaw in Bruce Unit 3 for the Baseline Case B3-1 with a Flaw Depth of 0.384 mm, a Corner Root Radius of 1.7 mm, and a Total Nominal Hoop Stress During Hydride Precipitation of 142.9 MPa Including Pressure on the Flaw Face

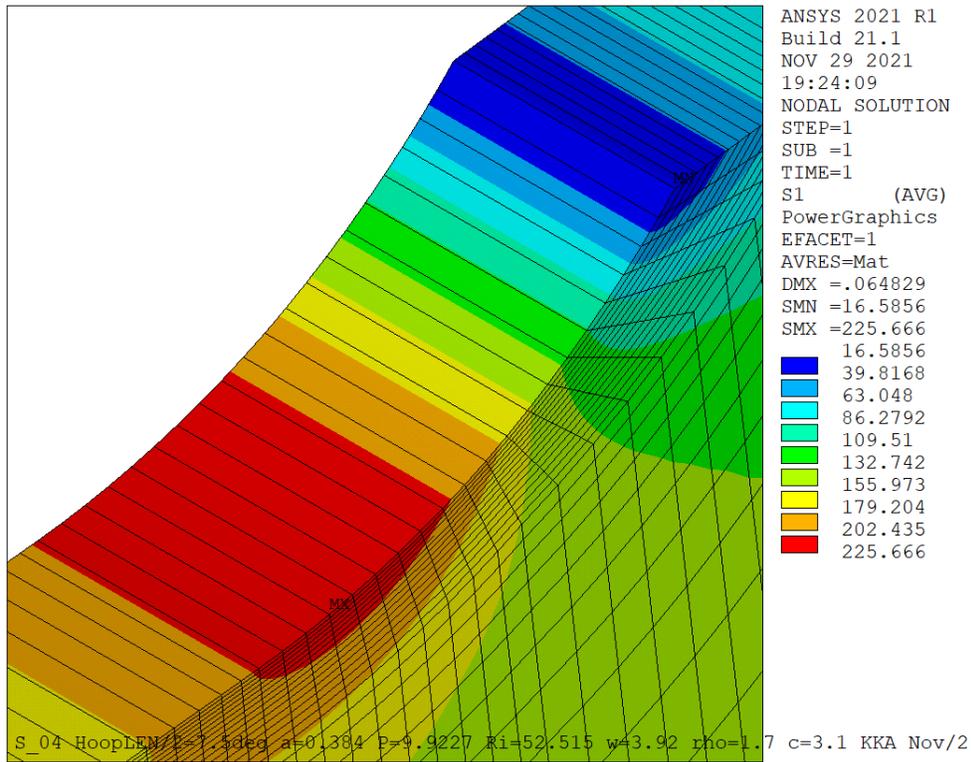
Figure 6-4: Close-Up View of Maximum Principal Stress Contours at CWEST Scrape Flaw in Bruce Unit 3 for the Baseline Case B3-1 with a Flaw Depth of 0.384 mm, a Corner Root Radius of 1.7 mm, and a Total Nominal Hoop Stress During Hydride Precipitation of 142.9 MPa Including Pressure on the Flaw Face

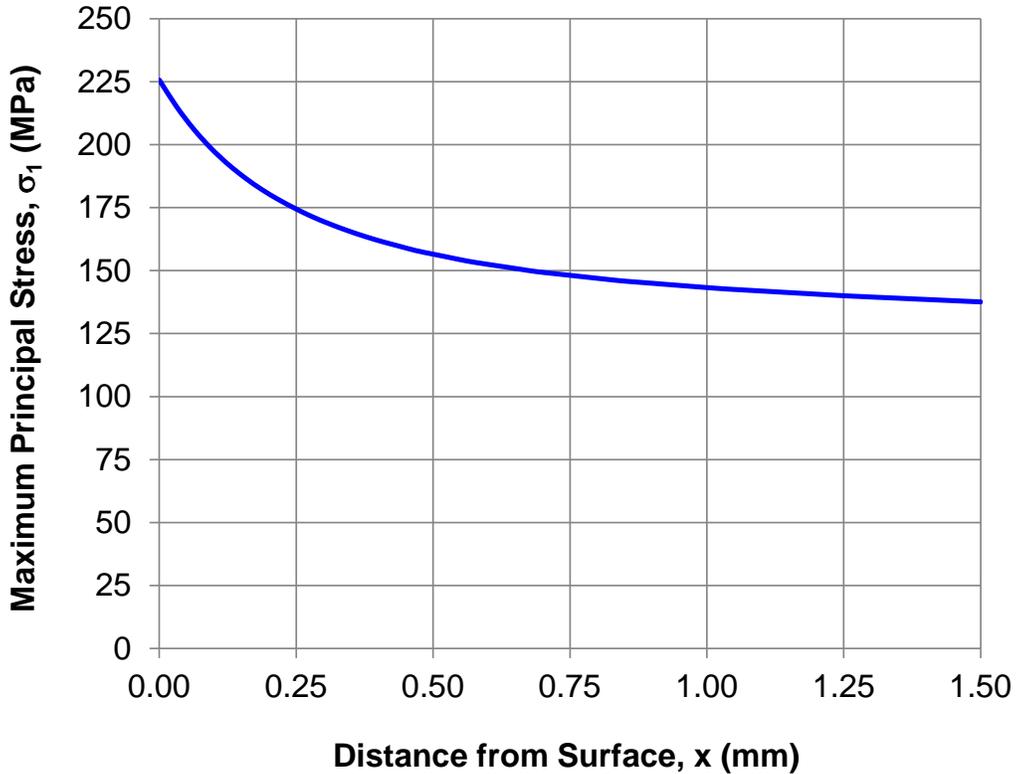
Figure 6-5: Fourth-Order Polynomial Representation of the Principal Stress Distribution at CWEST Scrape Flaw in Bruce Unit 3 for the Baseline Case B3-1 with a Flaw Depth of 0.384 mm, a Corner Root Radius of 1.7 mm, and a Total Nominal Hoop Stress During Hydride Precipitation of 142.9 MPa Including Pressure on the Flaw Face

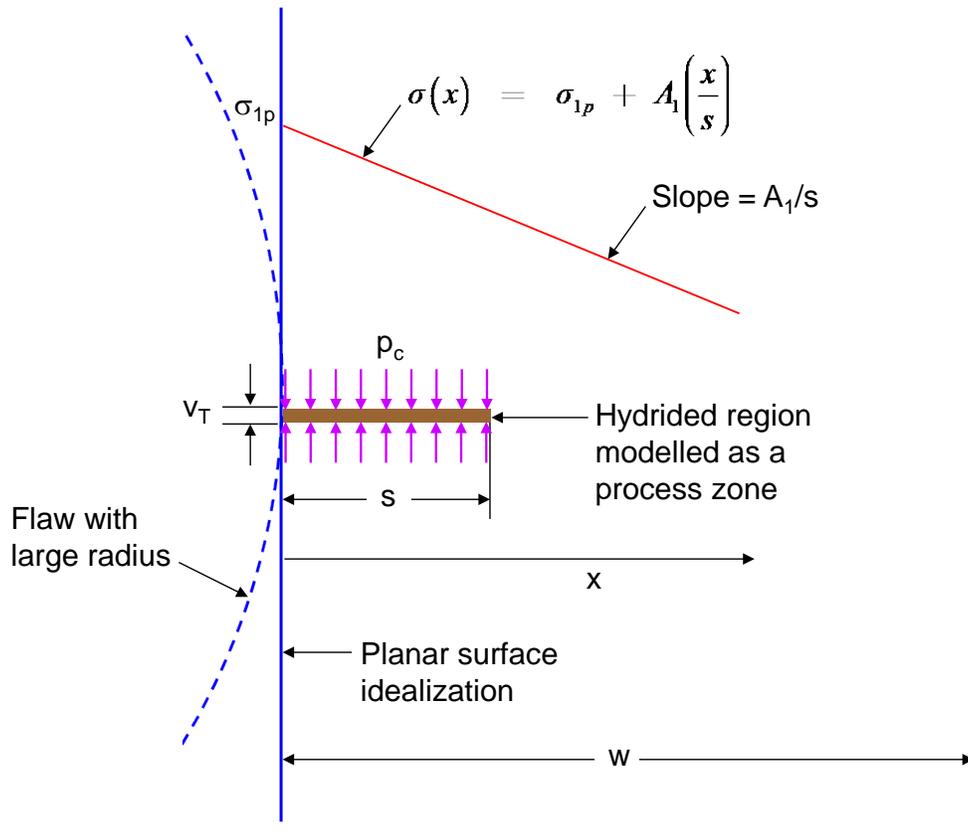
A process zone emanating from a planar surface and subjected to an applied linear stress distribution is shown in Figure 7-1. The stress distribution adjacent to the scrape flaw through the wall thickness is approximated as linear as given below

Figure 7-1: Process Zone Emanating from a Planar Surface and Subjected to an Applied Linear Stress Distribution

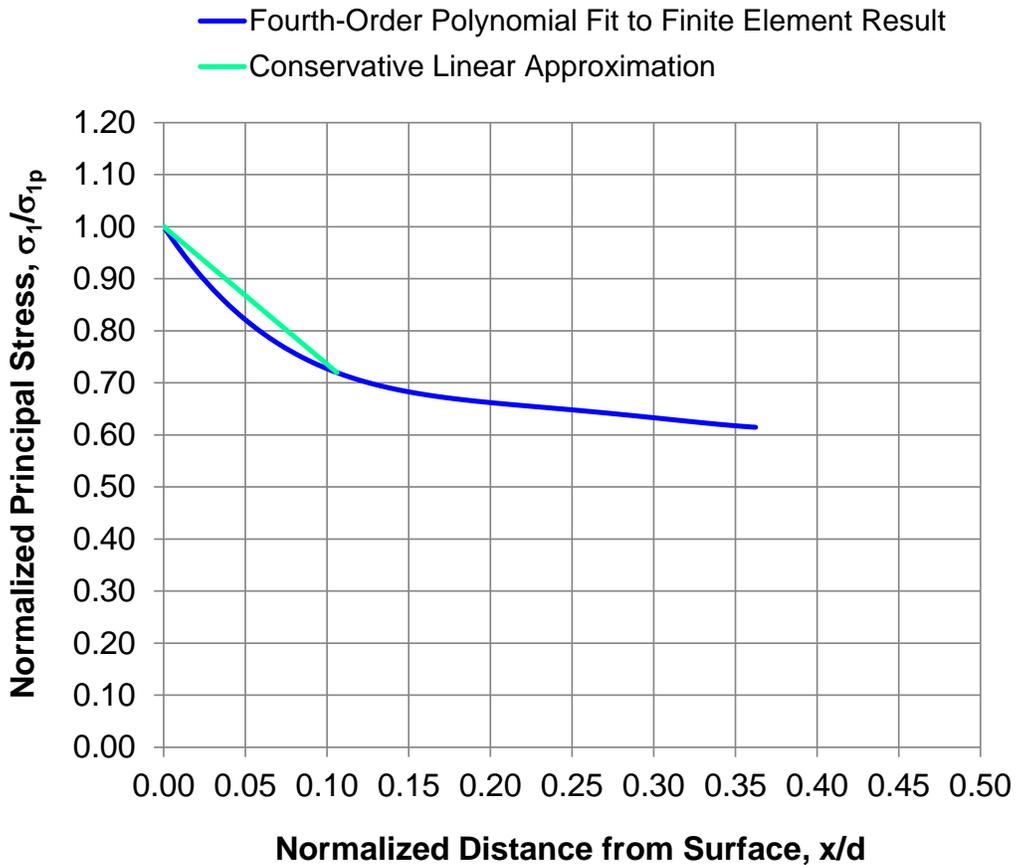
The conservative linear stress distribution approximation to the normalized fourth-order polynomial representation of the principal stress distribution at the scrape flaw in Bruce Unit 3 for the baseline Case B3-1 with a corner root radius of 1.7 mm is illustrated in Figure 7-2.

Figure 7-2: Illustration of the Conservative Linear Stress Distribution Approximation to the Normalized Fourth-Order Polynomial Representation of the Principal Stress Distribution at the Scrape Flaw in Bruce Unit 3 for Baseline Case B3-1 with a Corner Root Radius of 1.7 mm

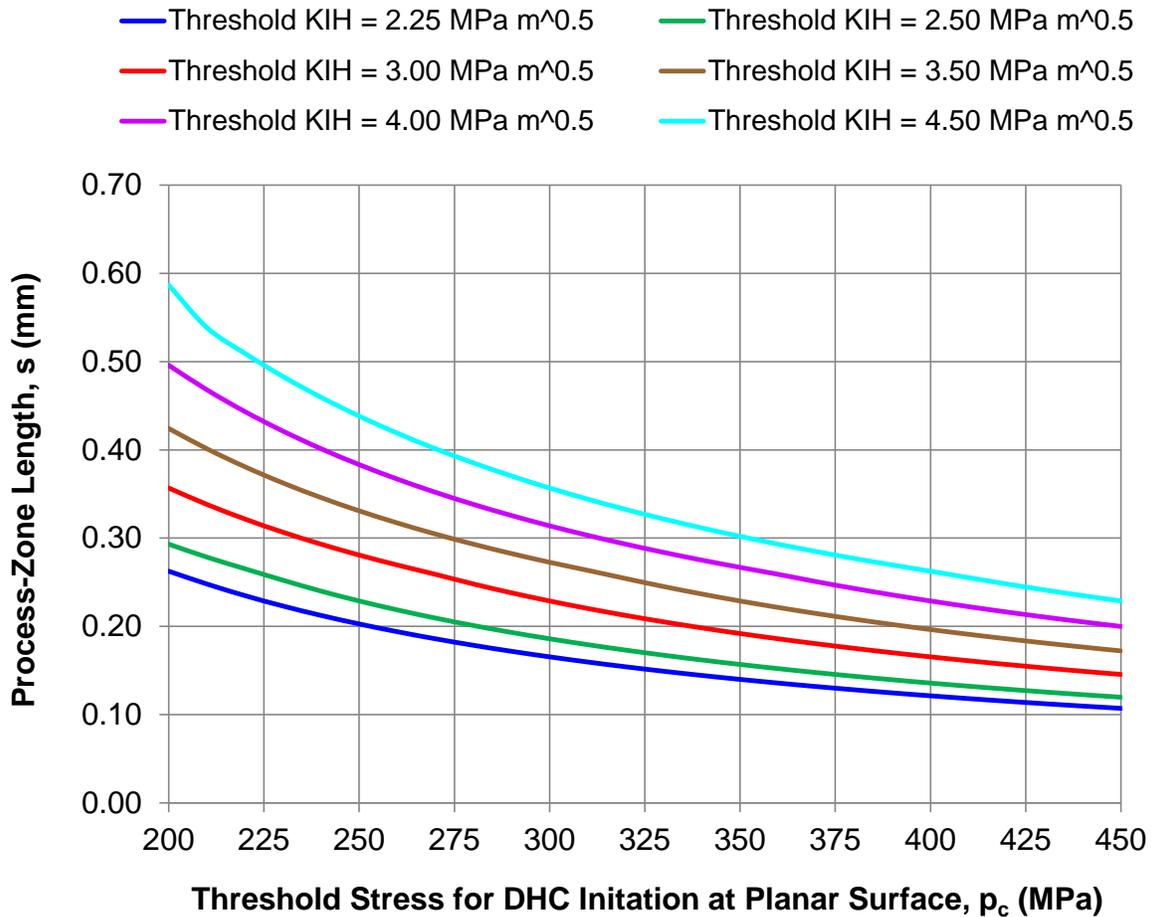
Figure 8-1: Variation of Predicted Process-Zone Length, *s*, with *p_c* for a Range of *K_{IH}* for Bruce Unit 3 Baseline Case B3-1 with a Scrape Flaw Depth of 0.384 mm and a Corner Root Radius of 1.7 mm

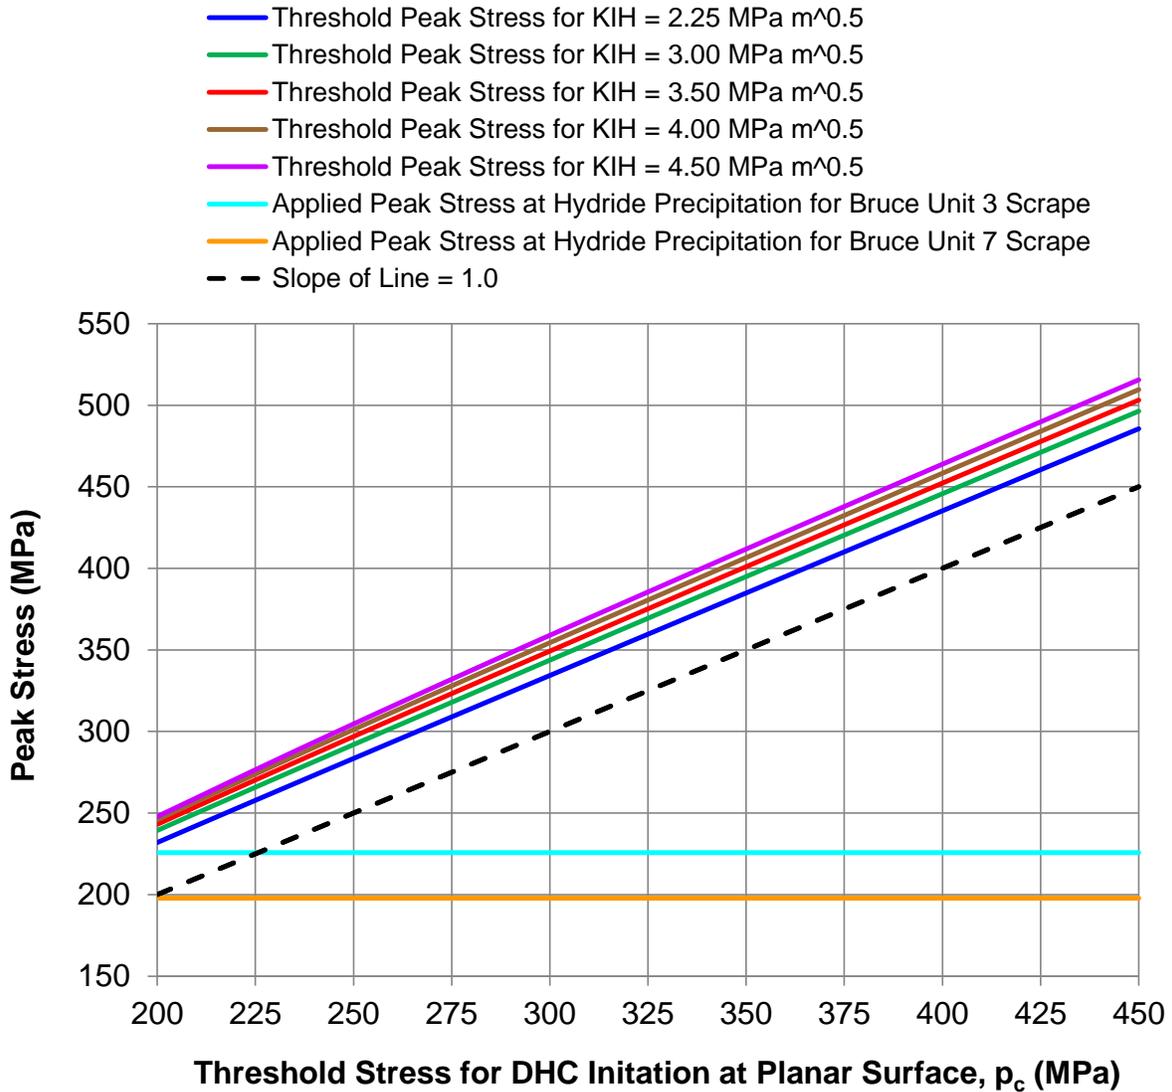
Figure 8-2: Variation of Predicted Threshold Peak Stress for DHC Initiation, σ_{th}, with p_c for a Range of K_{IH} for Bruce Unit 3 Baseline Case B3-1, and Bruce Unit 7 Baseline Case B7-1, with a Scrape Flaw Depth of 0.384 mm and a Corner Root Radius of 1.7 mm, with the Applied Peak Stresses

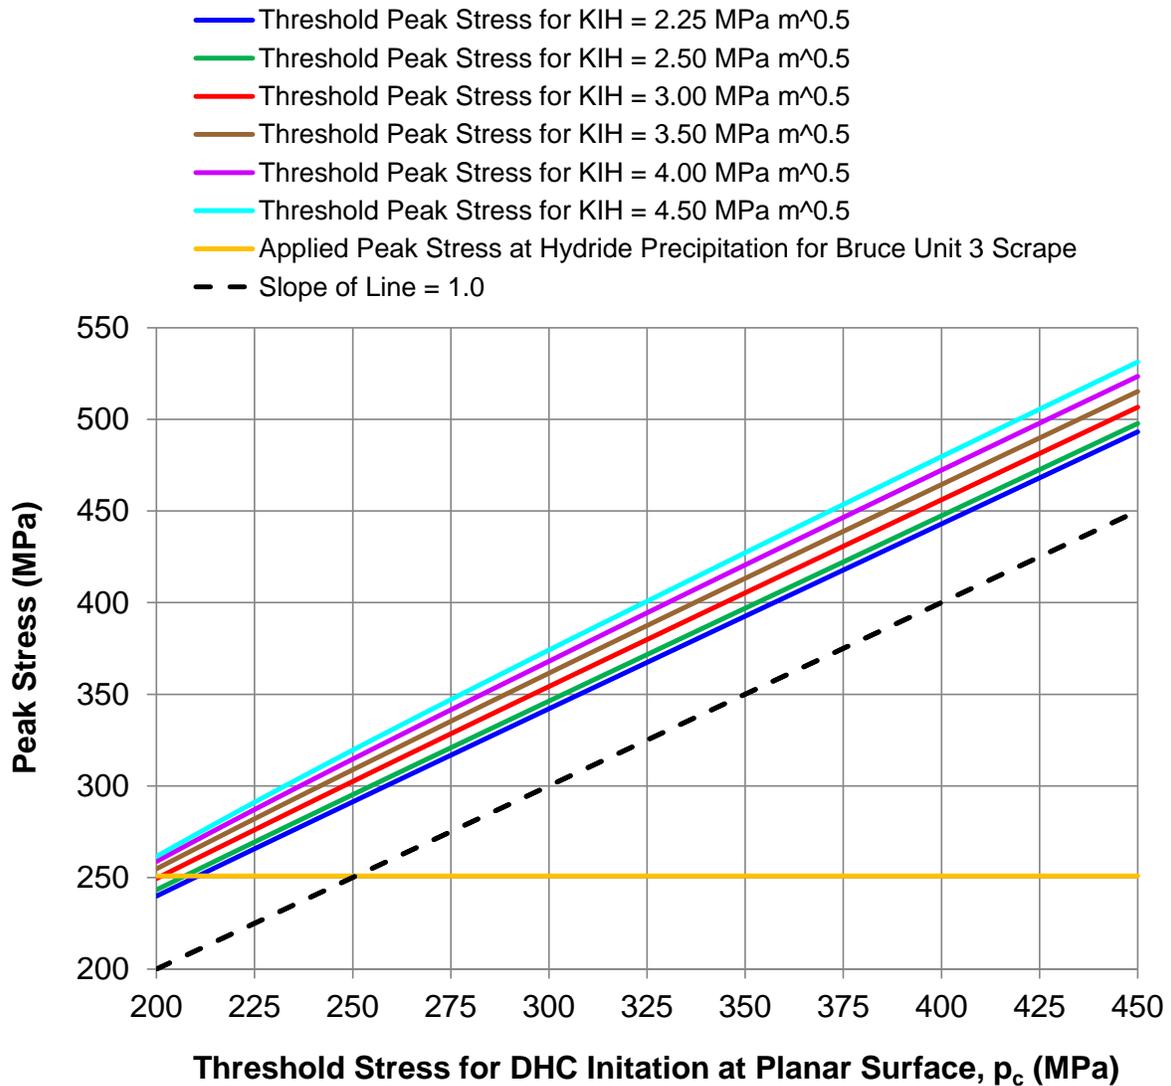
Figure 8-3: Variation of Predicted Threshold Peak Stress for DHC Initiation, σ_{th}, with p_c for a Range of K_{IH} for Bruce Unit 3 Case B3-4 with a Scrape Flaw Depth of 0.384 mm and a Corner Root Radius of 1.0 mm, with the Applied Peak Stress

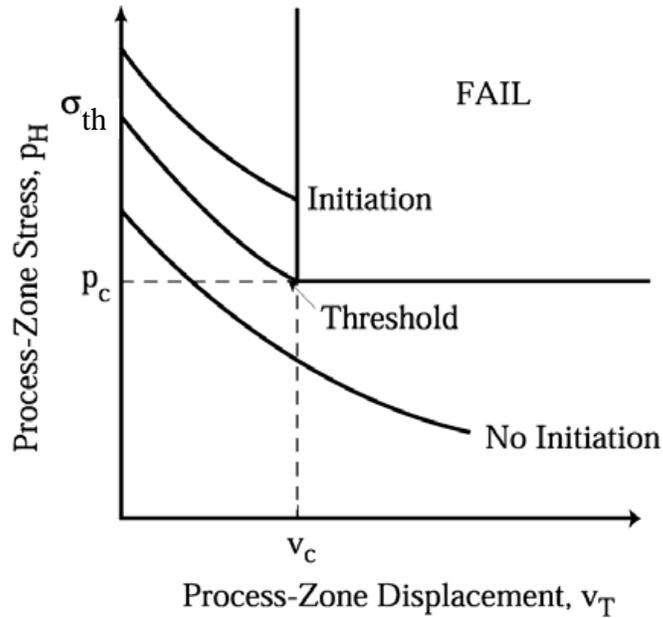
Figure A-2: Various p_H Versus v_T Behaviour as a Hydrided Region Develops at a Flaw Tip Illustrating the Threshold Peak Stress for DHC Initiation, σ_{th}
