Written submission from Ontario Power Generation

**Request for authorization to return
Pickering Nuclear Generating Station
Unit 5 to service, following its current
forced outage**

Pickering NGS: OPG responses to CNSC staff inquiries related to OPG's request for expedited authorization to restart following the Pickering Unit 5 2021 fall forced outage

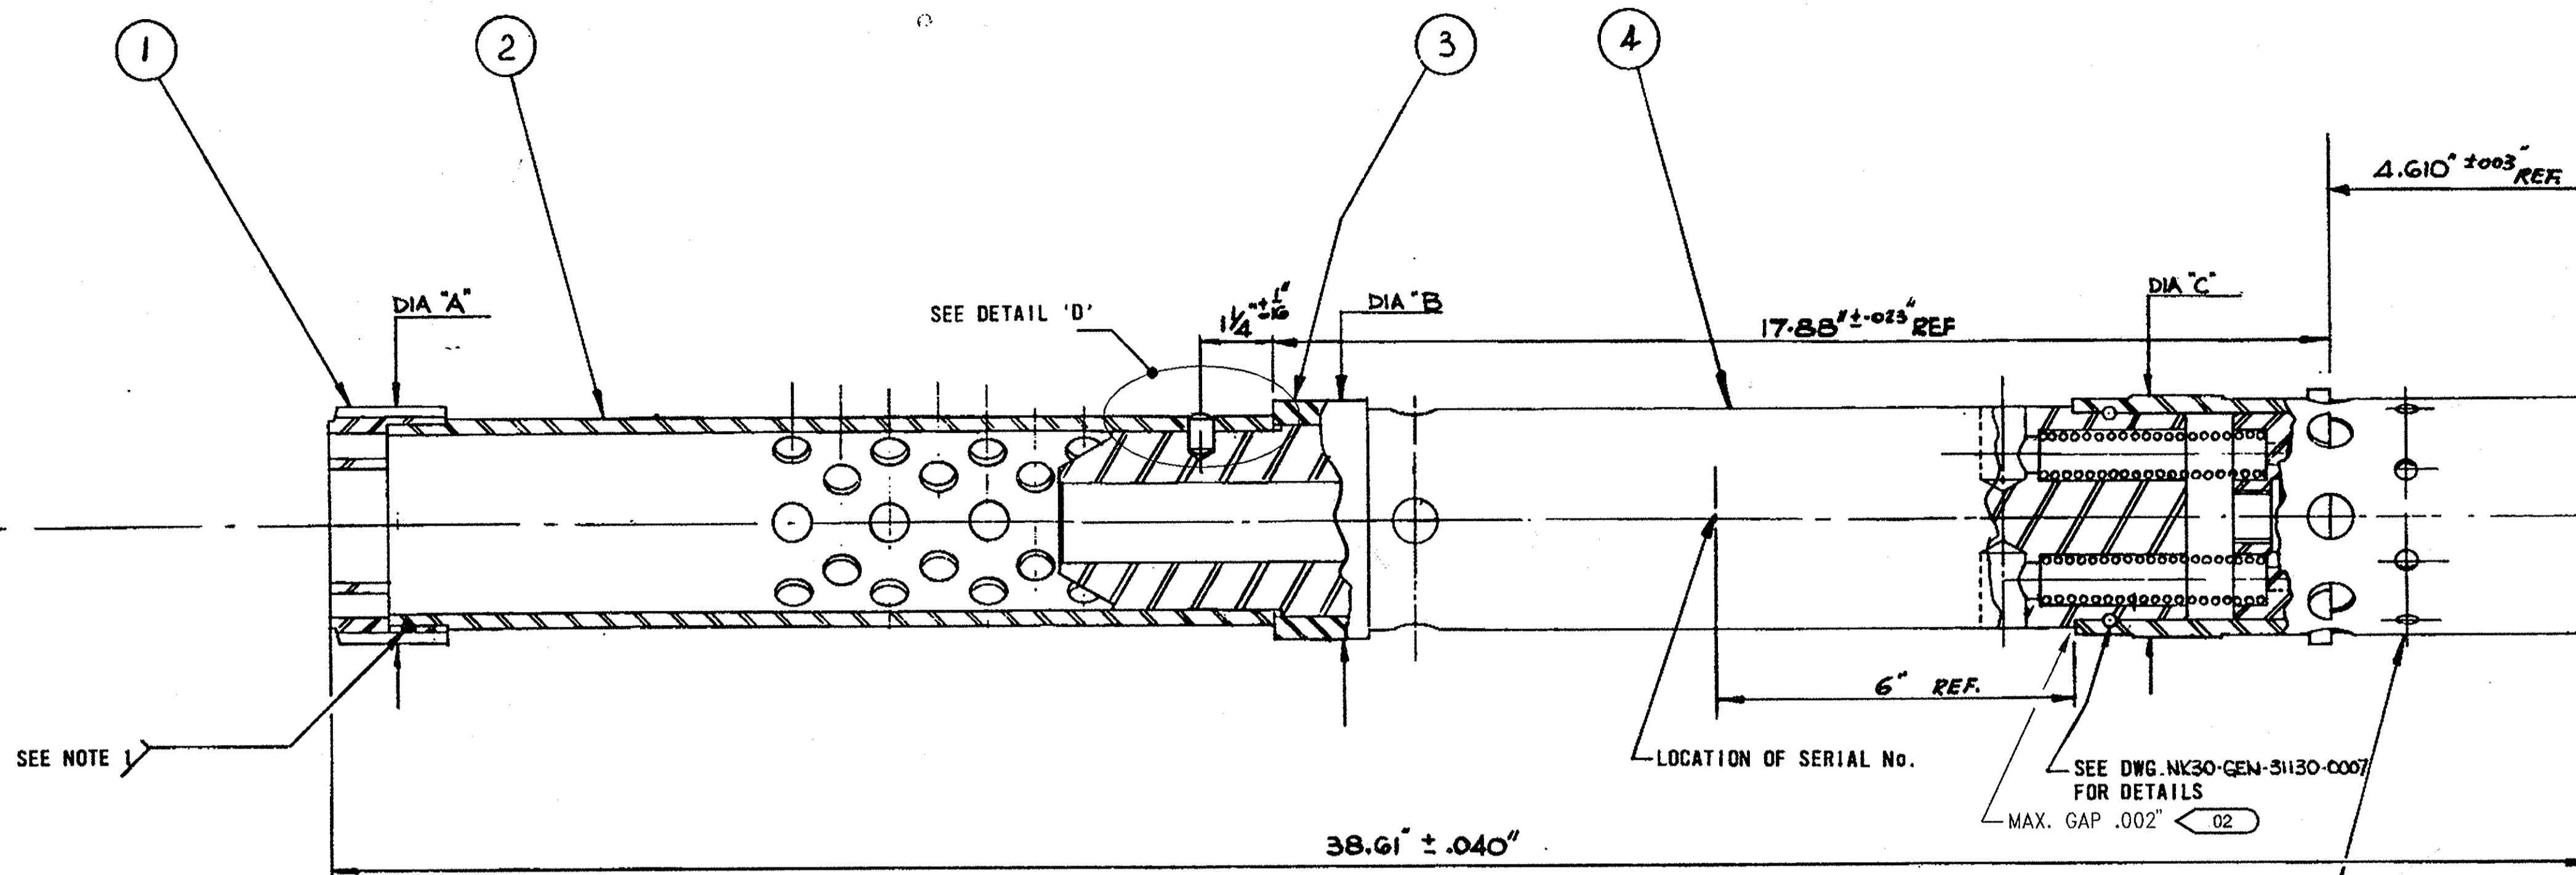
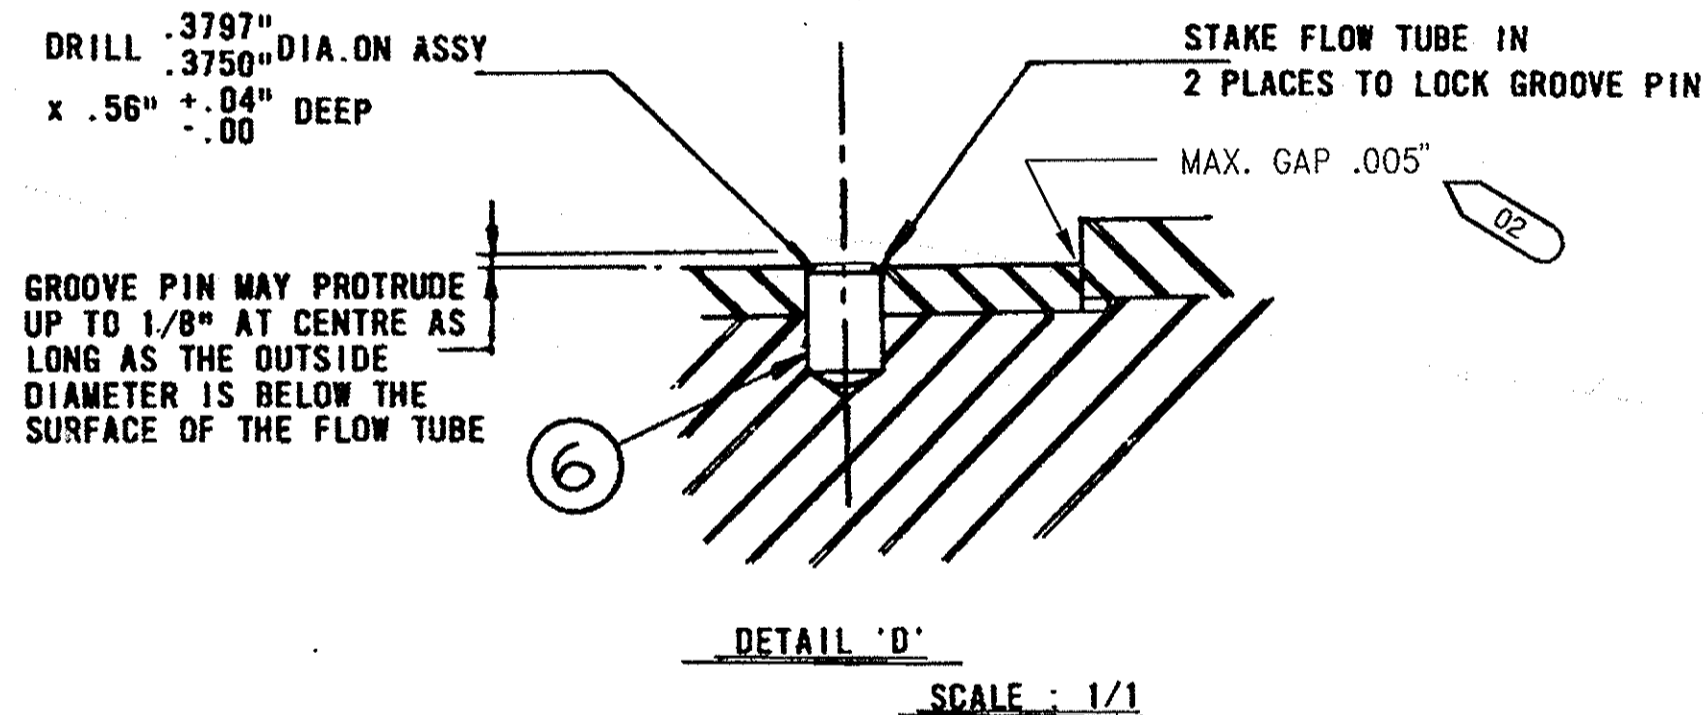
NK30-GDN-31130-0001-001 Rev 2

- NOTES:**
1. WELDING PROCEDURES FOR TIG WELDING ITEM 1 TO ITEM 2 AT 2 PLACES TO BE SUBMITTED TO A.E.C.L. FOR APPROVAL.
 2. AFTER ASSY DIA'S 'A' 'B' & 'C' TO BE CONCENTRIC WITHIN .020" T.I.R.
 3. NO PARTICULAR ORIENTATION IS REQUIRED BETWEEN ITEMS 1 2 & 4.
 4. SEE TECHNICAL SPEC. TS-30-31130-3 FOR ASSEMBLY AND TESTING DETAILS
 - 5 FOR L.S.F.C.R. OR FUEL CHANNEL REPLACEMENT SEE DWG 44RR-DCN-31120-0006
