**Written submission from  
Cameco Corporation**

**Cameco Corporation, Beaverlodge Project**

**Application to amend its licence to allow  
release of 18 Beaverlodge Project  
properties from CNSC licensing**

**Commission Public Hearing**

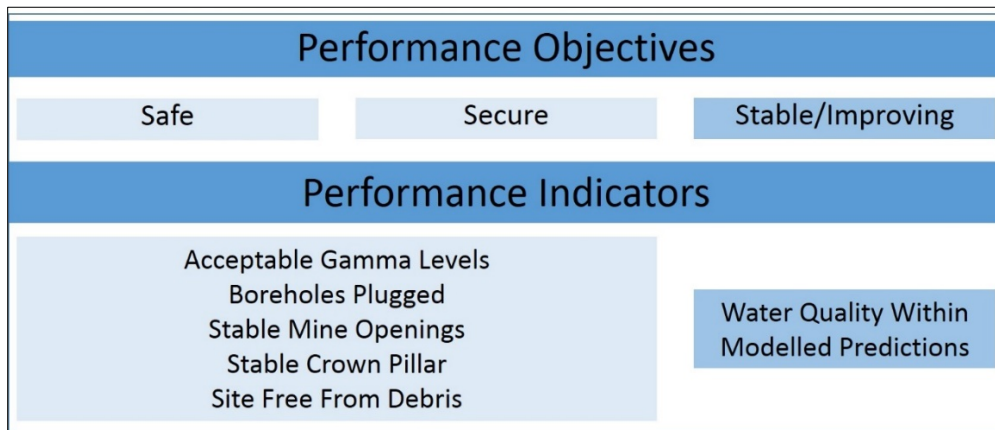
**Figure 1.1-3: Performance objectives and underlying indicators.**

To determine if a property is meeting the performance objectives, site specific performance indicators were established (Figure 1.1-3). Table 1-1 provides an overview of the performance indicators as presented to the Commission by CNSC staff during the 2014 update meeting. The applicable indicators vary depending on the nature of the property, but generally include ensuring that: risks associated with residual gamma radiation and crown pillars are acceptable; mine openings to surface are closed and stable; boreholes (if present) are plugged; and the property is free from historical mining debris. The stable/improving objective is also related to these performance indicators but is more relevant to monitoring water quality. To verify that conditions on and downstream of the properties are stable/improving, Cameco has continued to monitor the progress of natural recovery and the expected localized improvements from the additional remedial measures implemented at the properties. Meeting these objectives will ensure that residual human health and ecological risks are managed to acceptable levels to allow for a release from licensing.

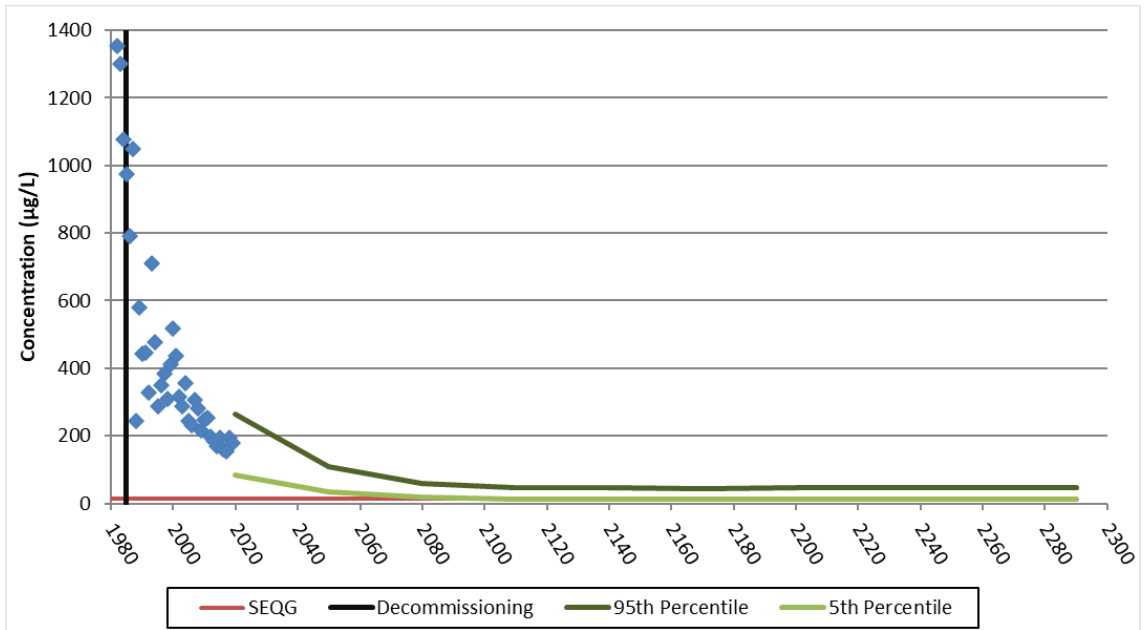
**Figure 3.2-3: Uranium concentrations and predictions at station DB-6.**

Water quality measured at Dubyna Creek (Station DB-6), located immediately downstream of Dubyna Lake, compared to modelled predictions is a performance indicator associated with the decommissioned EMAR 1 property. The relevant water quality constituents assessed as part of this performance indicator include, radium-226, uranium and selenium. As shown in Figures 3.2-2, 3.2-3 and 3.2-4, measured concentrations of these parameters fall within the range of modelled predictions for DB-6.

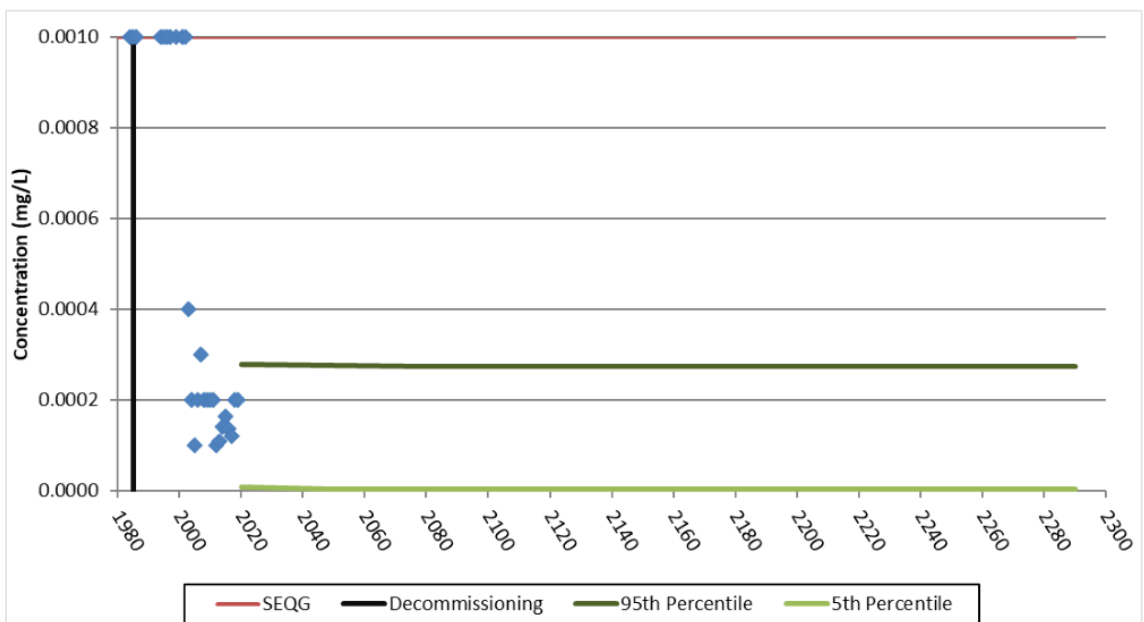
**Figure 3.3-4: Selenium (Se) concentrations and predictions at station AC-14.**

\*Note: Prior to 2000, the detection limit for Se was 0.001 mg/L and post 2000 it has been 0.0001 mg/L.

Seeps originating at the base on the Fay waste rock pile on the URA 7 property (not subject to this request) extend to EXC URA 7. Water quality measured at the outlet of Lower Ace Creek (station AC-14) compared to modelled predictions is a performance indicator associated with the decommissioned EXC URA 7 and URA FR properties. The relevant water quality constituents assessed as part of this performance indicator include, radium-226, uranium and selenium. As shown in Figures 3.3-2, 3.3-3 and 3.3-4, measured concentrations of these parameters fall within the range of modelled predictions for AC-14.

- Radium-226 and selenium levels in Lower Ace Creek are within the modelled range and are expected to remain low (e.g., below applicable surface water guideline levels) over the long-term
- Uranium concentrations in Lower Ace Creek are within the modelled range and are expected to continually decline over time
