**Written Submission from  
Orano Canada Inc.**

Application to renew the McClean Lake  
Operating Licence for 2-year term

### **Section A: JEB TMF Emergency Preparedness and Response Plan**

## **JEB TMF Emergency Preparedness and Response Plan**

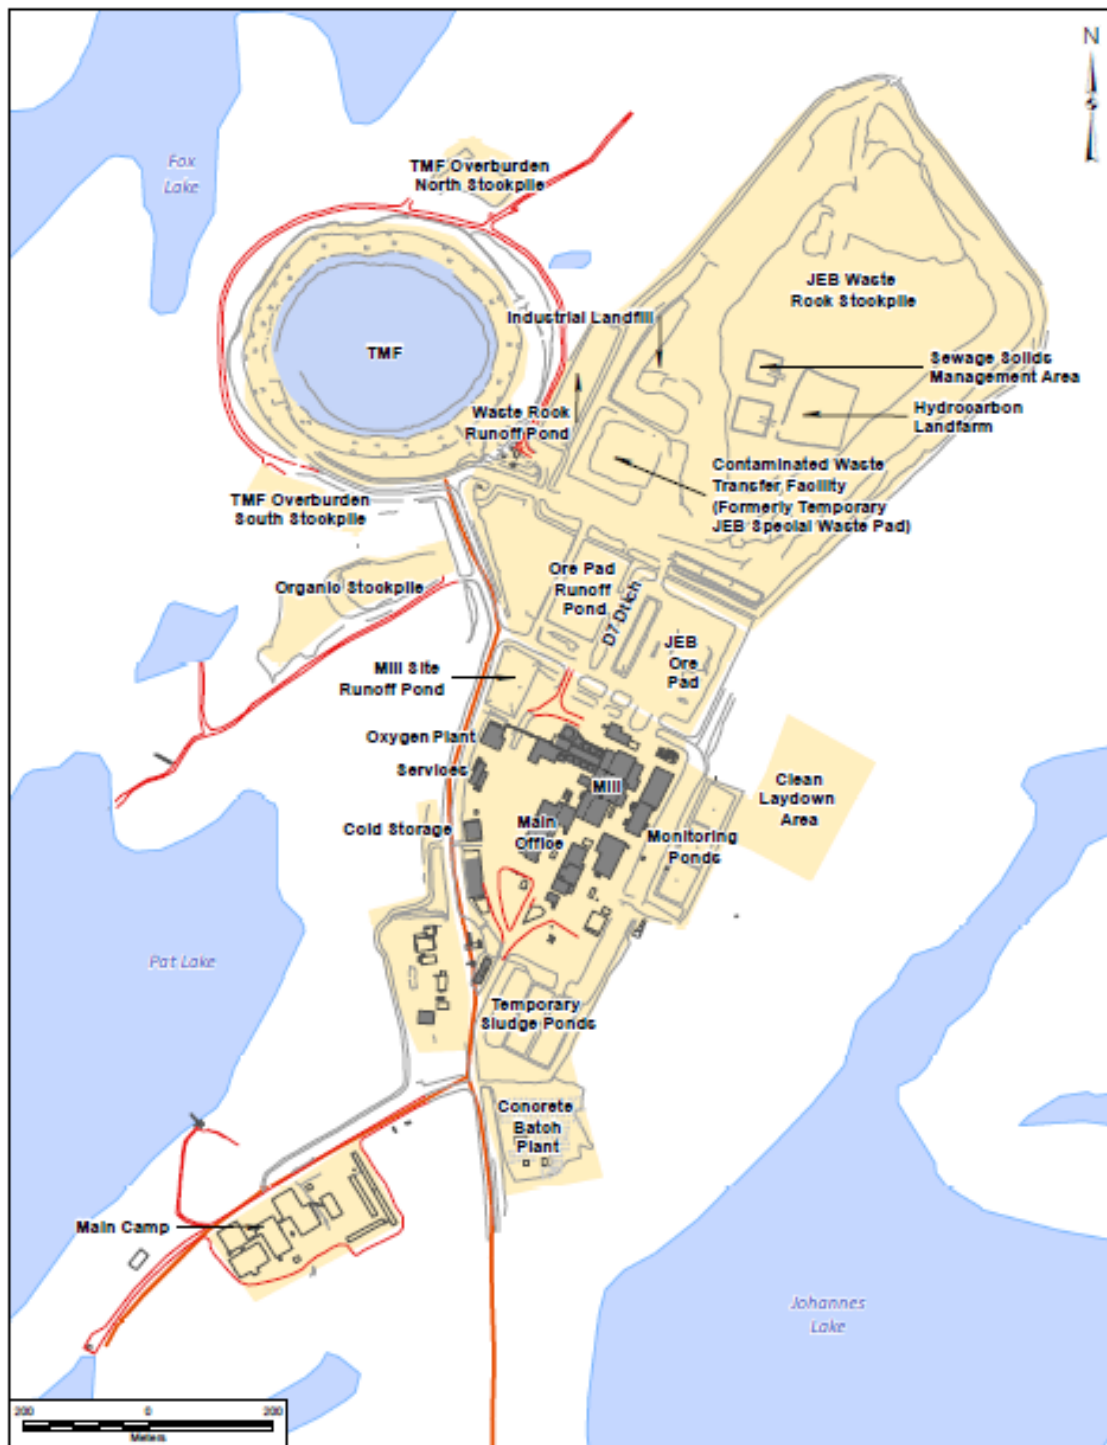
**Figure 2.3** Location of the JEB TMF at the McClean Lake Operation

Orano Canada Inc.'s (OCI) McClean Lake Operation is situated in Northern Saskatchewan, Canada as shown in Figure 2.1 and 2.2. Figure's 2.3 and 2.4 depict the location of the JEB Tailings Management Facility (TMF) within the McClean Lake Operation. The JEB TMF is operated and maintained by OCI. Engineering support comes from an Engineer of Record (EOR) team and an Independent Tailings Review Board (ITRB).

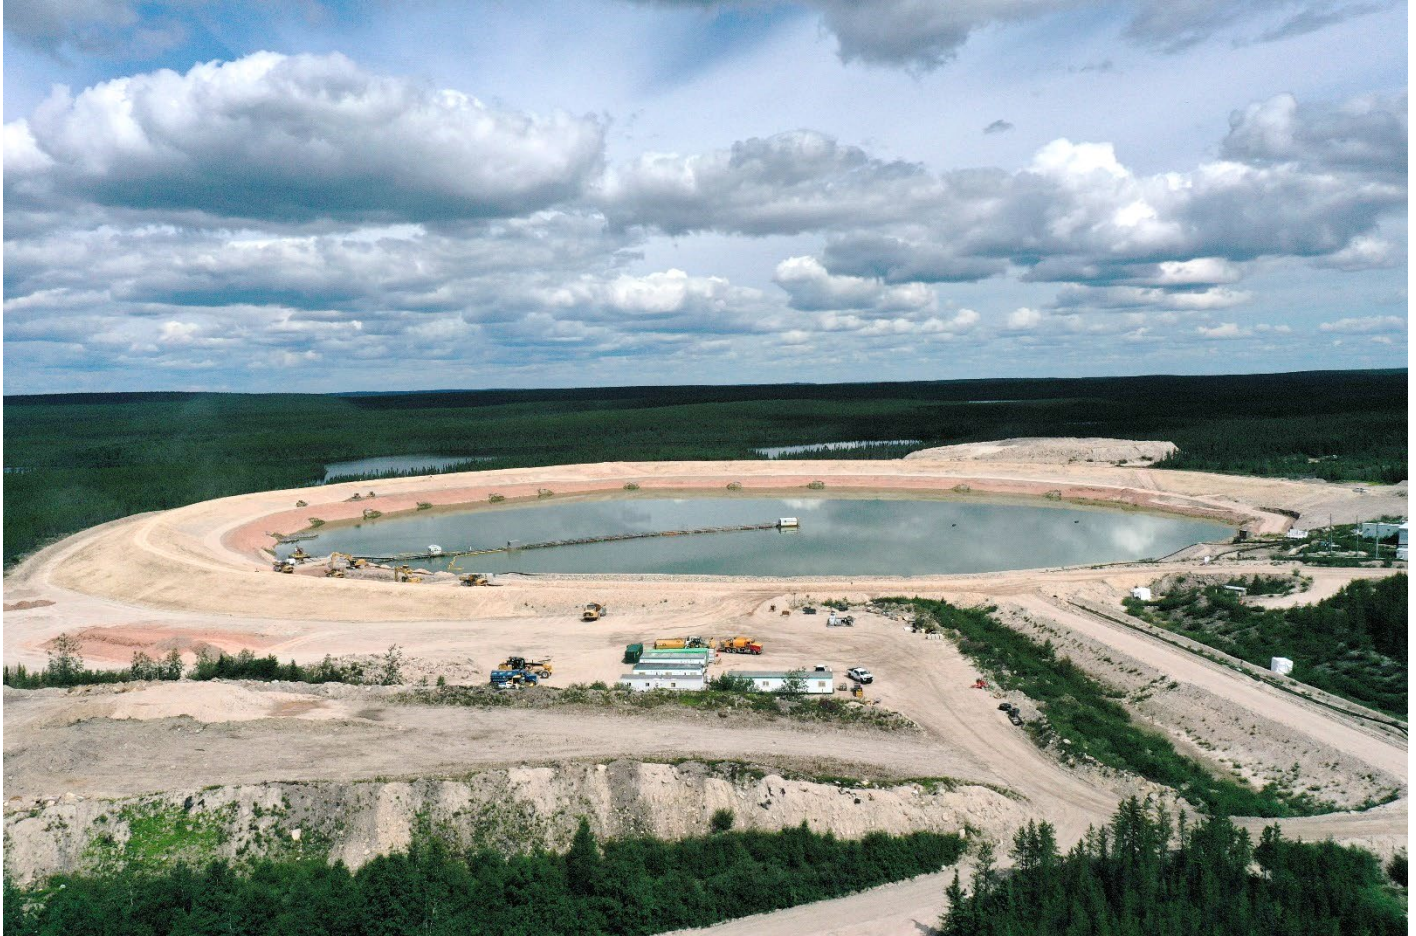
**Figure 2.4 The JEB TMF at the McClean Lake Operation, looking North**

The JEB TMF was a former open pit mine, converted to a tailings facility in 1999. The TMF has recently undergone expansion to store tailings above natural ground. The current Stage 1 expansion embankment of 457.5 masl has the capacity to store 1.5 Mm<sup>3</sup> of unconsolidated tailings once complete. The future Stage 2 expansion embankment to 468 masl will provide an additional 2.25 Mm<sup>3</sup> of unconsolidated tailings storage.

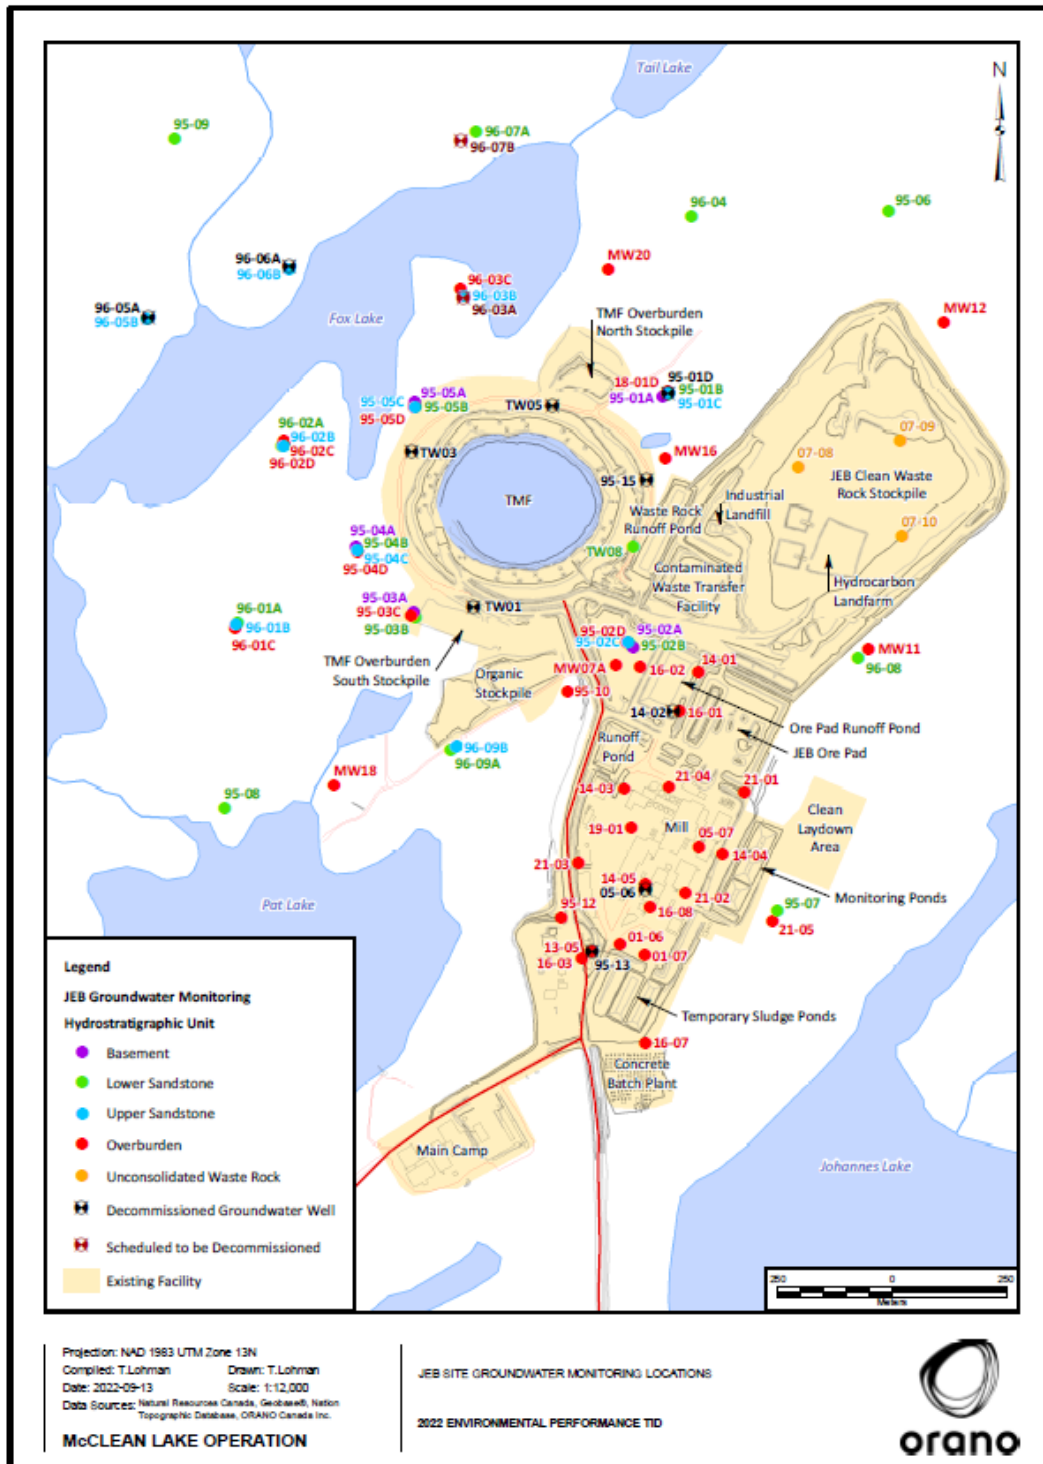
**Figure 9.1 JEB Site Groundwater Monitoring Locations**

To date, only a few minor trends have been observed. The water chemistry observed in the vicinity of the mining areas and JEB TMF show that there are no major changes to the groundwater chemistry to date that would indicate unanticipated migration of solutes. Mostly, the trends are related to the temporary lowering of the water table from mining activities resulting in the oxidation of rock in muskeg areas to the northeast and southwest of the JEB TMF, and from the recharge through the waste rock piles which contains some residual nitrogen from blasting. Overall, the concentrations of dissolved constituents in groundwater remain low (Orano 2023). Locations of the groundwater monitoring wells and surface water monitoring locations are shown in Figures 9.1 and 9.2 Respectively.

Groundwater monitoring and surface water monitoring is conducted throughout the McClean operation with specific groundwater wells and lakes that are sampled adjacent and downstream of the JEB TMF. This is part of Orano's larger environmental performance monitoring. Pre-development chemistry is compared to operational chemistry. The sampling frequency and parameters are outlined in the Saskatchewan Ministry of Environment (SMOE) Approval to Operate. The results are reported in Orano's Environmental Performance Technical Information Document (Orano 2022), the 2023 McClean Lake Operation Annual Report and provided to the SMOE and CNSC.
