CMD 19-H2.1

Written submission from Best Theratronics Limited

Application for the renewal of the Class IB Nuclear Substance Processing Facility Operating Licence Demande de renouvellement du permis d'exploitation d'une installation de traitement de substances nucléaires de catégorie IB

Commission Public Hearing

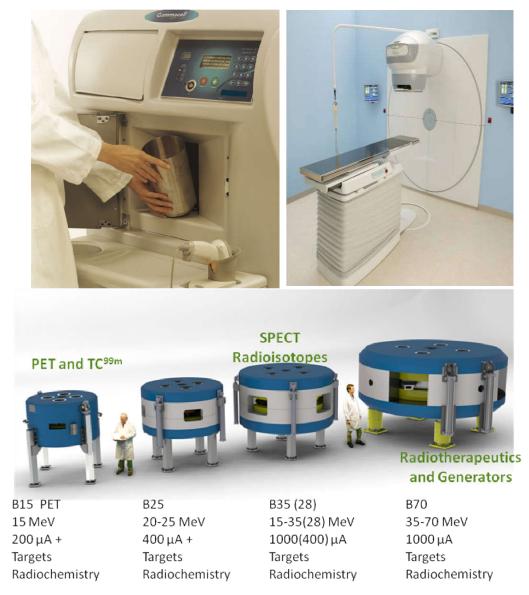
Our main products (Figure 2) related to current Class 1B licence included:

- 1. Co60-based external beam radiation therapy units,
- 2. Cs137-based self-contained irradiators (SCIs) for blood or research irradiation,
- 3. Cyclotrons with beam energies ranging from 15 to 70 MeV.

Figure 2 BTL products, shown clockwise from upper left: Gammacell blood irradiator; Co60 teletherapy unit; 15 – 70 MeV cyclotrons

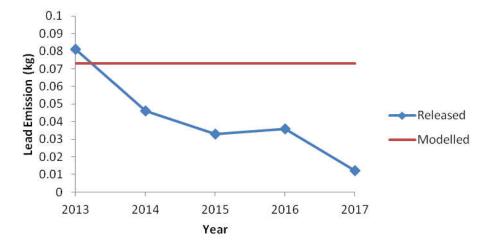
Figure 3 Lead emissions released between 2013 and 2017. The modelled value is a calculated emission estimate based on the amount of lead used annually at BTL.

BTL submits a report on lead, and its compounds, to the National Pollutant Release Inventory, maintaining annual compliance with the Toxics Reduction Act. There have not been any abnormal instances within the licensing period. Between 2013 and 2017, there has been a decrease in the amount of lead emissions released into the environment (Figure 3). This can be attributed to improvements in the lead control program over the time period, and to a decrease in manufacturing over the licensing period.
